Historic Libertyville

BEGINNING STREET NUMBER	<input type="text" value="609"/>
END STREET NUMBER	<input type="text" value="-"/>
STREET # SUFFIX	<input type="text" value="-"/>
STREET NAME	<input type="text" value="First Street"/>
PIN	<input type="text" value=""/>
<u>LOCAL</u>	
WITHIN LOCAL DISTRICT?	<input type="text" value="No"/>
LOCAL DIST CONTRIB/NON-CONTRIB?	<input type="text" value="C"/>
LOCAL LANDMARK?	<input type="text" value="No"/>
YEAR	<input type="text" value="-"/>
LOCAL LANDMARK ELIGIBLE?	<input type="text" value="No"/>
CRITERIA	<input type="text" value="-"/>

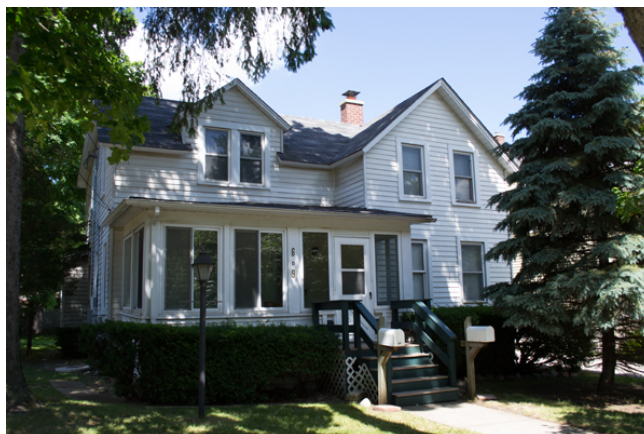
Photo Id: FirstSt609(1)

1.5-story north-end front gable bay intersected by 1.5-story south side gable wing; front porch structure is historic, but may not be original

One story rear additions are very early (pre-1924--see Sanborn map); aluminum siding (1990); front porch enclosed (1960); front through-the cornice dormer addition (no date); non-historic replacement windows in original openings
