Historic Libertyville

BEGINNING STREET NUMBER	<input type="text" value="619"/>
END STREET NUMBER	<input type="text" value="-"/>
STREET # SUFFIX	<input type="text" value="-"/>
STREET NAME	<input type="text" value="First Street"/>
PIN	<input type="text"/>
<u>LOCAL</u>	
WITHIN LOCAL DISTRICT?	<input type="text" value="No"/>
LOCAL DIST CONTRIB/NON-CONTRIB?	<input type="text" value="C"/>
LOCAL LANDMARK?	<input type="text" value="No"/>
YEAR	<input type="text" value="-"/>
LOCAL LANDMARK ELIGIBLE?	<input type="text" value="No"/>
CRITERIA	<input type="text" value="-"/>

Downtown Libertyville

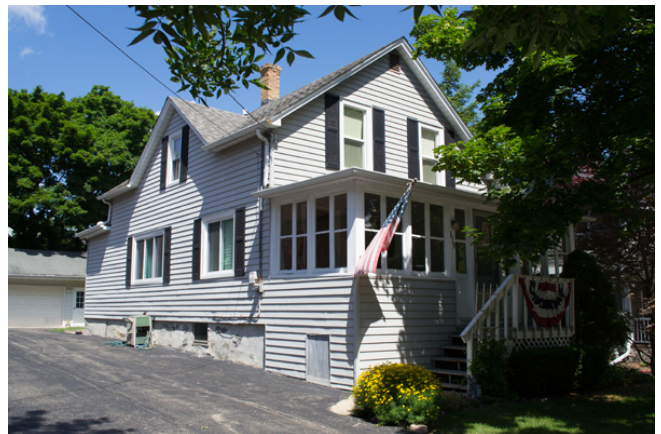
Photo Id: FirstSt619(1)

CATEGORY	<input type="text" value="Building"/>	HISTORIC USE	<input type="text" value="Domestic - single dwelling"/>
CONDITION	<input type="text" value="Good"/>	SECONDARY STRUCTURE	<input type="text" value="Detached garage"/>
INTEGRITY	<input type="text" value="Moderate alterations"/>	NR SECOND	<input type="text" value="NC"/>
CURRENT USE	<input type="text" value="Domestic - single dwelling"/>

Replacement windows in original openings (some casement windows, not historically appropriate, 2011); wood steps to front porch entrance
