Historic Libertyville

BEGINNING STREET NUMBER	<input type="text" value="113"/>
END STREET NUMBER	<input type="text" value="-"/>
STREET # SUFFIX	<input type="text" value="-"/>
STREET NAME	<input type="text" value="First Street"/>
PIN	<input type="text"/>
<u>LOCAL</u>	
WITHIN LOCAL DISTRICT?	<input type="text" value="No"/>
LOCAL DIST CONTRIB/NON-CONTRIB?	<input type="text" value="NC"/>
LOCAL LANDMARK?	<input type="text" value="No"/>
YEAR	<input type="text" value="-"/>
LOCAL LANDMARK ELIGIBLE?	<input type="text" value="No"/>
CRITERIA	<input type="text" value="-"/>

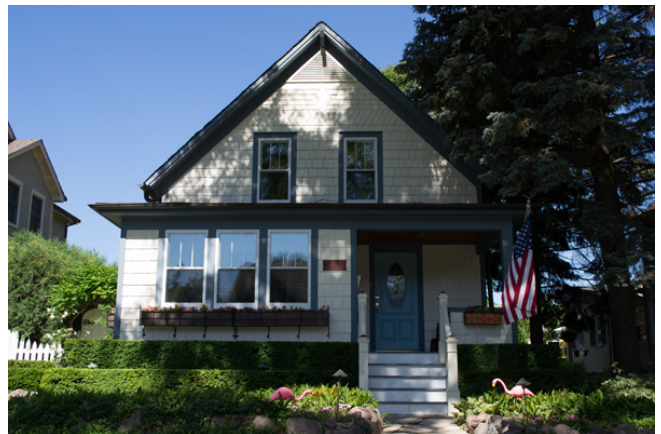
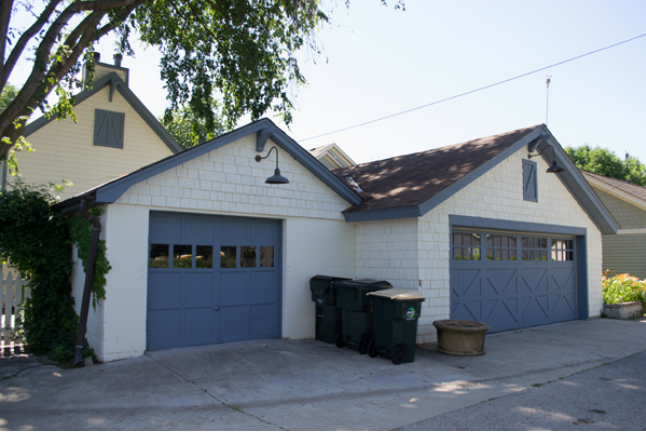
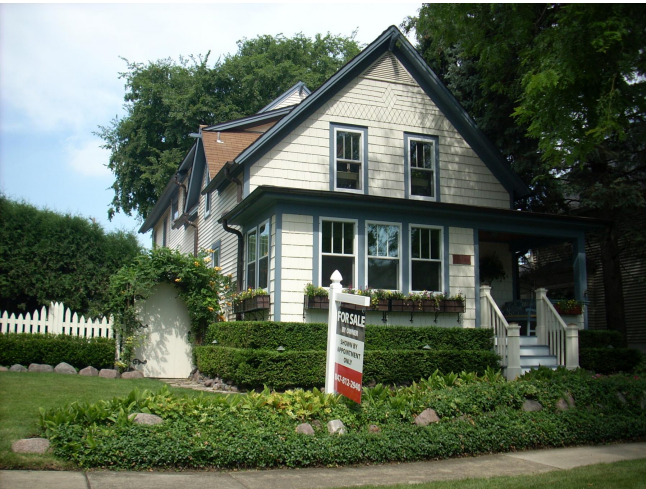
Photo Id: FirstSt113(2)

CATEGORY	<input type="text" value="Building"/>	HISTORIC USE	<input type="text" value="Domestic - single dwelling"/>
CONDITION	<input type="text" value="Good"/>	SECONDARY STRUCTURE	<input type="text" value="Detached garage"/>
INTEGRITY	<input type="text" value="Major alterations and additions"/>	NR SECOND	<input type="text" value="C"/>
CURRENT USE	<input type="text" value="Domestic - single dwelling"/>

Front gable roof; hipped roof full-front porch structure (partially enclosed c. 1920); historic (but not original) 3/1 double hung windows on front facade

Large 2-story rear addition that is taller than original house (1997); wood shingles on front facade (1951); front porch partially enclosed c. 1920; entry porch steps and railing are more recent

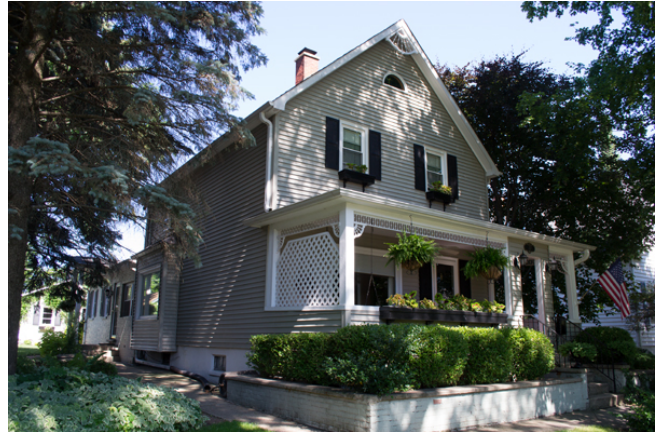
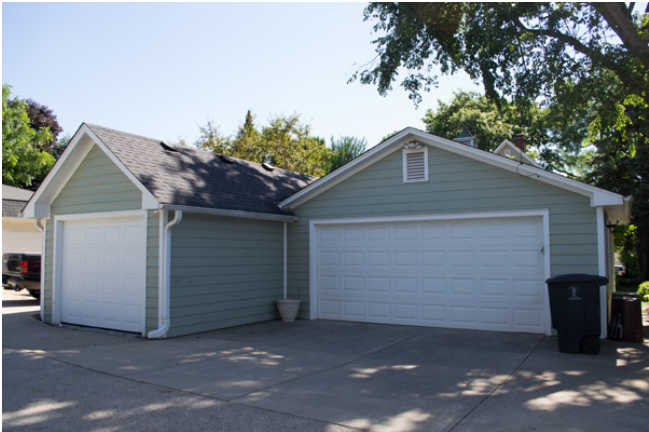
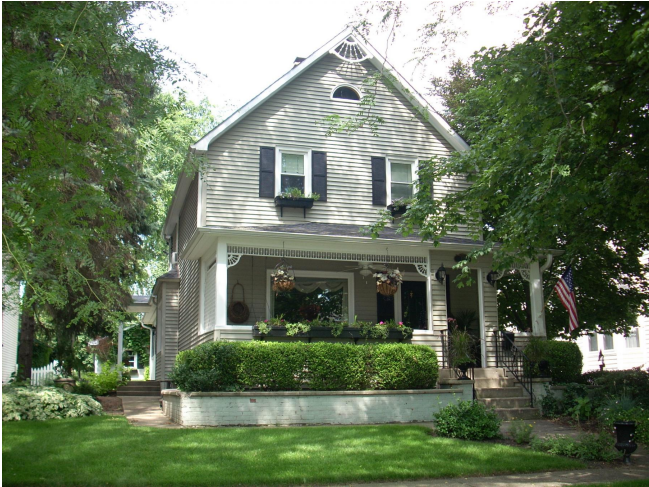
Photo Id: FirstSt117(1)

CATEGORY	Building	HISTORIC USE	Domestic - single dwelling
CONDITION	Good	SECONDARY STRUCTURE	Detached garage
INTEGRITY	Minor alterations and additions	NR SECOND	NC
CURRENT USE	Domestic - single dwelling

Front gable roof and rectangular massing; full-front hipped-roof porch structure

Replacement siding (1963); replacement windows in original openings (2010); one-story rear addition (1973); alterations to front porch--enclosure around entry; verge board at gable and spindle work on porch are not historic

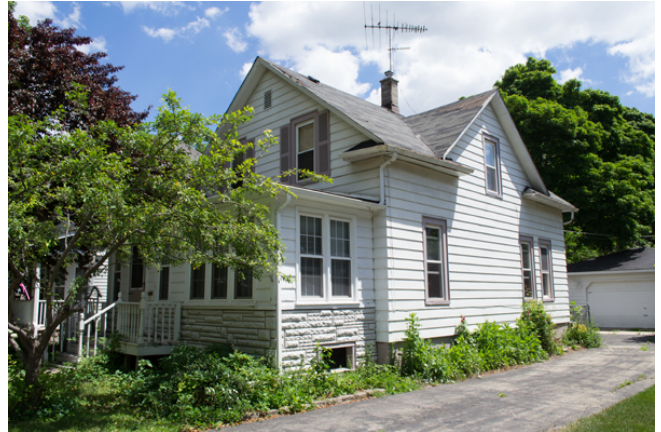
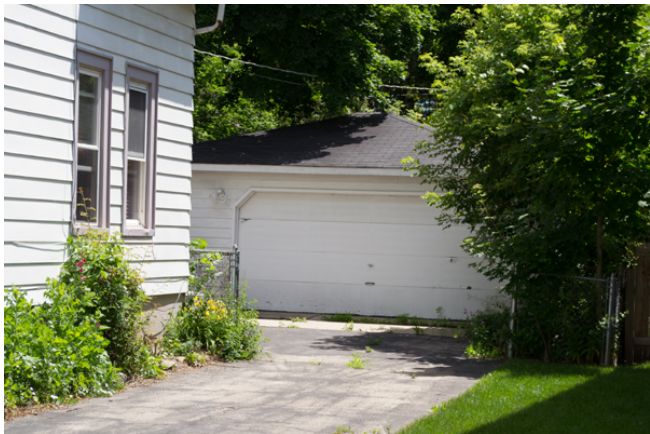
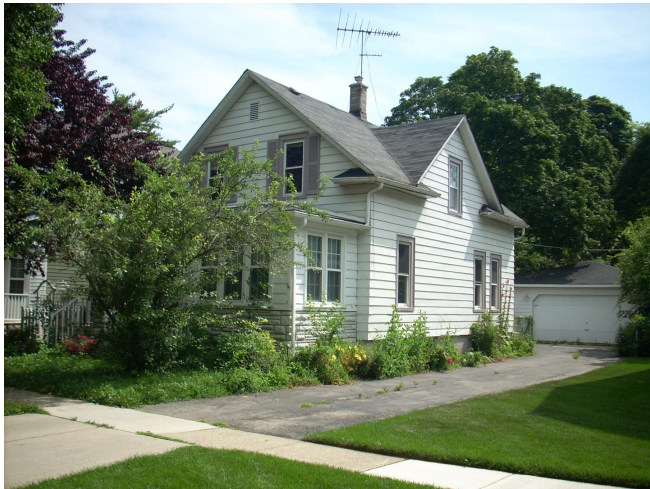
Photo Id: FirstSt118(2)

CATEGORY	<input type="text" value="Building"/>	HISTORIC USE	<input type="text" value="Domestic - single dwelling"/>
CONDITION	<input type="text" value="Good"/>	SECONDARY STRUCTURE	<input type="text" value="Detached garage"/>
INTEGRITY	<input type="text" value="Minor alterations"/>	NR SECOND	<input type="text" value="NC"/>
CURRENT USE	<input type="text" value="Domestic - single dwelling"/>

Front gable roof with cornice returns; north and south gable through-the-cornice dormers with cornice returns; hipped roof front porch structure (enclosed)

Replacement windows in original openings; front porch enclosed, wood entry stoop at porch entrance; replacement siding; fixed shutters on front facade

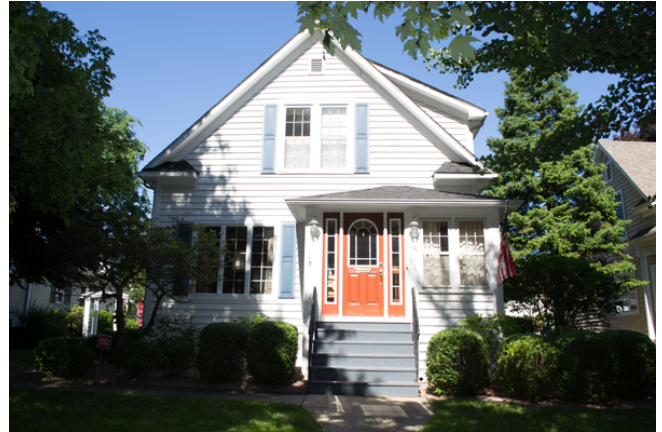
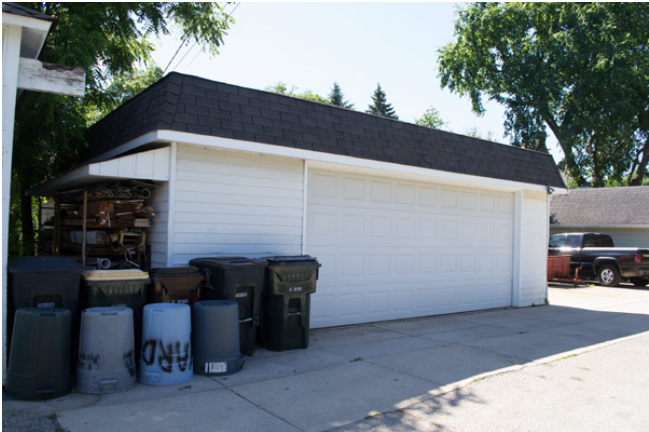
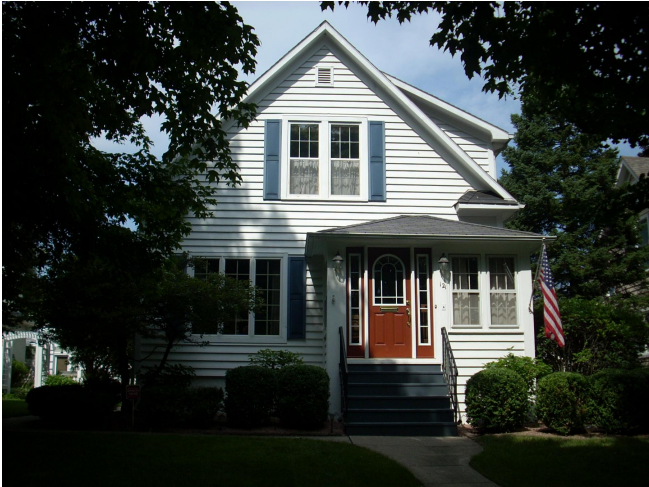
Photo Id: FirstSt121(1)

CATEGORY	Building	HISTORIC USE	Domestic - single dwelling
CONDITION	Good	SECONDARY STRUCTURE	Detached garage
INTEGRITY	Minor alterations and additions	NR SECOND	NC
CURRENT USE	Domestic - single dwelling

Front gable roof with cornice returns; south side gable through-the-cornice dormer; three-sided first story window bay on south facade; historic 6/6 wood windows

Front entry porch is historic addition (1924-1933) that was enclosed some time after 1948; replacement siding; replacement casement windows in front window bay; north side shed-roof dormer addition (1974)

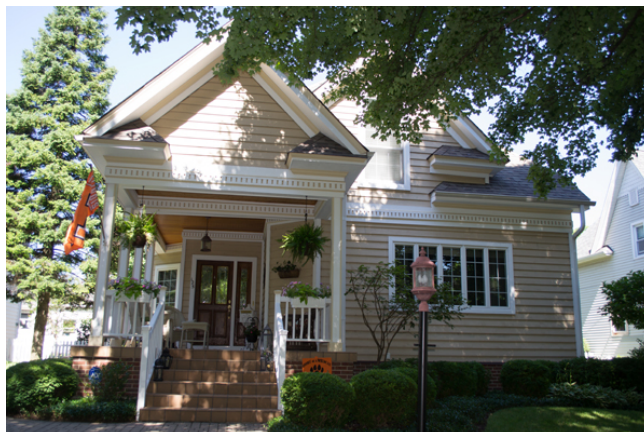
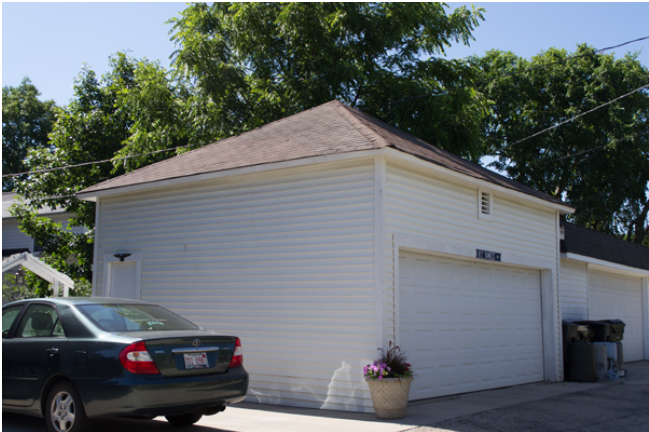
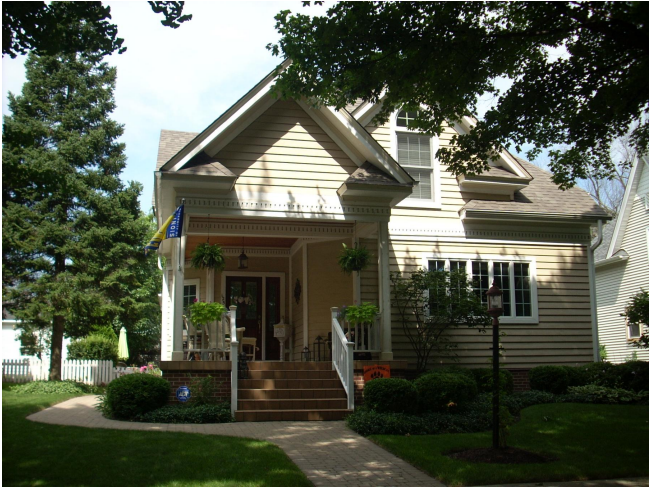
Photo Id: FirstSt125(2)

CATEGORY	Building	HISTORIC USE	Domestic - single dwelling
CONDITION	Good	SECONDARY STRUCTURE	Detached garage
INTEGRITY	Moderate alterations	NR SECOND	NC
CURRENT USE	Domestic - single dwelling

Steeply pitched hipped main roof; rectangular massing

Sanborn maps indicate that a polygonal front bay just north of the corner entry porch on the front facade was leveled off some time between 1924 and 1933; replacement front porch (2004); replacement siding; front gable through-the-wall dormer with round-arch window; replacement windows in original openings

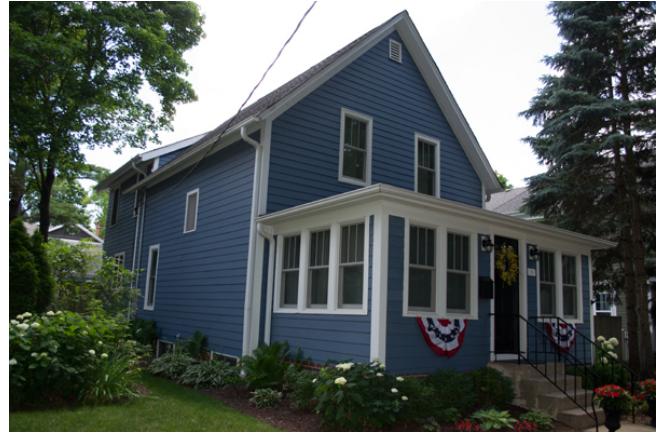
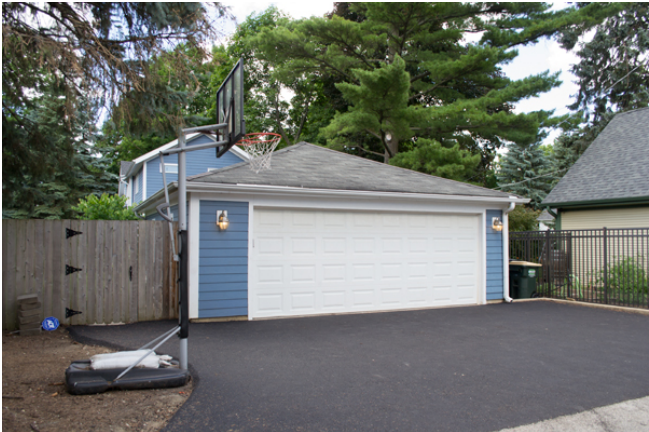
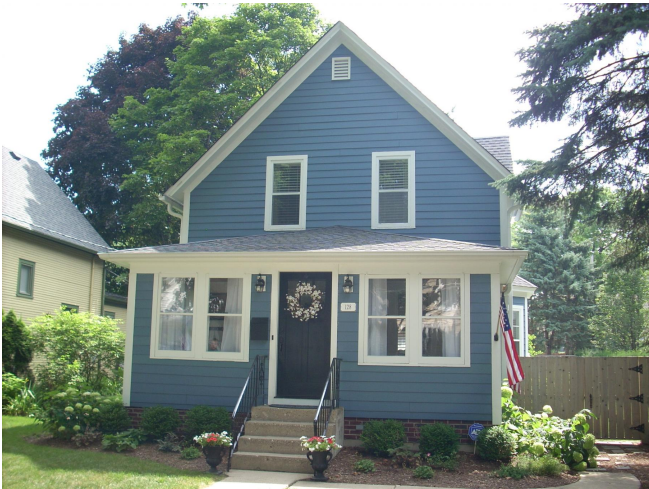
Photo Id: FirstSt128(2)

CATEGORY	Building	HISTORIC USE	Domestic - single dwelling
CONDITION	Good	SECONDARY STRUCTURE	Detached garage
INTEGRITY	Minor alterations	NR SECOND	C
CURRENT USE	Domestic - single dwelling

Front gable roof; south side gable dormer and three-sided first story window bay; hipped front porch structure (enclosed)

Replacement siding; front porch enclosed; 2-story rear addition (2005); replacement windows in original openings

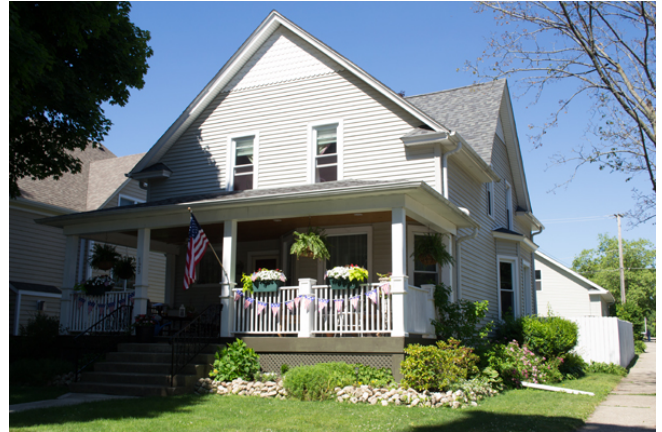
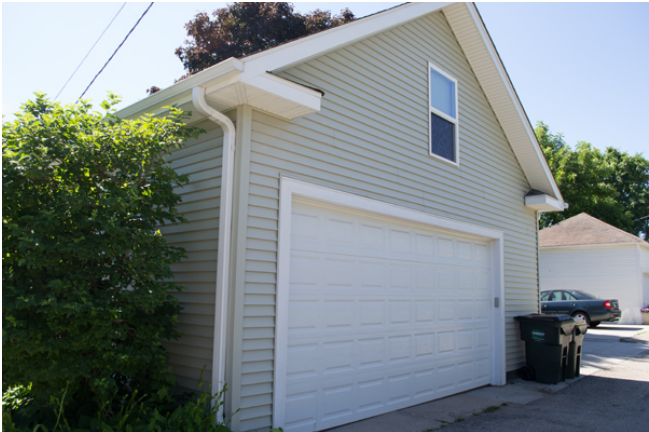
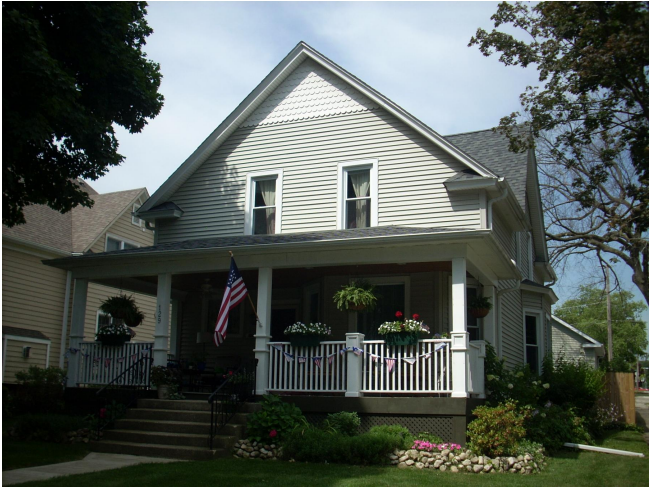
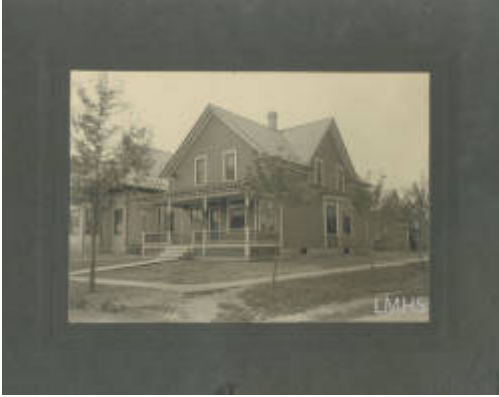
Photo Id: FirstSt129(1)

CATEGORY	Building	HISTORIC USE	Domestic - single dwelling
CONDITION	Good	SECONDARY STRUCTURE	Detached garage
INTEGRITY	Moderate alterations and additions	NR SECOND	NC
CURRENT USE	Domestic - single dwelling

Replacement siding; replacement windows in original openings; porch knee wall and columns are non-historic replacements

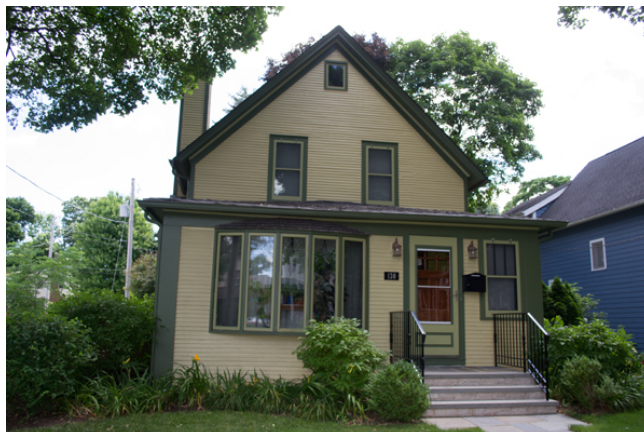
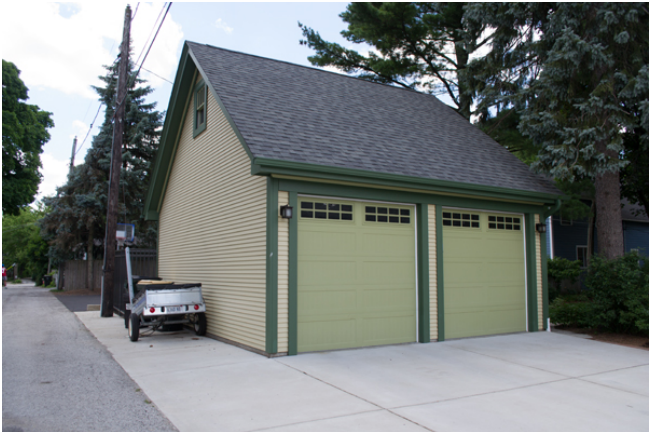
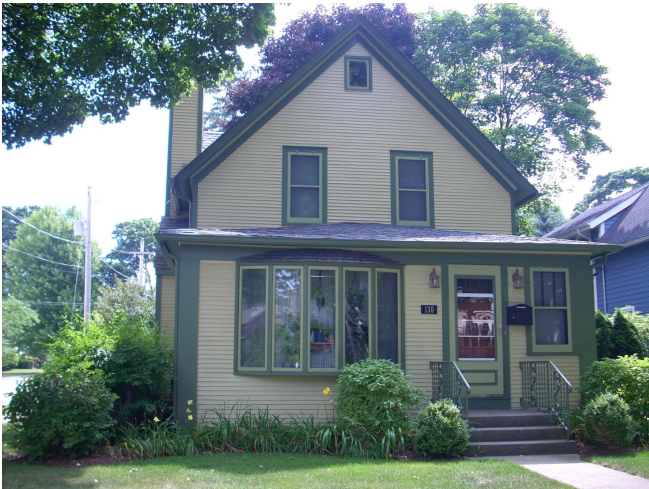
Photo Id: FirstSt130(2)

CATEGORY	Building	HISTORIC USE	Domestic - single dwelling
CONDITION	Good	SECONDARY STRUCTURE	Detached garage
INTEGRITY	Minor alterations	NR SECOND	C
CURRENT USE	Domestic - single dwelling

Front porch enclosed (c. 1920); chimney added to north elevation; curving bay window on front wall of porch (not historic); rear deck addition

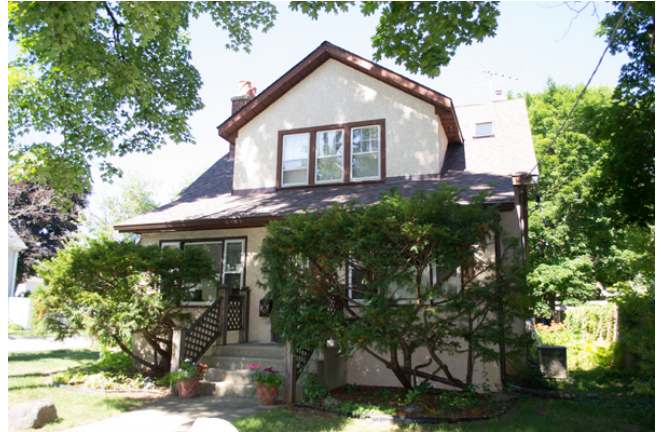
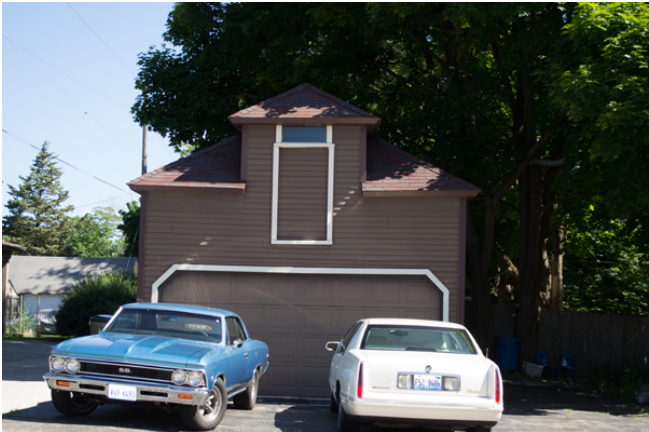
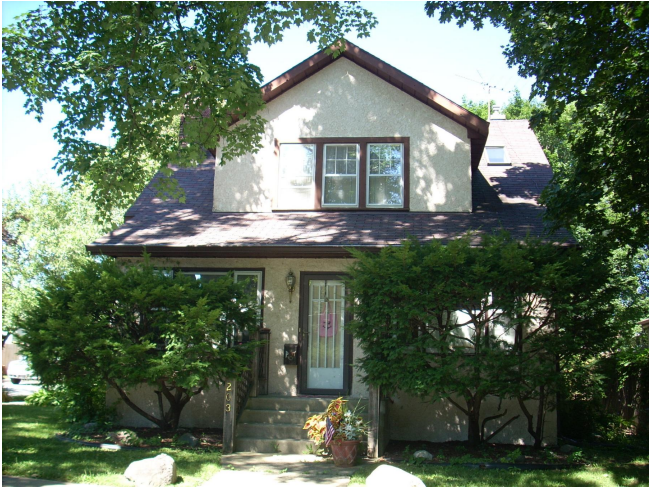
Photo Id: FirstSt203(1)

CATEGORY	Building	HISTORIC USE	Domestic - single dwelling
CONDITION	Good	SECONDARY STRUCTURE	Detached garage
INTEGRITY	Minor alterations	NR SECOND	NC
CURRENT USE	Domestic - single dwelling

Front porch enclosed (post-1948); wood and concrete front stoop is replacement; skylight
