# Historic Libertyville

<b>BEGINNING STREET NUMBER</b>	307
<b>END STREET NUMBER</b>	-
<b>STREET # SUFFIX</b>	-
<b>STREET NAME</b>	Brainerd Avenue
<b>PIN</b>	
<b><u>LOCAL</u></b>	
<b>WITHIN LOCAL DISTRICT?</b>	No
<b>LOCAL DIST CONTRIB/NON-CONTRIB?</b>	C
<b>LOCAL LANDMARK?</b>	No
<b>YEAR</b>	-
<b>LOCAL LANDMARK ELIGIBLE?</b>	Yes
<b>CRITERIA</b>	A

Photo Id: BrainerdAve307(1)

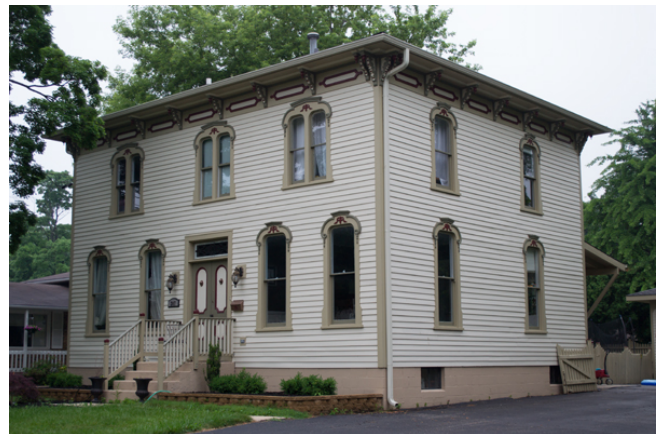
Handsome 19th-century Italianate residence with characteristic bracketed cornice and ornamental window surrounds. House was moved to current location in 1957.

Low-pitched hipped roof; paneled wood frieze with wood brackets; symmetrical facade with center entry; ornamental wood window surrounds

House moved in 1957 (concrete block foundation); replacement front stoop; replacement windows in original openings (historically appropriate type and configuration)
