Historic Libertyville

| STREET NAME | Douglas Avenue |

Tudor Revival

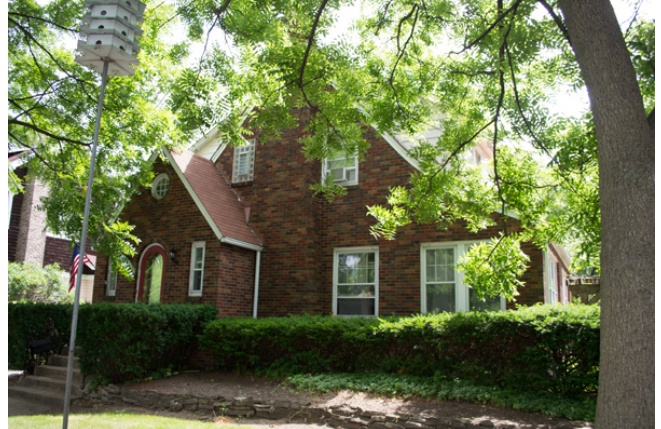
Photo Id: DouglasAve120(1)

| Good | Detached garage |
| Minor alterations and additions | C |

Broad, asymmetrical front gable roof that extends south to include a south side sun porch; prominent brick end chimney centered; nested 1-story front gable entry bay; round-arch front entry; historic wood windows

South side shed-roof dormer addition; replacement front door; rear deck addition; glass block window on front facade at 2nd story
