Historic Libertyville

BEGINNING STREET NUMBER	<input type="text" value="118"/>
END STREET NUMBER	<input type="text" value="-"/>
STREET # SUFFIX	<input type="text" value="-"/>
STREET NAME	<input type="text" value="First Street"/>
PIN	<input type="text"/>
<u>LOCAL</u>	
WITHIN LOCAL DISTRICT?	<input type="text" value="No"/>
LOCAL DIST CONTRIB/NON-CONTRIB?	<input type="text" value="C"/>
LOCAL LANDMARK?	<input type="text" value="No"/>
YEAR	<input type="text" value="-"/>
LOCAL LANDMARK ELIGIBLE?	<input type="text" value="No"/>
CRITERIA	<input type="text" value="-"/>

Photo Id: FirstSt118(2)

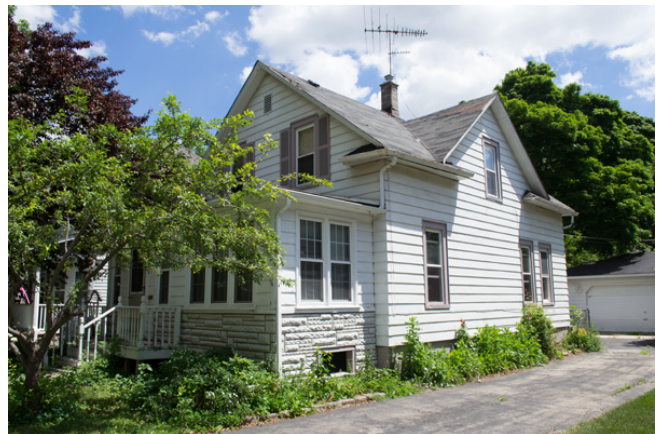
CATEGORY	<input type="text" value="Building"/>	HISTORIC USE	<input type="text" value="Domestic - single dwelling"/>
CONDITION	<input type="text" value="Good"/>	SECONDARY STRUCTURE	<input type="text" value="Detached garage"/>
INTEGRITY	<input type="text" value="Minor alterations"/>	NR SECOND	<input type="text" value="NC"/>
CURRENT USE	<input type="text" value="Domestic - single dwelling"/>

Front gable roof with cornice returns; north and south gable through-the-cornice dormers with cornice returns; hipped roof front porch structure (enclosed)

Replacement windows in original openings; front porch enclosed, wood entry stoop at porch entrance; replacement siding; fixed shutters on front facade
