Historic Libertyville

BEGINNING STREET NUMBER	<input type="text" value="121"/>
END STREET NUMBER	<input type="text" value="-"/>
STREET # SUFFIX	<input type="text" value="-"/>
STREET NAME	<input type="text" value="First Street"/>
PIN	<input type="text" value=""/>
<u>LOCAL</u>	
WITHIN LOCAL DISTRICT?	<input type="text" value="No"/>
LOCAL DIST CONTRIB/NON-CONTRIB?	<input type="text" value="C"/>
LOCAL LANDMARK?	<input type="text" value="No"/>
YEAR	<input type="text" value="-"/>
LOCAL LANDMARK ELIGIBLE?	<input type="text" value="No"/>
CRITERIA	<input type="text" value="-"/>

Photo Id: FirstSt121(1)

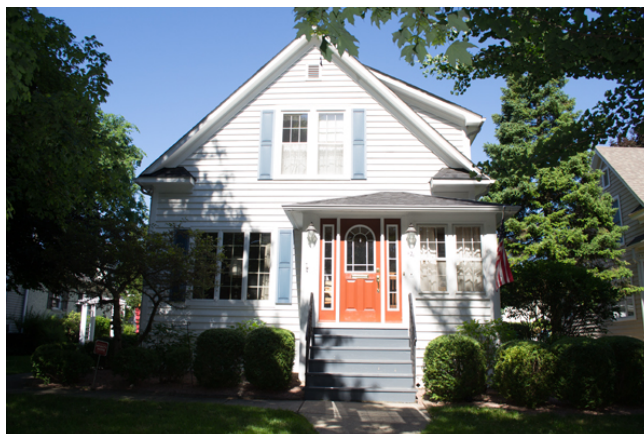
Front gable roof with cornice returns; south side gable through-the-cornice dormer; three-sided first story window bay on south facade; historic 6/6 wood windows

Front entry porch is historic addition (1924-1933) that was enclosed some time after 1948; replacement siding; replacement casement windows in front window bay; north side shed-roof dormer addition (1974)
