Historic Libertyville

BEGINNING STREET NUMBER	129
END STREET NUMBER	-
STREET # SUFFIX	-
STREET NAME	First Street
PIN	
<u>LOCAL</u>	
WITHIN LOCAL DISTRICT?	No
LOCAL DIST CONTRIB/NON-CONTRIB?	C
LOCAL LANDMARK?	No
YEAR	-
LOCAL LANDMARK ELIGIBLE?	No
CRITERIA	-

Photo Id: FirstSt129(1)

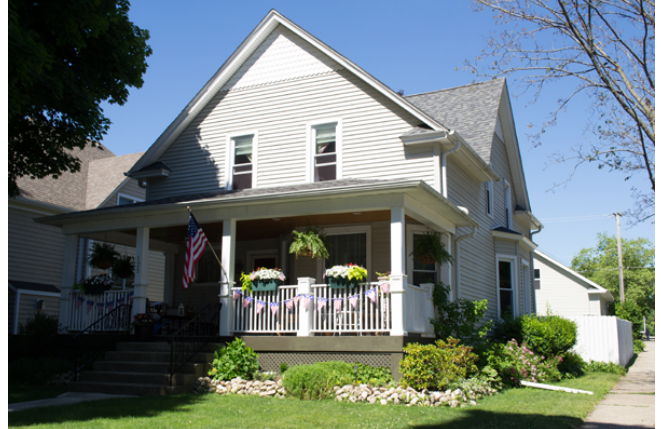
CATEGORY	HISTORIC USE
Building	Domestic - single dwelling
CONDITION	SECONDARY STRUCTURE
Good	Detached garage
INTEGRITY	NR SECOND
Moderate alterations and additions	NC
CURRENT USE	
Domestic - single dwelling

Front gable roof; north and south intersecting gables; three-sided north window bay; hipped roof full front porch structure (altered)

Replacement siding; replacement windows in original openings; porch knee wall and columns are non-historic replacements
