Historic Libertyville

BEGINNING STREET NUMBER	<input type="text" value="203"/>
END STREET NUMBER	<input type="text" value="-"/>
STREET # SUFFIX	<input type="text" value="-"/>
STREET NAME	<input type="text" value="First Street"/>
PIN	<input type="text"/>
<u>LOCAL</u>	
WITHIN LOCAL DISTRICT?	<input type="text" value="No"/>
LOCAL DIST CONTRIB/NON-CONTRIB?	<input type="text" value="C"/>
LOCAL LANDMARK?	<input type="text" value="No"/>
YEAR	<input type="text" value="-"/>
LOCAL LANDMARK ELIGIBLE?	<input type="text" value="No"/>
CRITERIA	<input type="text" value="-"/>

Photo Id: FirstSt203(1)

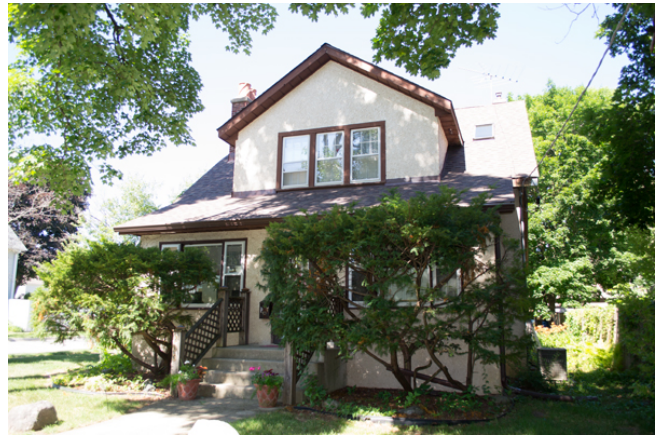
Broad side gable roof with overhanging eaves; large gable-roof front dormer; inset full-front porch with square stucco piers set on stucco knee wall (enclosed); historic 6/1 wood windows; south side square oriel window bay

Front porch enclosed (post-1948); wood and concrete front stoop is replacement; skylight
