Historic Libertyville

BEGINNING STREET NUMBER	<input type="text" value="208"/>
END STREET NUMBER	<input type="text" value="-"/>
STREET # SUFFIX	<input type="text" value="-"/>
STREET NAME	<input type="text" value="First Street"/>
PIN	<input type="text"/>
<u>LOCAL</u>	
WITHIN LOCAL DISTRICT?	<input type="text" value="No"/>
LOCAL DIST CONTRIB/NON-CONTRIB?	<input type="text" value="C"/>
LOCAL LANDMARK?	<input type="text" value="No"/>
YEAR	<input type="text" value="-"/>
LOCAL LANDMARK ELIGIBLE?	<input type="text" value="No"/>
CRITERIA	<input type="text" value="-"/>

Photo Id: FirstSt208(1)

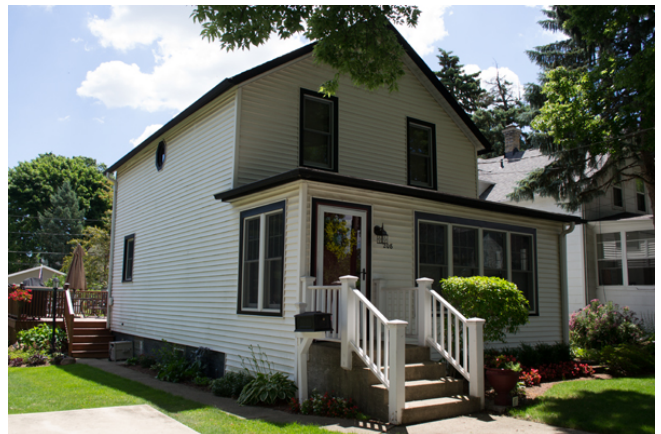
Front gable roof; rectangular massing; hipped-roof full-front porch structure

Replacement siding; replacement windows in original openings; front porch enclosed (1969); front steps replaced; rear deck addition
