# Historic Libertyville

<b>BEGINNING STREET NUMBER</b>	121
<b>END STREET NUMBER</b>	-
<b>STREET # SUFFIX</b>	-
<b>STREET NAME</b>	W. Park Avenue
<b>PIN</b>	
<b><u>LOCAL</u></b>	
<b>WITHIN LOCAL DISTRICT?</b>	No
<b>LOCAL DIST CONTRIB/NON-CONTRIB?</b>	C
<b>LOCAL LANDMARK?</b>	No
<b>YEAR</b>	-
<b>LOCAL LANDMARK ELIGIBLE?</b>	No
<b>CRITERIA</b>	-

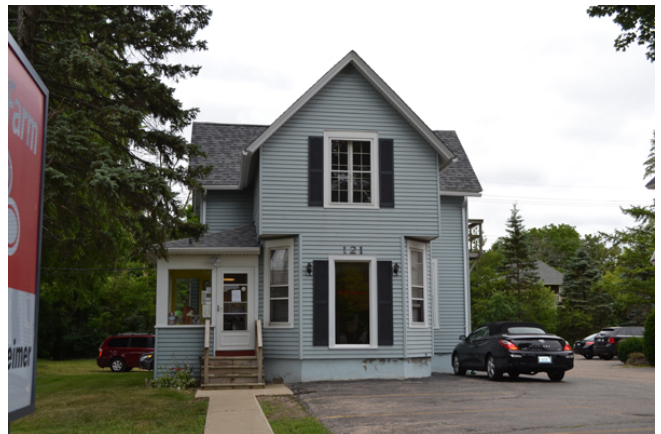
Photo Id: ParkAveW121(2)

Two story front gable bay with east and west two-story cross-bays; cutaway corners on front bay; square, east-side oriel bay with historic wood windows

Replacement siding (2005); replacement windows in downsized openings (except in oriel bay); corner entry porch (historic alteration likely dating from the 1910s or 20s, enclosed later); fixed shutters; rear east-side addition; east deck addition; exterior staircase on west bay (2006)
