Historic Libertyville

Photo Id: ParkAveW147(3)

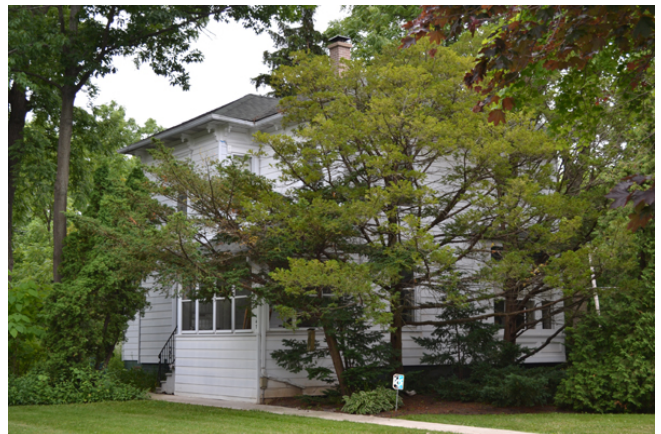
CATEGORY	<input type="text" value="Building"/>	HISTORIC USE	<input type="text" value="Domestic - single dwelling"/>
CONDITION	<input type="text" value="Good"/>	SECONDARY STRUCTURE	<input type="text" value="Barn"/>
INTEGRITY	<input type="text" value="Moderate alterations"/>	NR SECOND	<input type="text" value="C"/>
CURRENT USE	<input type="text" value="Domestic - single dwelling"/>

Hipped roof; wood cornice with paneled frieze and brackets with drop pendants; square front oriel bay with classical surround and historic wood windows; 1/1 wood windows on all facades with classical surrounds

Replacement siding (1976); Two-story rear addition; replacement front porch (later enclosed)
