Historic Libertyville

Photo Id: WrightCt320(1)

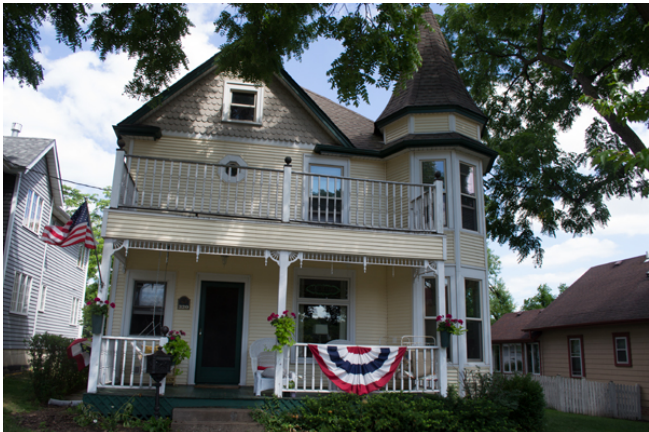
Hipped main roof with front gable bay; 2-story south bay with cutaway corners; hipped-roof front porch structure; historic wood front door

Replacement siding; replacement windows in original openings; replacement front porch; 2-story rear addition (2002)
