Historic Libertyville

| STREET NAME | <input type="text" value="W. Maple Avenue"/> |

Queen Anne

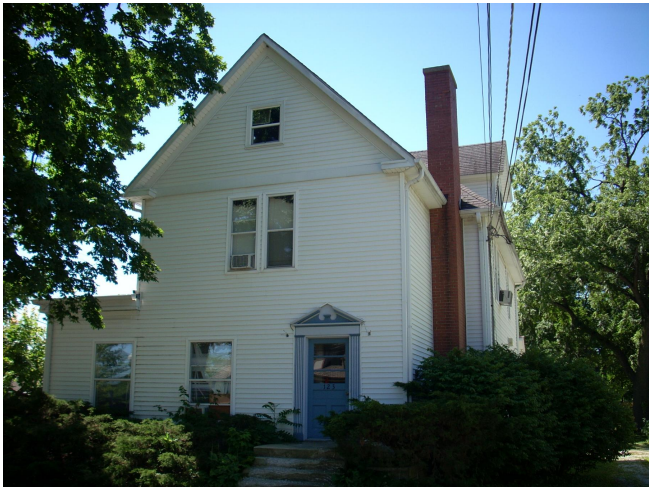
Photo Id: maple123

Hipped main roof; large 2-story front gable bay at north end; 2-story east bay with cutaway corners; west side gable dormer window

Replacement siding; original wraparound porch removed (post-1948); 1-story east side addition (may have originally been part of porch that was enclosed); replacement windows, most in original openings; 1st story front window in altered opening; replacement front door and surround, concrete stoop (1950s); concrete stoop and door at west elevation
