Historic Libertyville

| STREET NAME | W. Park Avenue |

BUILDING DETAILS

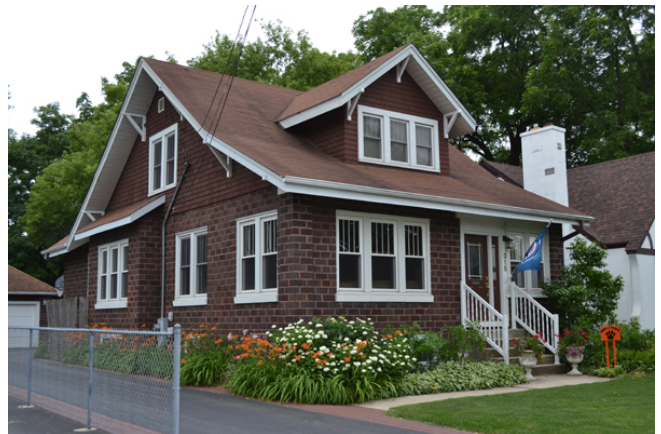
Photo Id: ParkAveW315(2)

| CONDITION | Good | SECONDARY STRUCTURE | Detached garage |
| INTEGRITY | Minor alterations | NR SECOND | C |

Side gable roof with overhanging eaves and L brackets; gable front dormer; inset corner entry porch with brick pier and knee walls; she-roof square window bay on east facade; oversized brick and wood shingle exterior

Replacement windows in original openings; front porch enclosed
