Historic Libertyville

Photo Id: CookAveE100(1)

Two Part Commercial Block

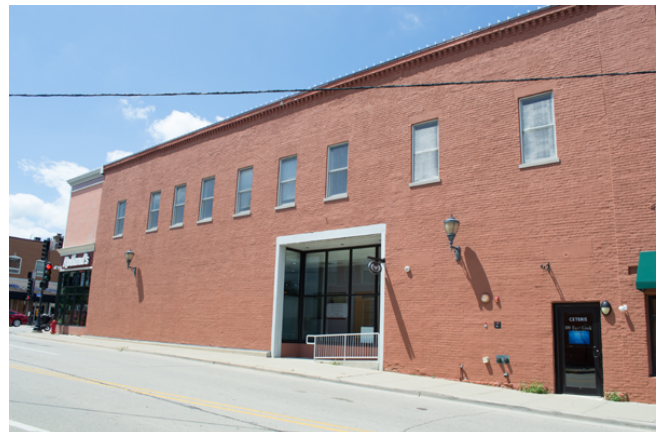
CATEGORY	<input type="text" value="Building"/>	HISTORIC USE	<input type="text" value="Commerce/Trade"/>
CONDITION	<input type="text" value="Good"/>	SECONDARY STRUCTURE	<input type="text" value="-"/>
INTEGRITY	<input type="text" value="Moderate alterations"/>	NR SECOND	<input type="text" value="-"/>
CURRENT USE	<input type="text" value="Commerce/Trade"/>

corbelled brick cornice; original stone lintels visible on 2nd floor

Brick painted; replacement windows in downsized openings on upper floors; replacement storefront windows and door in altered/downsized openings
