# Historic Libertyville

<b>BEGINNING STREET NUMBER</b>	755-759
<b>END STREET NUMBER</b>	-
<b>STREET # SUFFIX</b>	-
<b>STREET NAME</b>	N. Milwaukee Avenue
<b>PIN</b>	
<b>LOCAL</b>	
<b>WITHIN LOCAL DISTRICT?</b>	No
<b>LOCAL DIST CONTRIB/NON-CONTRIB?</b>	NC
<b>LOCAL LANDMARK?</b>	No
<b>YEAR</b>	-
<b>LOCAL LANDMARK ELIGIBLE?</b>	No
<b>CRITERIA</b>	-

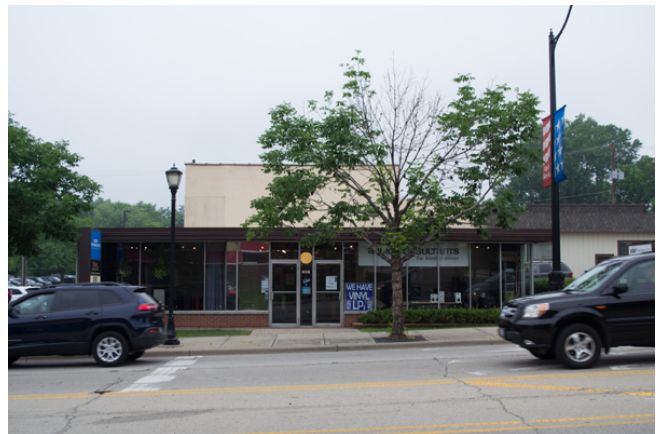
Photo Id: MilwaukeeAveN755(1)

East section of building was original gas station--garage openings still visible on south wall of building; metal angled storefront windows appear historic, but not original (1950s or 1960s)

Multiple 2-story west side additions (Assessor's photograph from the mid-1970s shows additions)
