# Historic Libertyville

<b>BEGINNING STREET NUMBER</b>	<input type="text" value="113"/>
<b>END STREET NUMBER</b>	<input type="text" value="-"/>
<b>STREET # SUFFIX</b>	<input type="text" value="-"/>
<b>STREET NAME</b>	<input type="text" value="First Street"/>
<b>PIN</b>	<input type="text"/>
<b><u>LOCAL</u></b>	
<b>WITHIN LOCAL DISTRICT?</b>	<input type="text" value="No"/>
<b>LOCAL DIST CONTRIB/NON-CONTRIB?</b>	<input type="text" value="NC"/>
<b>LOCAL LANDMARK?</b>	<input type="text" value="No"/>
<b>YEAR</b>	<input type="text" value="-"/>
<b>LOCAL LANDMARK ELIGIBLE?</b>	<input type="text" value="No"/>
<b>CRITERIA</b>	<input type="text" value="-"/>

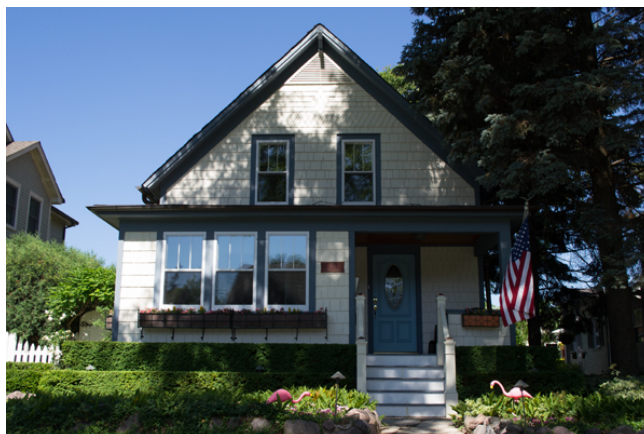
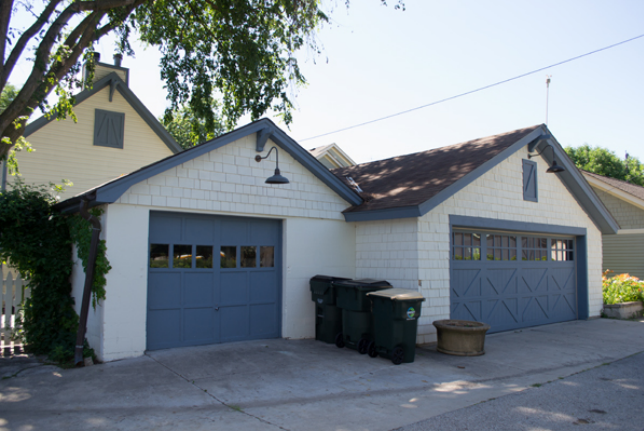
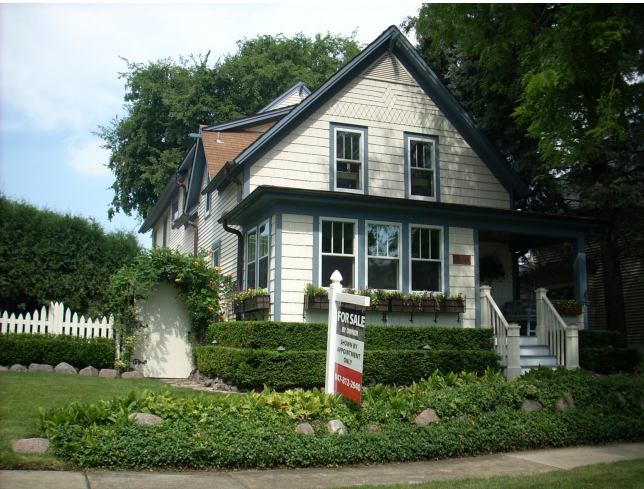
Photo Id: FirstSt113(2)

Front gable roof; hipped roof full-front porch structure (partially enclosed c. 1920); historic (but not original) 3/1 double hung windows on front facade

Large 2-story rear addition that is taller than original house (1997); wood shingles on front facade (1951); front porch partially enclosed c. 1920; entry porch steps and railing are more recent

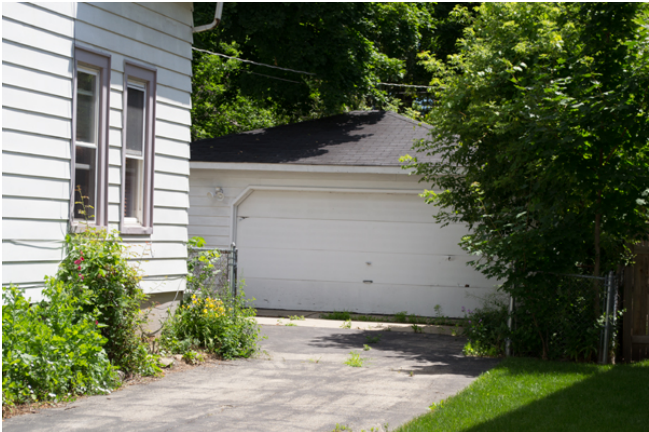
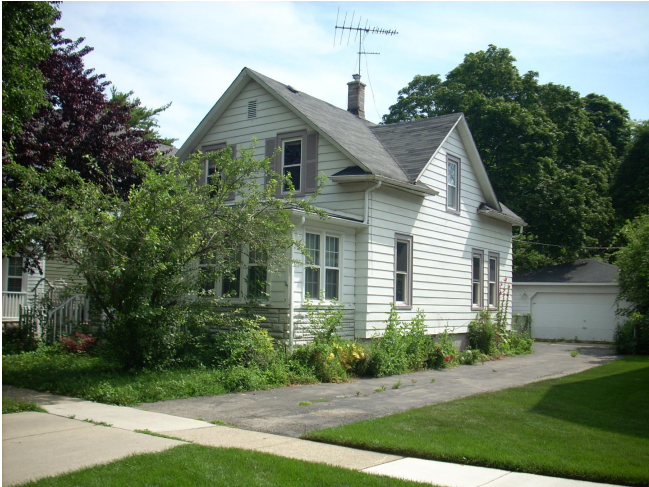
Photo Id: FirstSt118(2)

Front gable roof with cornice returns; north and south gable through-the-cornice dormers with cornice returns; hipped roof front porch structure (enclosed)

Replacement windows in original openings; front porch enclosed, wood entry stoop at porch entrance; replacement siding; fixed shutters on front facade

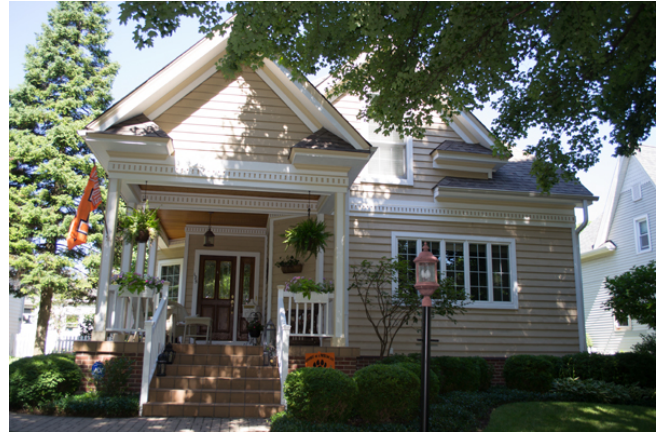
Photo Id: FirstSt125(2)

Steeply pitched hipped main roof; rectangular massing

Sanborn maps indicate that a polygonal front bay just north of the corner entry porch on the front facade was leveled off some time between 1924 and 1933; replacement front porch (2004); replacement siding; front gable through-the-wall dormer with round-arch window; replacement windows in original openings

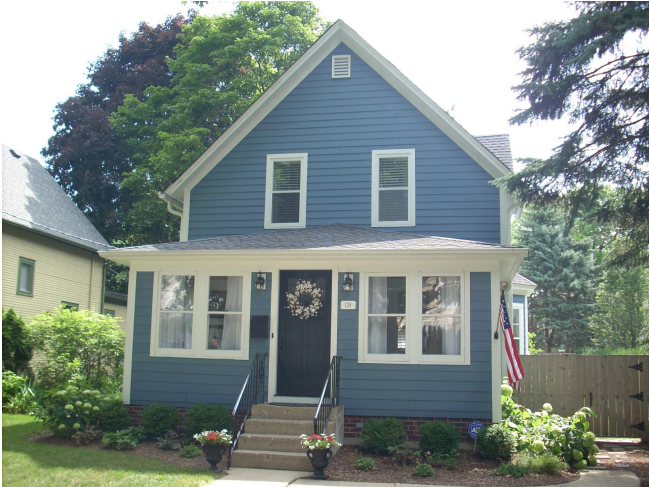
Photo Id: FirstSt128(2)

Replacement siding; front porch enclosed; 2-story rear addition (2005); replacement windows in original openings

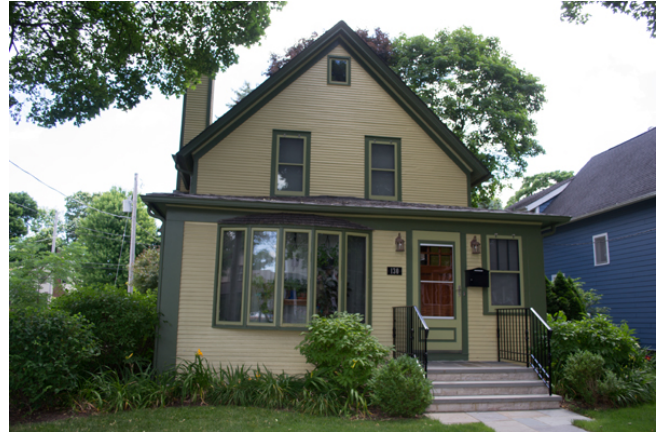
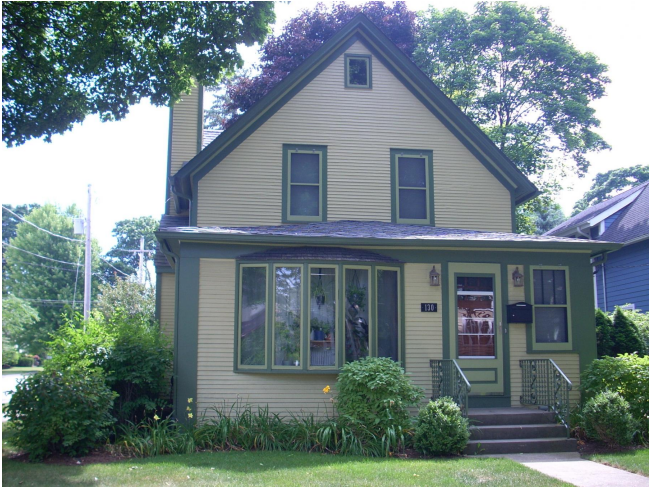
Photo Id: FirstSt130(2)

Front porch enclosed (c. 1920); chimney added to north elevation; curving bay window on front wall of porch (not historic); rear deck addition

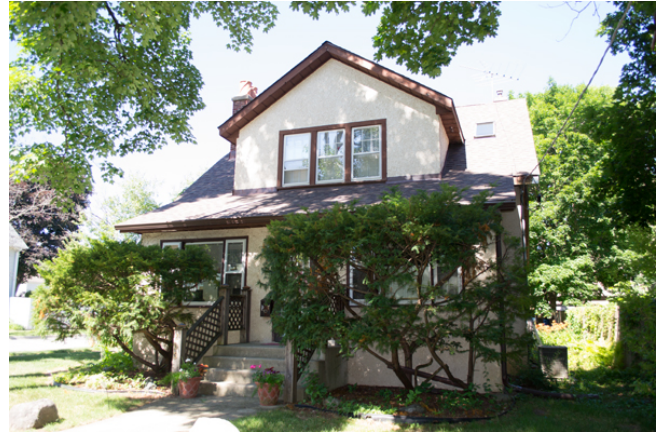
Photo Id: FirstSt203(1)

Front porch enclosed (post-1948); wood and concrete front stoop is replacement; skylight
