# Historic Libertyville

<b>BEGINNING STREET NUMBER</b>	<input type="text" value="204"/>
<b>END STREET NUMBER</b>	<input type="text" value="-"/>
<b>STREET # SUFFIX</b>	<input type="text" value="-"/>
<b>STREET NAME</b>	<input type="text" value="First Street"/>
<b>PIN</b>	<input type="text" value=""/>
<b><u>LOCAL</u></b>	
<b>WITHIN LOCAL DISTRICT?</b>	<input type="text" value="No"/>
<b>LOCAL DIST CONTRIB/NON-CONTRIB?</b>	<input type="text" value="C"/>
<b>LOCAL LANDMARK?</b>	<input type="text" value="No"/>
<b>YEAR</b>	<input type="text" value="-"/>
<b>LOCAL LANDMARK ELIGIBLE?</b>	<input type="text" value="No"/>
<b>CRITERIA</b>	<input type="text" value="-"/>

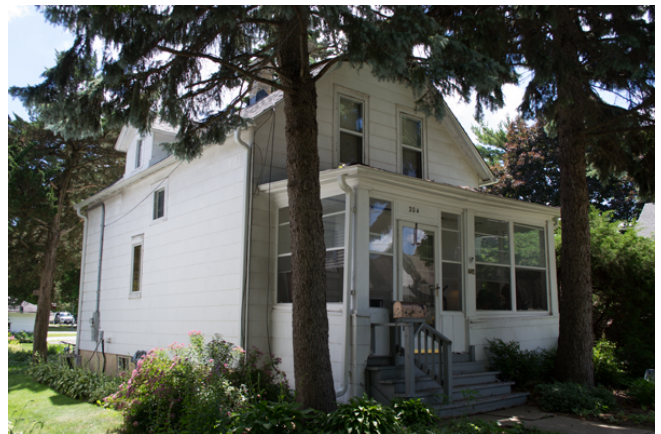
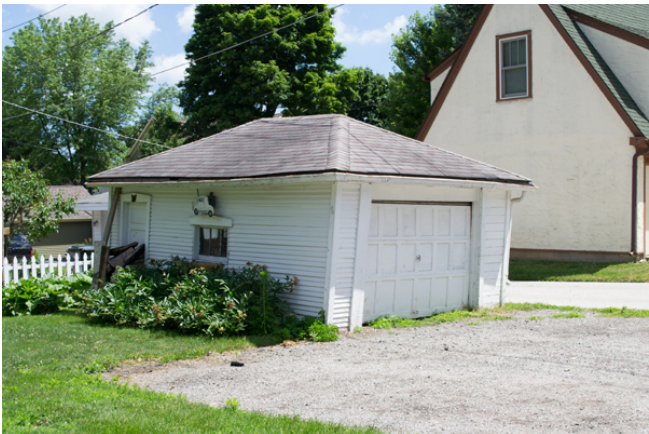
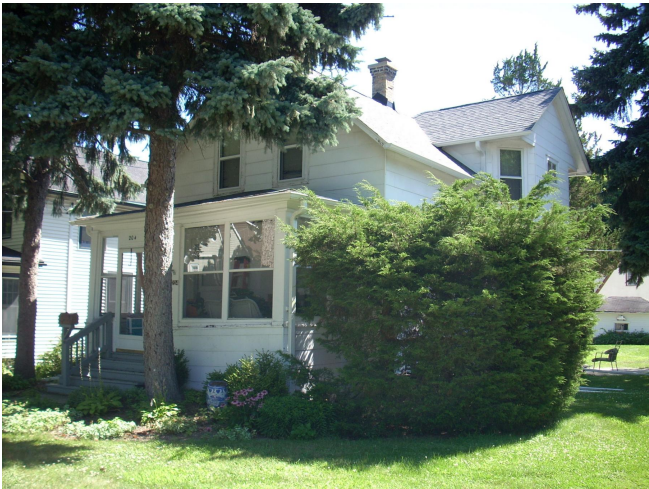
Photo Id: FirstSt204(1)

Front gable roof; rectangular massing; 2-story south side bay with cutaway corners; hipped roof porch structure (partially enclosed); north side gable dormer; historic 1/1 wood windows

Replacement siding; front porch partially enclosed; replacement front steps to porch

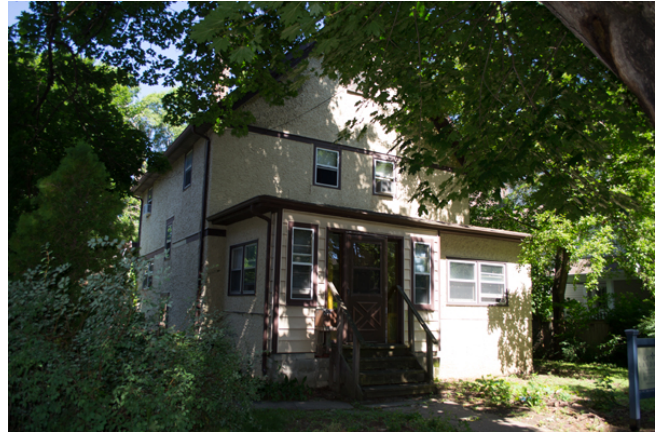
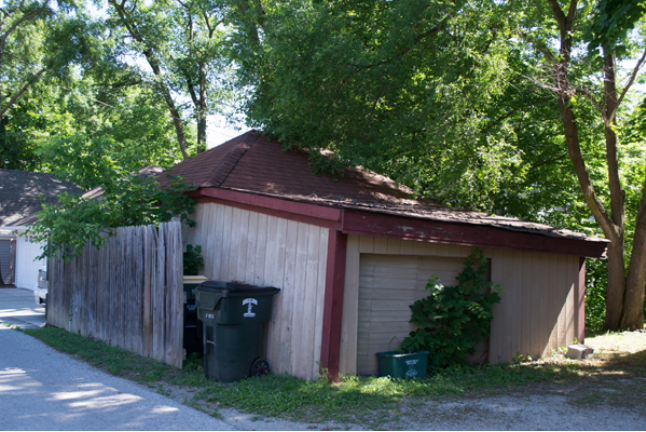
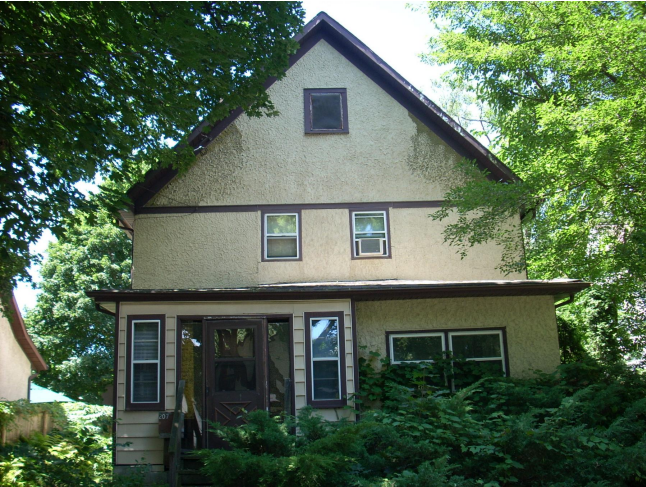
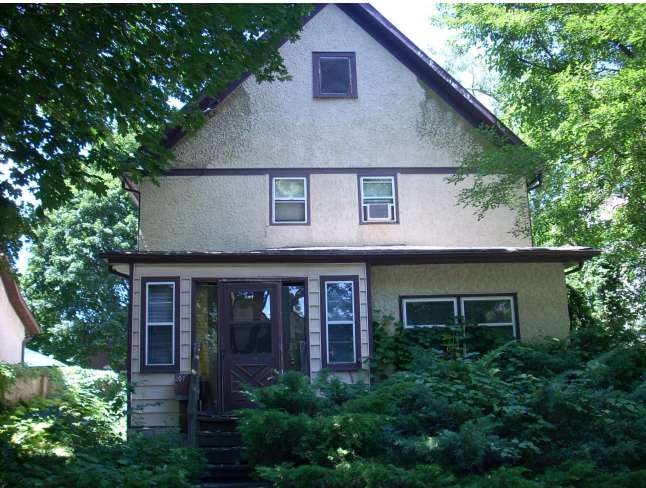
Photo Id: FirstSt207(1)

Front gable roof and rectangular massing; hipped roof front porch structure (enclosed)

Front porch enclosed (appears to have been enclosed partially at an earlier date, then fully enclosed later--non-historic windows in porch); windows on second story of front facade appear too small--may be replacement windows in downsized openings

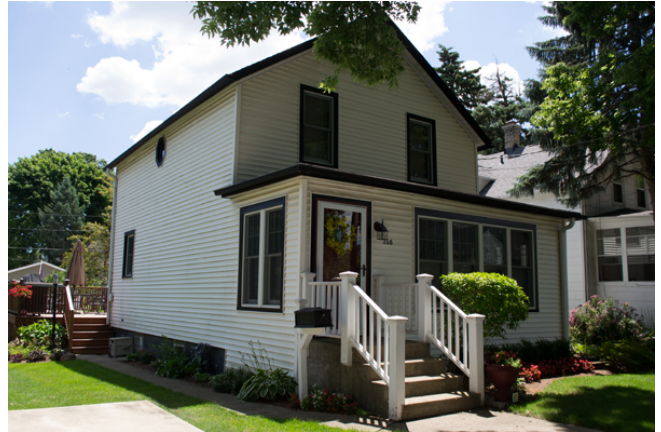
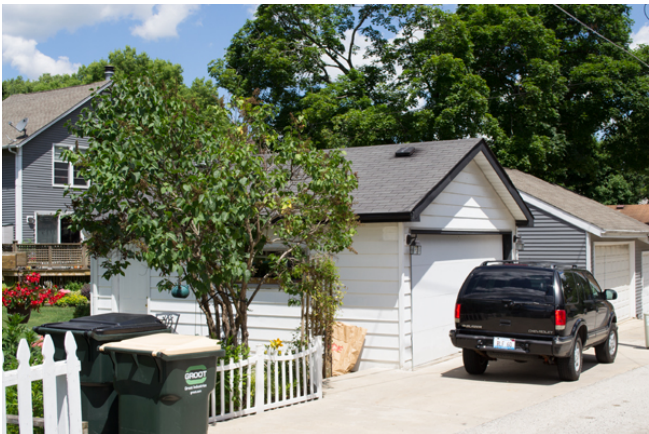
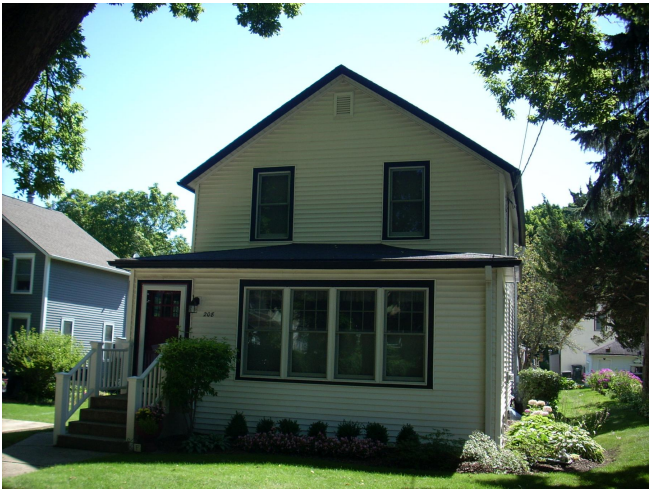
Photo Id: FirstSt208(1)

Front gable roof; rectangular massing; hipped-roof full-front porch structure

Replacement siding; replacement windows in original openings; front porch enclosed (1969); front steps replaced; rear deck addition

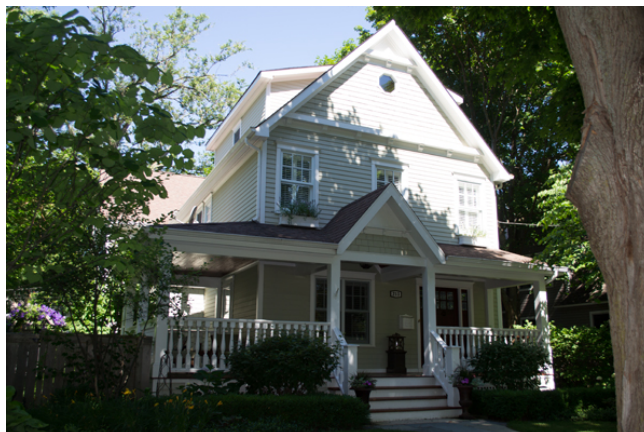
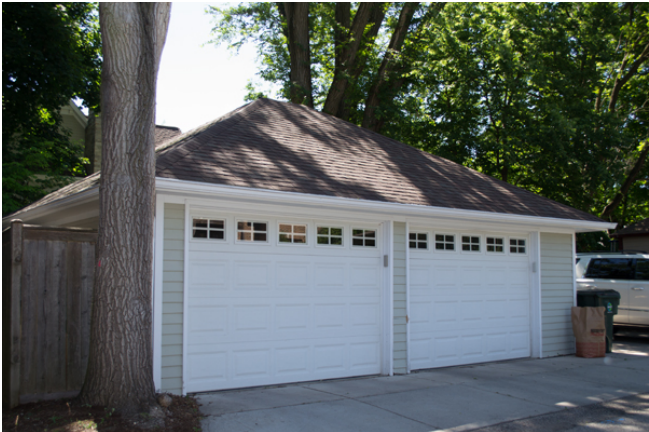
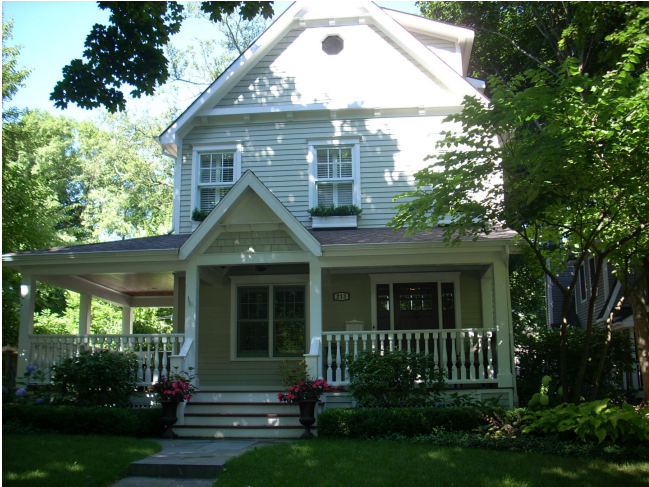
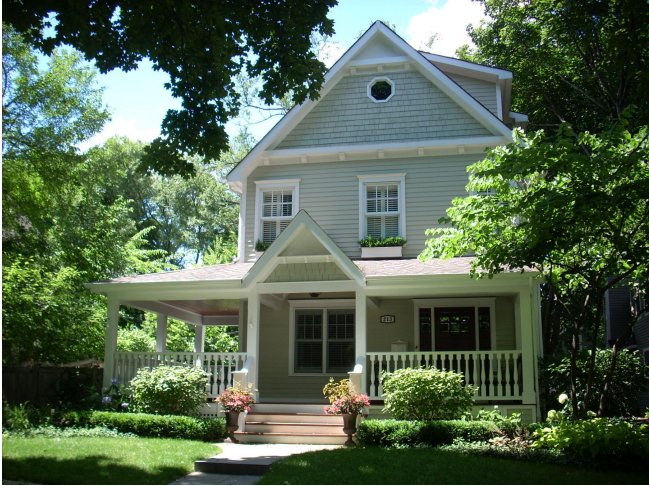
Photo Id: FirstSt213(1)

[According to Sanborn maps from 1924-1948, house was a 1.5-story dwelling with a full-width, open front porch]

Original house obscured by multiple alterations and additions, most of which date from 2012--wraparound front porch; multiple dormer additions on north and south side of roof (1962, later); large 2-story rear addition; replacement siding; replacement windows in original openings

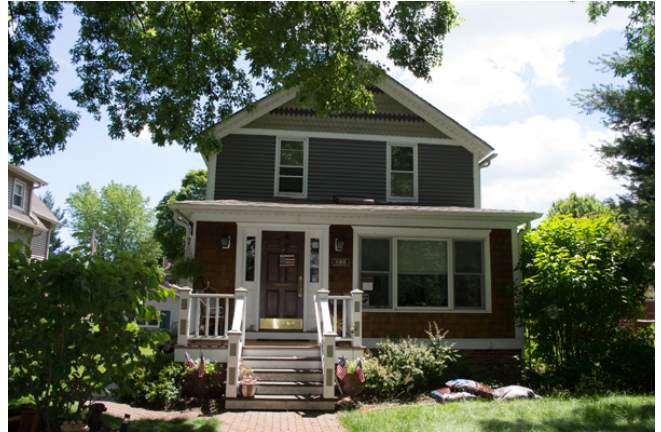
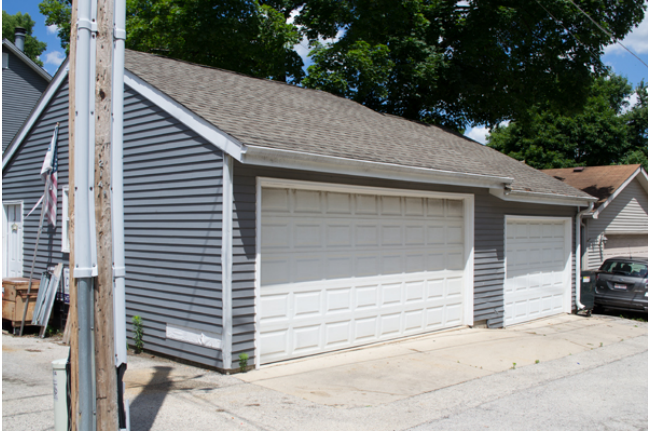
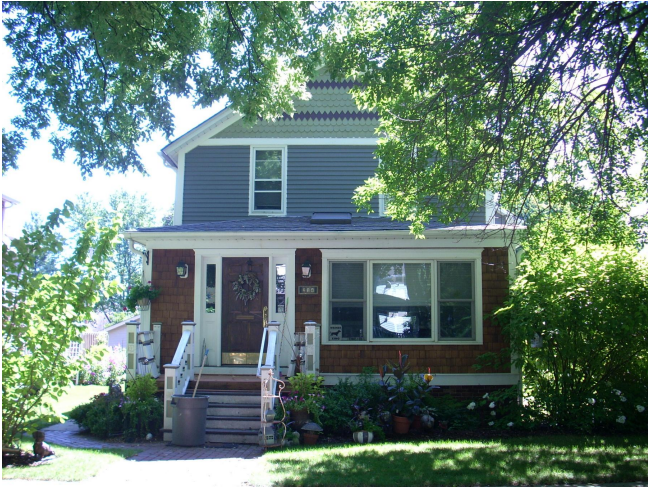
Photo Id: FirstSt214(2)

Front gable roof; rectangular massing; hipped-roof full-front porch structure (enclosed)

Front porch enclosed (2004); 2-story rear addition and deck (1991-2); replacement siding; replacement windows in original openings

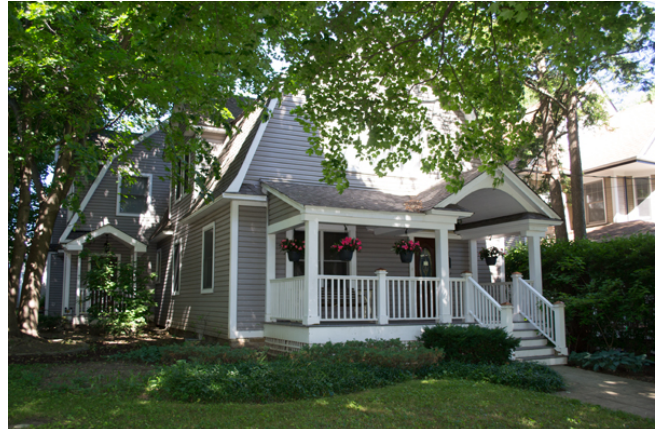
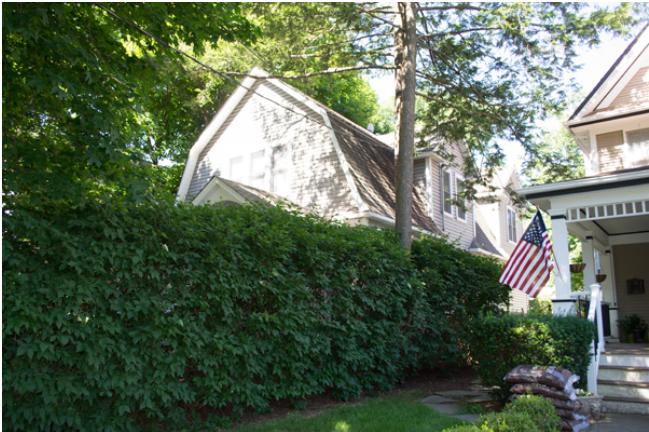
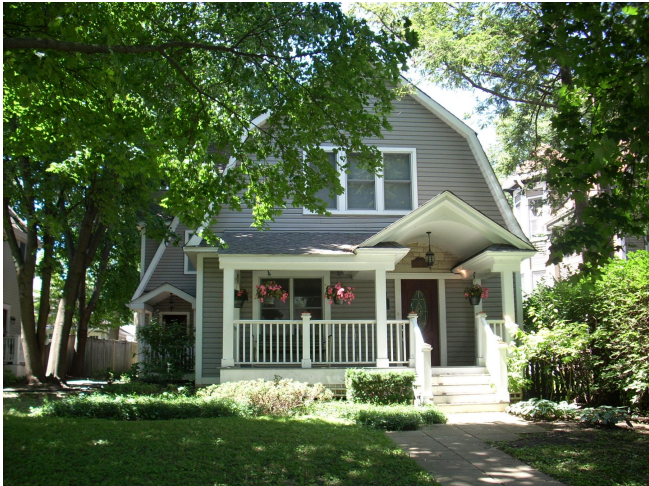
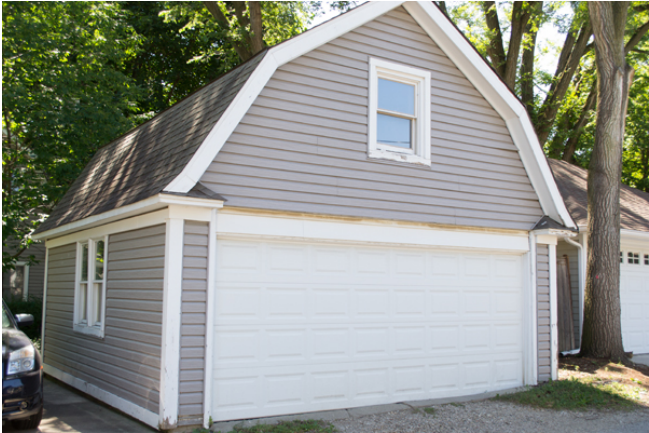
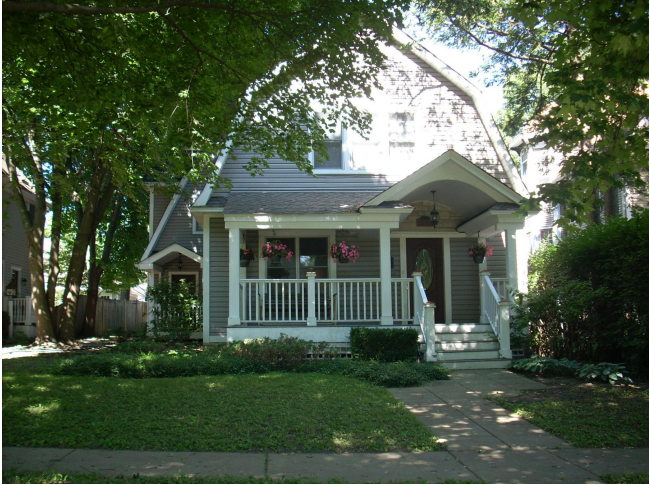
Photo Id: FirstSt217(1)

Front gambrel roof; large gabled through-the-cornice dormer on north facade

Replacement siding; replacement front porch (not historic); 2-story rear/south addition (2003); stone veneer above entry (1950s); replacement front door; replacement windows in original openings

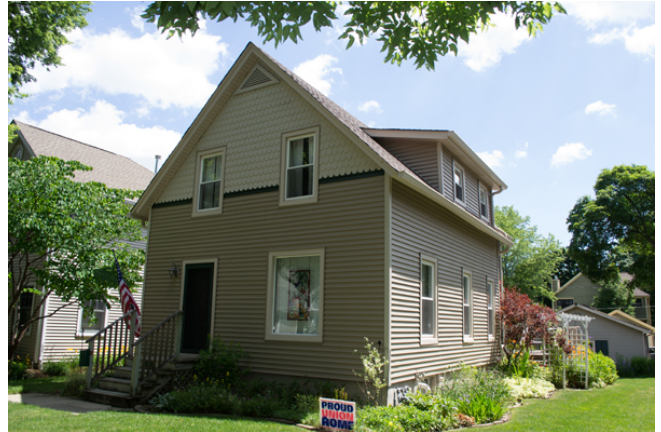
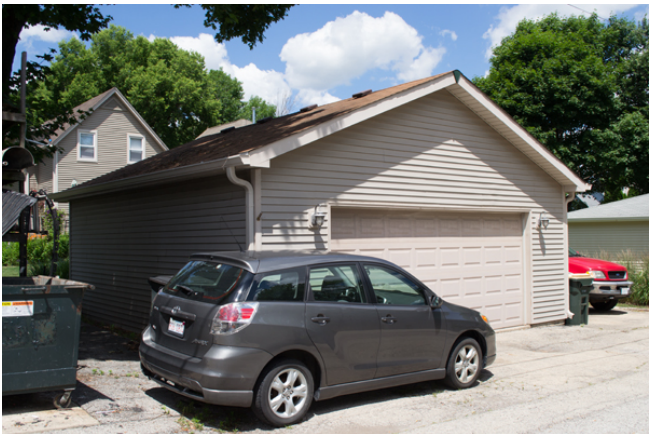
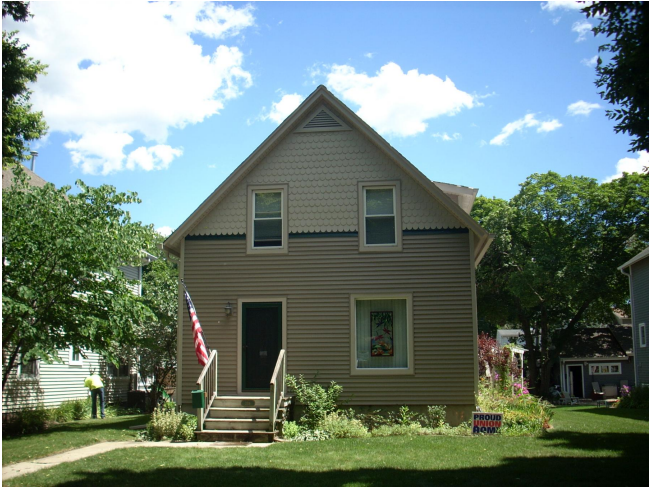
Photo Id: FirstSt218(1)

Replacement siding; replacement windows in original openings; south dormer addition; front porch removed; wood entry stoop; replacement front door

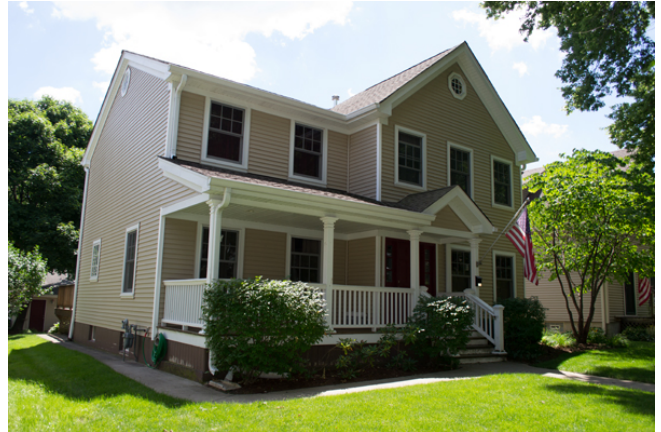
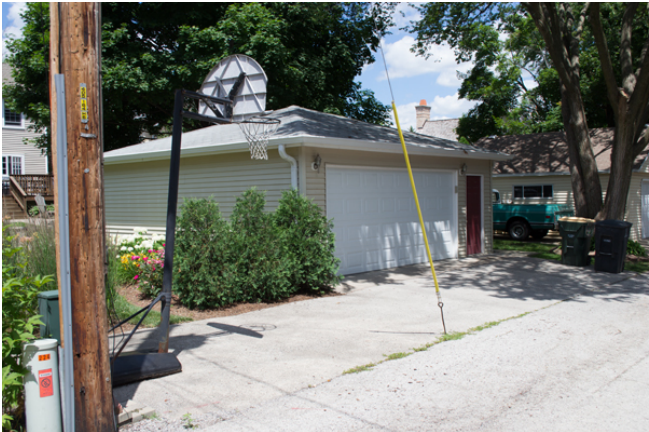
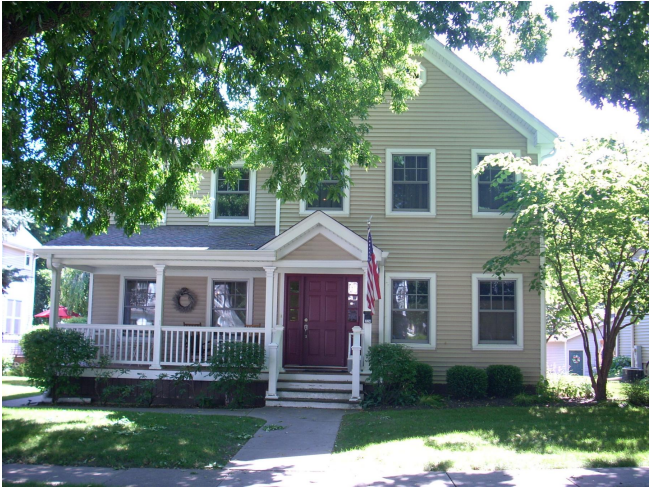
Photo Id: FirstSt224(2)

Original one-story frame residence (1956) obscured by extensive alterations and additions--2nd story addition; front porch; replacement siding; replacement windows on first story of original house; replacement front door

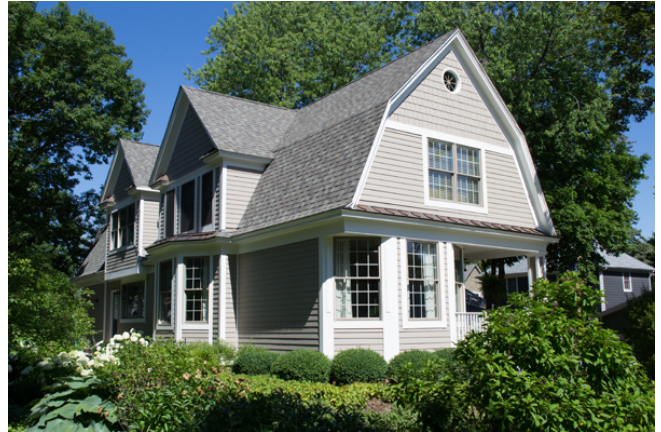
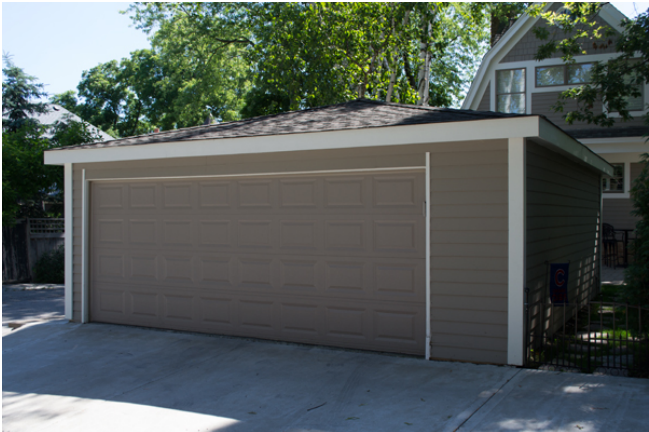
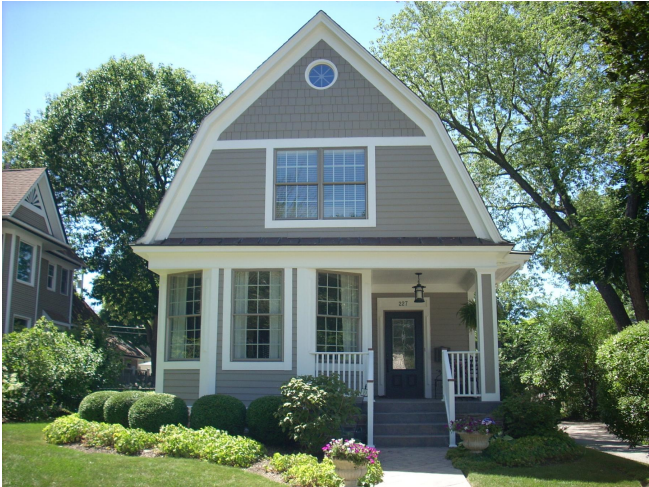
Photo Id: FirstSt227(1)

Replacement siding; replacement windows in original openings (configuration is not historically appropriate); two-story rear addition (2007); round window under front gambrel
