Historic Libertyville

BEGINNING STREET NUMBER	<input type="text" value="525"/>
END STREET NUMBER	<input type="text" value="-"/>
STREET # SUFFIX	<input type="text" value="-"/>
STREET NAME	<input type="text" value="First Street"/>
PIN	<input type="text"/>
<u>LOCAL</u>	
WITHIN LOCAL DISTRICT?	<input type="text" value="No"/>
LOCAL DIST CONTRIB/NON-CONTRIB?	<input type="text" value="NC"/>
LOCAL LANDMARK?	<input type="text" value="No"/>
YEAR	<input type="text" value="-"/>
LOCAL LANDMARK ELIGIBLE?	<input type="text" value="No"/>
CRITERIA	<input type="text" value="-"/>

Photo Id: FirstSt525(3)

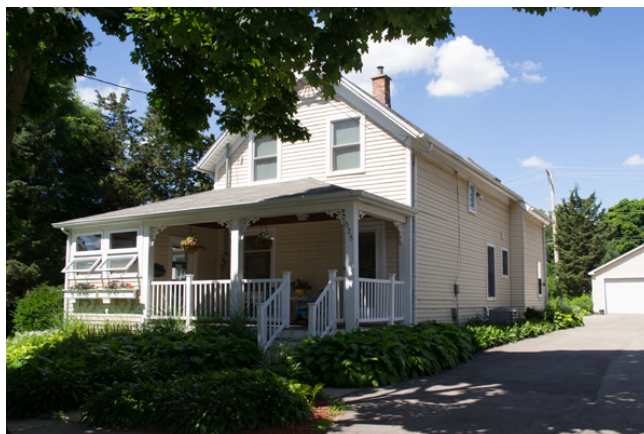
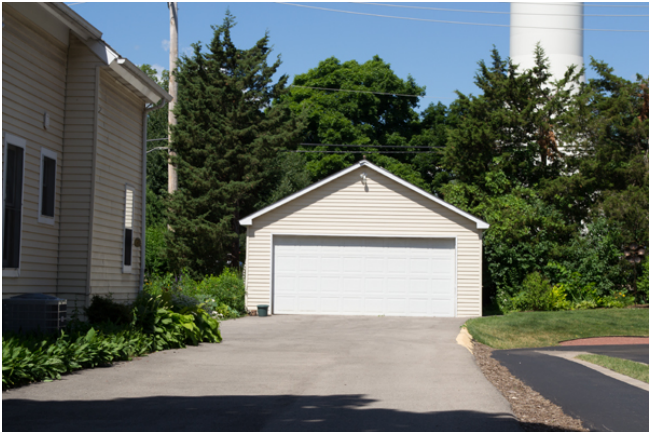
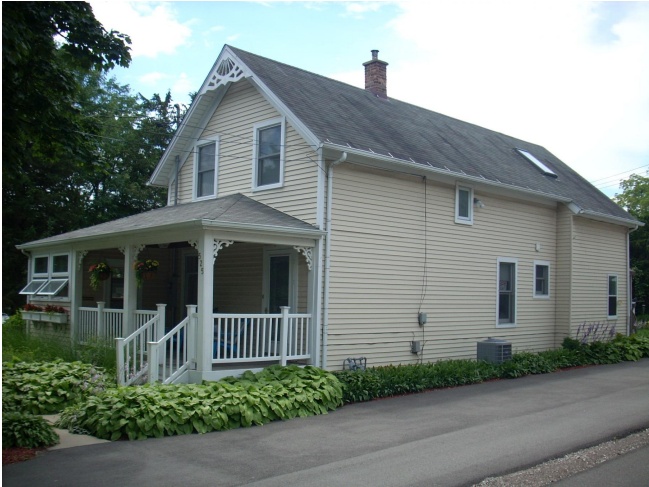
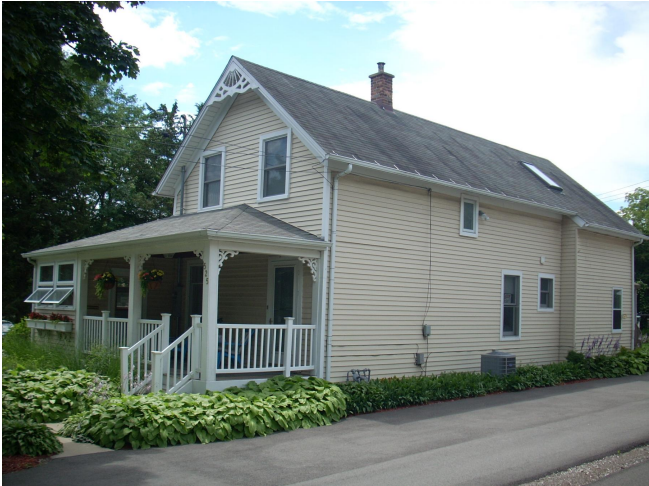
CATEGORY	<input type="text" value="Building"/>	HISTORIC USE	<input type="text" value="Domestic - single dwelling"/>
CONDITION	<input type="text" value="Good"/>	SECONDARY STRUCTURE	<input type="text" value="Detached garage"/>
INTEGRITY	<input type="text" value="Major alterations and additions"/>	NR SECOND	<input type="text" value="NC"/>
CURRENT USE	<input type="text" value="Domestic - single dwelling"/>

Gable Front

Front gable roof; some historic wood windows on first story

Original house obscured by multiple additions and alterations--2-story south side addition; 2-story rear addition (1992); front porch replaced (1997); replacement siding (1983); replacement windows in original openings; skylight

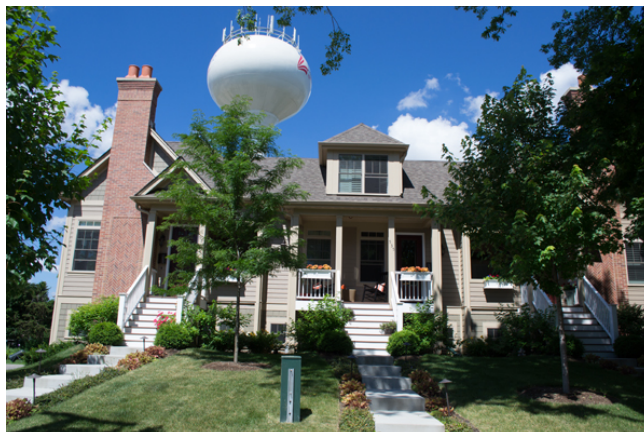
Photo Id: FirstSt533-537(2)

CATEGORY	Building	HISTORIC USE	Domestic - multiple dwelling
CONDITION	Excellent	SECONDARY STRUCTURE	-
INTEGRITY	Not altered	NR SECOND	-
CURRENT USE	Domestic - multiple dwelling

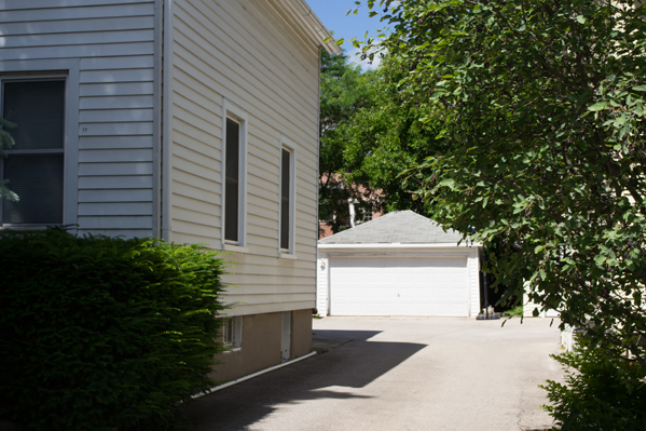
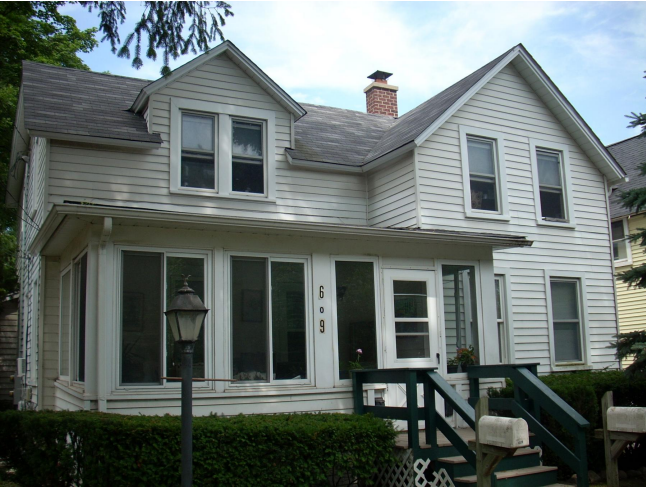
Photo Id: FirstSt609(1)

CATEGORY	Building	HISTORIC USE	Domestic - single dwelling
CONDITION	Good	SECONDARY STRUCTURE	Detached garage
INTEGRITY	Moderate alterations	NR SECOND	NC
CURRENT USE	Domestic - single dwelling

1.5-story north-end front gable bay intersected by 1.5-story south side gable wing; front porch structure is historic, but may not be original

One story rear additions are very early (pre-1924--see Sanborn map); aluminum siding (1990); front porch enclosed (1960); front through-the cornice dormer addition (no date); non-historic replacement windows in original openings

1569 (8/23/1956)--reside house with insulated siding; 3977 (8/4/1966)--new doors on garage; 2762 (1960)--enclose front porch with glass windows; 90-584 (1990)--aluminum siding, fascia, and soffit

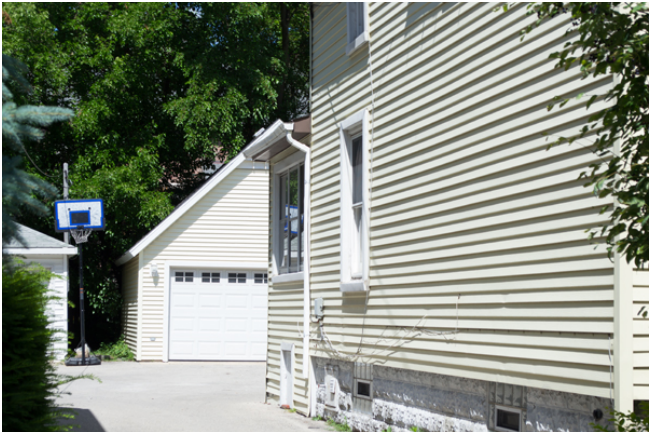
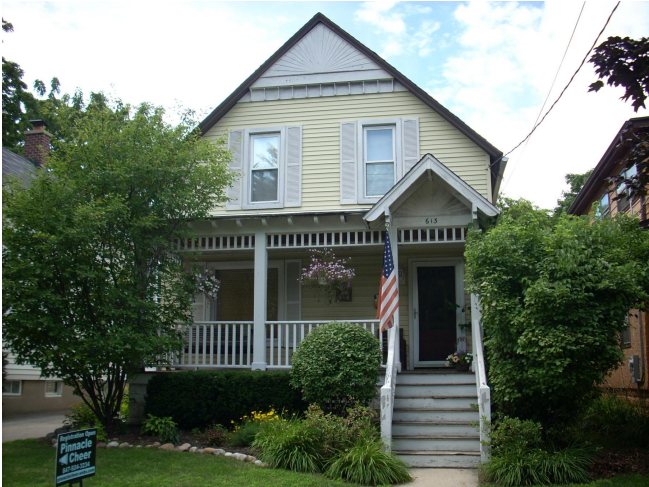
Photo Id: FirstSt613(1)

CATEGORY	<input type="text" value="Building"/>	HISTORIC USE	<input type="text" value="Domestic - single dwelling"/>
CONDITION	<input type="text" value="Good"/>	SECONDARY STRUCTURE	<input type="text" value="Detached garage"/>
INTEGRITY	<input type="text" value="Major alterations"/>	NR SECOND	<input type="text" value="NC"/>
CURRENT USE	<input type="text" value="Domestic - single dwelling"/>

Front gable roof; sunburst motif under gable

Replacement siding; replacement windows in original openings; replacement front porch (2001); fixed shutters

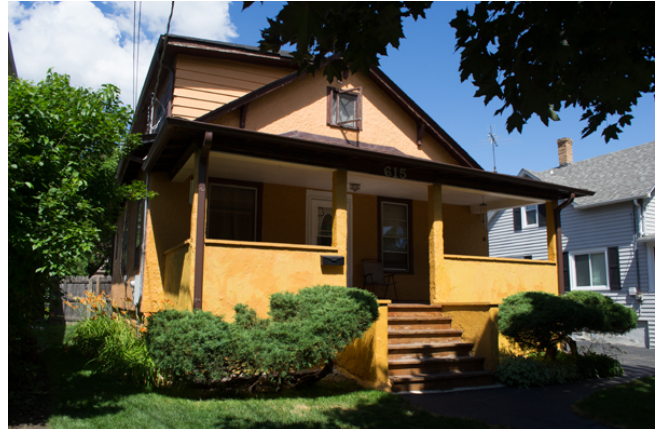
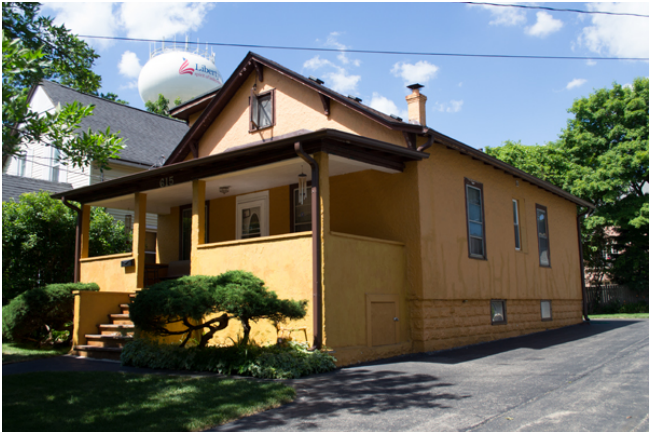
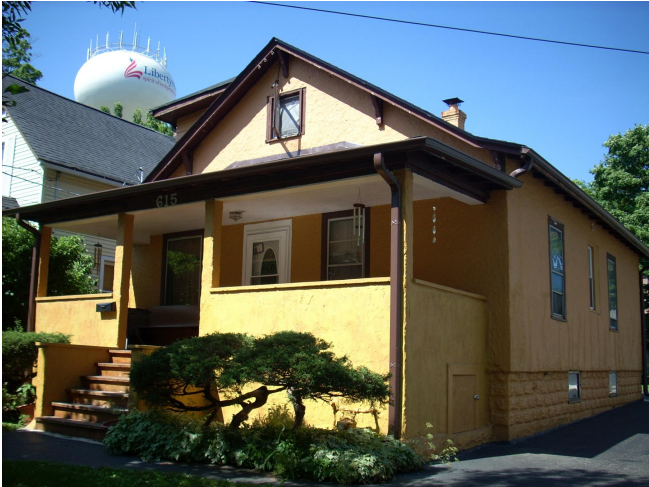
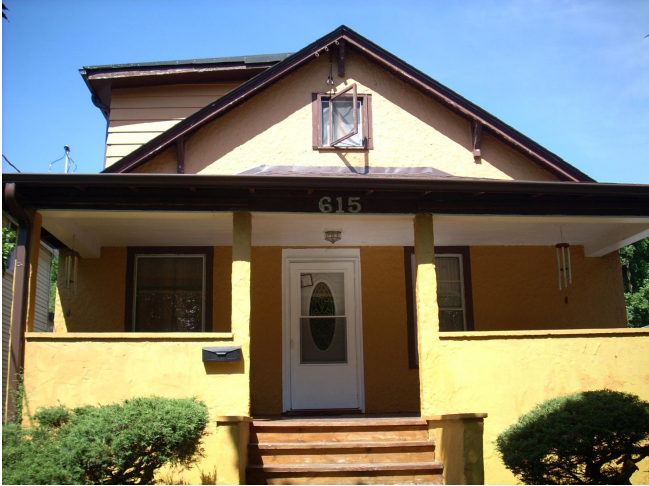
Photo Id: FirstSt615(1)

CATEGORY	Building	HISTORIC USE	Domestic - single dwelling
CONDITION	Good	SECONDARY STRUCTURE	-
INTEGRITY	Minor alterations and additions	NR SECOND	-
CURRENT USE	Domestic - single dwelling

Broad front gable roof with overhanging eaves and exposed rafter tails; full front porch with hipped roof, square piers on solid knee walls; historic 1/1 wood windows

Shed roof front porch on south facade (1960); replacement front door; replacement front porch steps; shed roof dormer addition (1963)

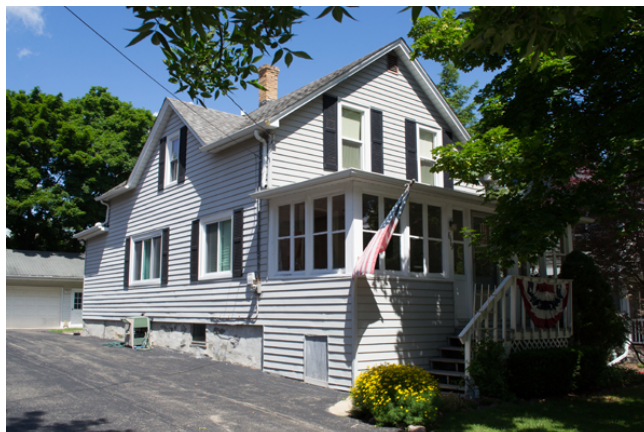
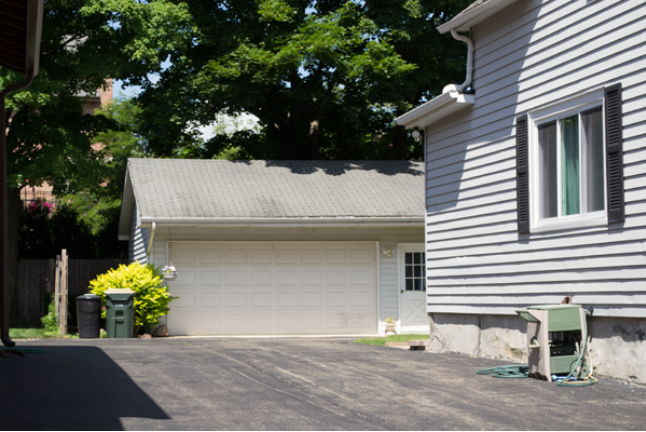
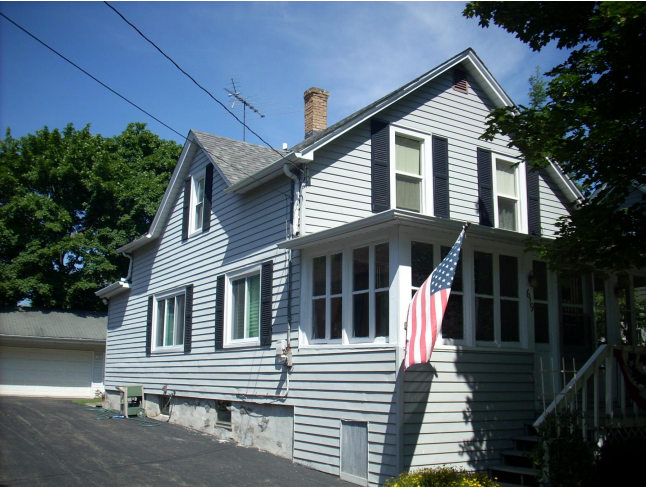
Photo Id: FirstSt619(1)

CATEGORY	Building	HISTORIC USE	Domestic - single dwelling
CONDITION	Good	SECONDARY STRUCTURE	Detached garage
INTEGRITY	Moderate alterations	NR SECOND	NC
CURRENT USE	Domestic - single dwelling

Front gable roof; rectangular massing; hipped roof full-front porch (enclosed before 1933); north and south gable dormers

Replacement windows in original openings (some casement windows, not historically appropriate, 2011); wood steps to front porch entrance

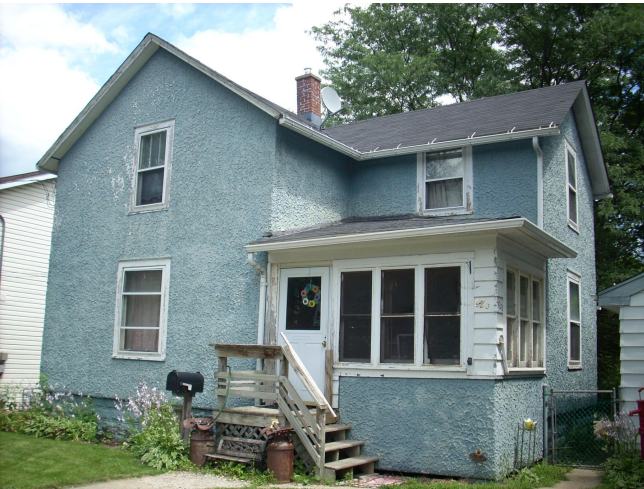
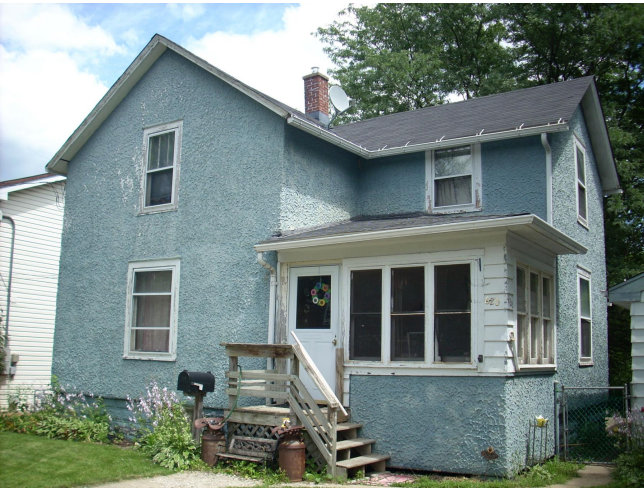
Photo Id: FirstSt620(1)

CATEGORY	Building	HISTORIC USE	Domestic - single dwelling
CONDITION	Fair	SECONDARY STRUCTURE	Detached garage
INTEGRITY	Moderate alterations	NR SECOND	NC
CURRENT USE	Domestic - single dwelling

Stucco cladding; front porch enclosed; wood stairs to porch entry; wood windows appear historic, but not original

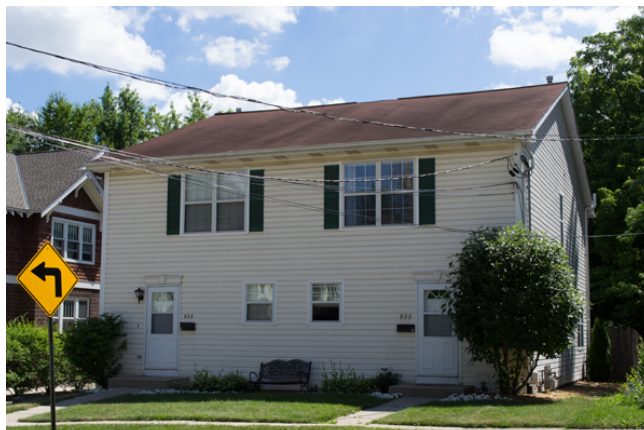
Photo Id: FirstSt622(1)

CATEGORY	Building	HISTORIC USE	Domestic - multiple dwelling
CONDITION	Good	SECONDARY STRUCTURE	Detached garage
INTEGRITY	Minor alterations	NR SECOND	NC
CURRENT USE	Domestic - multiple dwelling

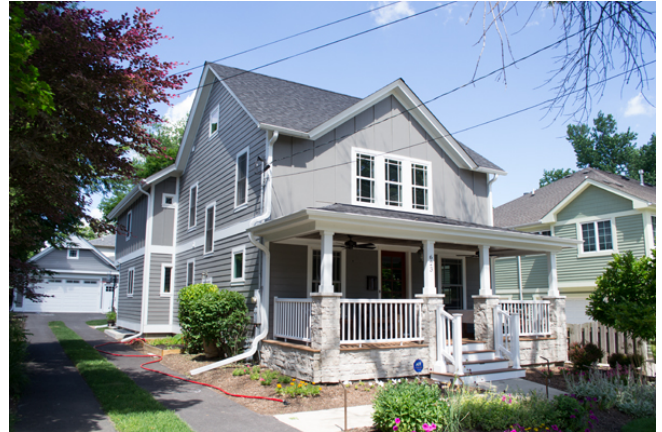
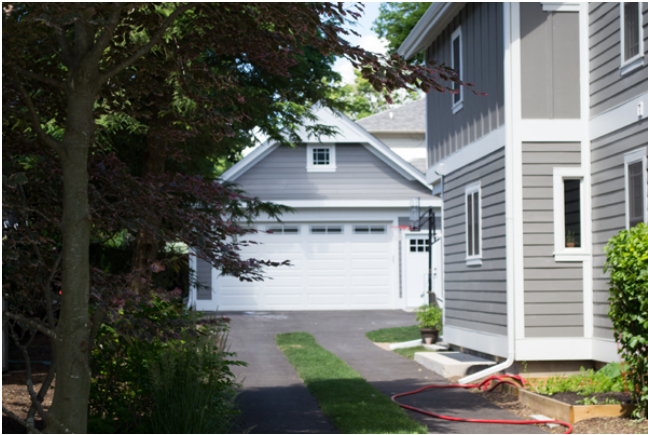
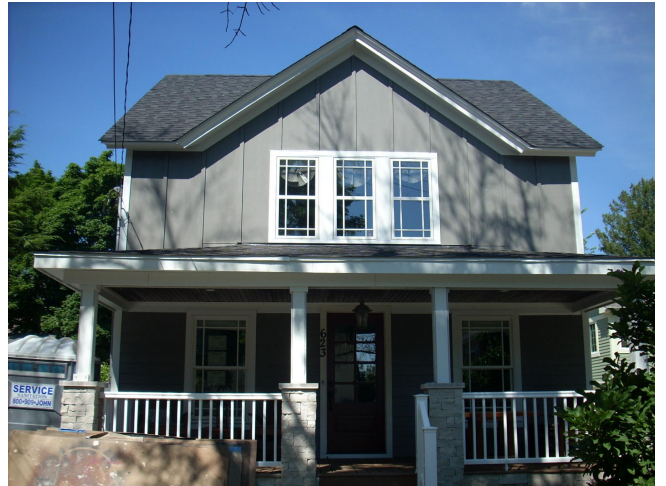
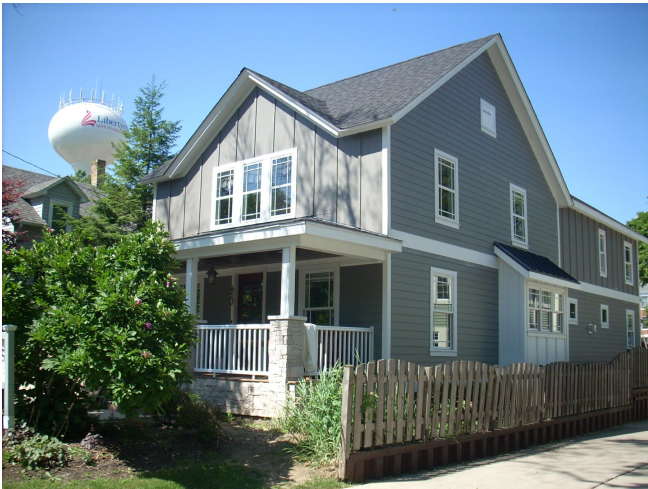
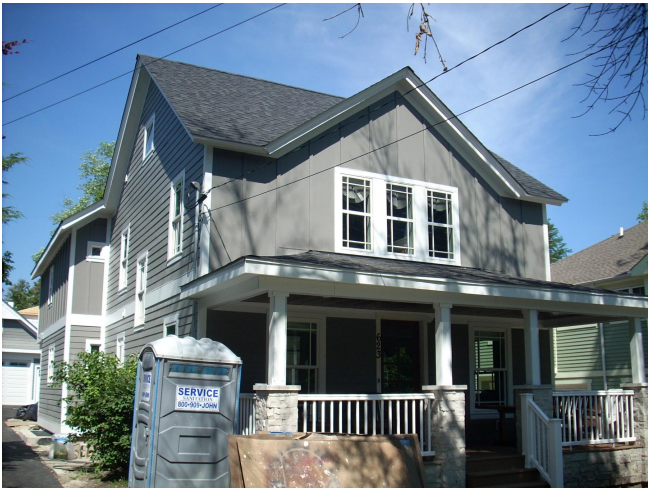
Photo Id: FirstSt623(1)

CATEGORY	Building	HISTORIC USE	Domestic - single dwelling
CONDITION	Excellent	SECONDARY STRUCTURE	Detached garage
INTEGRITY	Major alterations and additions	NR SECOND	NC
CURRENT USE	Domestic - single dwelling

Replacement siding (2014); replacement windows in original openings (2014); replacement front door (2014); replacement front porch (1993); 2-story rear addition (2015)

93-309 (1993)--rebuilt existing porch; JLC-11-0152 (2011)--remove rear deck and replace with patio; JRE-14-0058 (2014)--repair porch, replace door, windows and siding; JRA-14-0029 (2015)--addition and remodel, detached garage
