Historic Libertyville

BEGINNING STREET NUMBER	<input type="text" value="125"/>
END STREET NUMBER	<input type="text" value="-"/>
STREET # SUFFIX	<input type="text" value="-"/>
STREET NAME	<input type="text" value="Lake Street"/>
PIN	<input type="text"/>
<u>LOCAL</u>	
WITHIN LOCAL DISTRICT?	<input type="text" value="No"/>
LOCAL DIST CONTRIB/NON-CONTRIB?	<input type="text" value="NC"/>
LOCAL LANDMARK?	<input type="text" value="No"/>
YEAR	<input type="text" value="-"/>
LOCAL LANDMARK ELIGIBLE?	<input type="text" value="No"/>
CRITERIA	<input type="text" value="-"/>

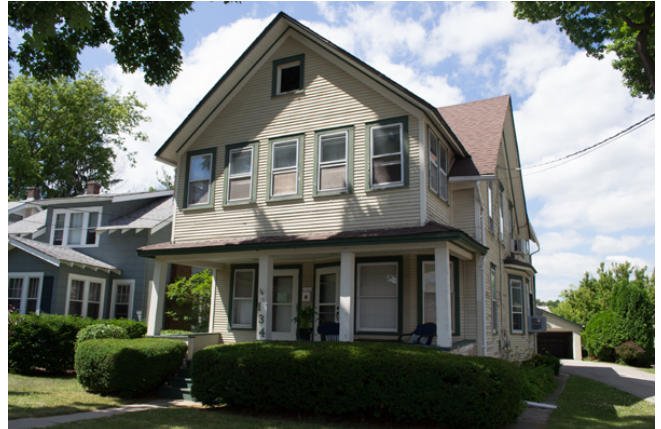
Photo Id: LakeSt134(2)

CATEGORY	Building	HISTORIC USE	Domestic - single dwelling
CONDITION	Good	SECONDARY STRUCTURE	Detached garage
INTEGRITY	Minor alterations and additions	NR SECOND	NC
CURRENT USE	Domestic - multiple dwelling

Broad side gable roof crossed with front gable roof; recessed entry porch under front gable bay; 2-story west side gable bay; three-sided 1st-story window bay on east facade

Replacement wood windows; second entrance set within three-sided window bay under porch (building converted to multifamily some time between 1924 and 1933)

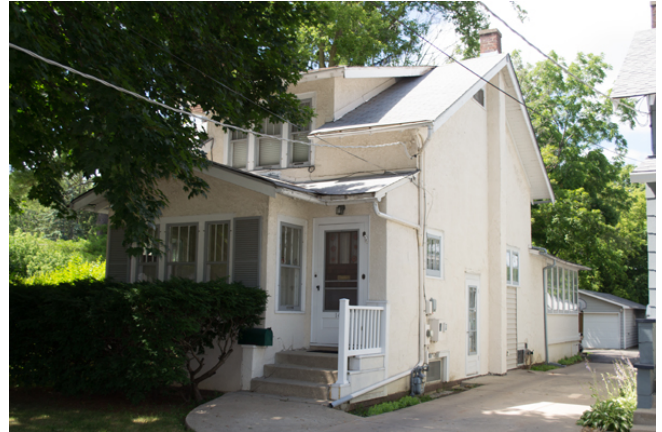
Photo Id: LakeSt140(1)

CATEGORY	Building	HISTORIC USE	Domestic - single dwelling
CONDITION	Fair	SECONDARY STRUCTURE	Detached garage
INTEGRITY	Minor alterations	NR SECOND	NC
CURRENT USE	Domestic - single dwelling

Side gable roof with overhanging eaves; shed-roof, through-the-cornice dormer on front facade; 1-story front gable center bay with attached east end shed-roof entry bay; historic wood double hung windows; historic front door

Aluminum siding on a portion of the east facade; replacement railing at front entry stoop; rear second-story addition; rear deck addition (1996)

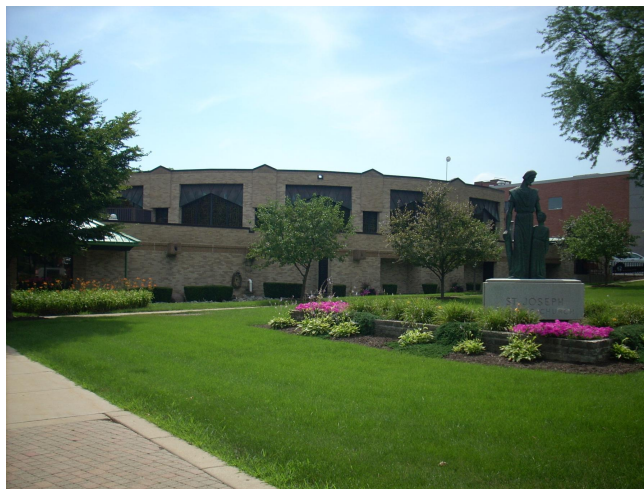
Photo Id: Maple121

CATEGORY	<input type="text" value="Building"/>	HISTORIC USE	<input type="text" value="Religion - religious facility"/>
CONDITION	<input type="text" value="Good"/>	SECONDARY STRUCTURE	<input type="text" value="-"/>
INTEGRITY	<input type="text" value="Moderate alterations and additions"/>	NR SECOND	<input type="text" value="-"/>
CURRENT USE	<input type="text" value="Religion - religious facility"/>

Round sanctuary space set atop ground-level brick base; stained glass windows regularly spaced at sanctuary level; 1-story projecting, polygonal entry bay at north side of church building

peaked metal roofs above pilasters between larger stained glass windows on sanctuary building removed (see 1970s Assessor photo); hipped and mansard metal standing seam roofs added to lower section of church building

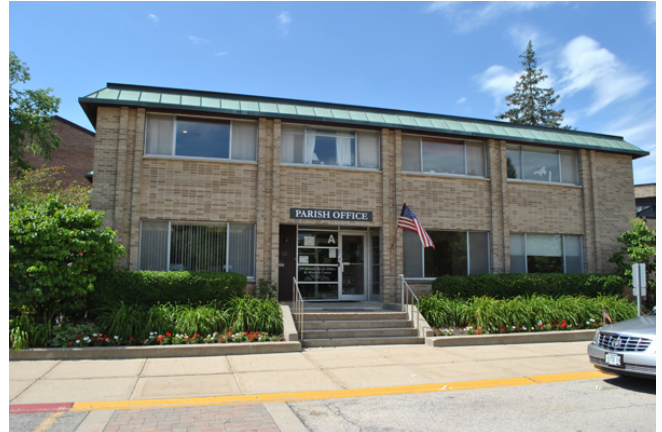
Photo Id: MapleAveE121(2)

CATEGORY	<input type="text" value="Building"/>	HISTORIC USE	<input type="text" value="Religion - church office"/>
CONDITION	<input type="text" value="Good"/>	SECONDARY STRUCTURE	<input type="text" value="-"/>
INTEGRITY	<input type="text" value="Minor alterations"/>	NR SECOND	<input type="text" value="-"/>
CURRENT USE	<input type="text" value="Religion - church office"/>

Variegated beige brick exterior; three-part windows separated by simple brick piers

Metal roof added (1990s)

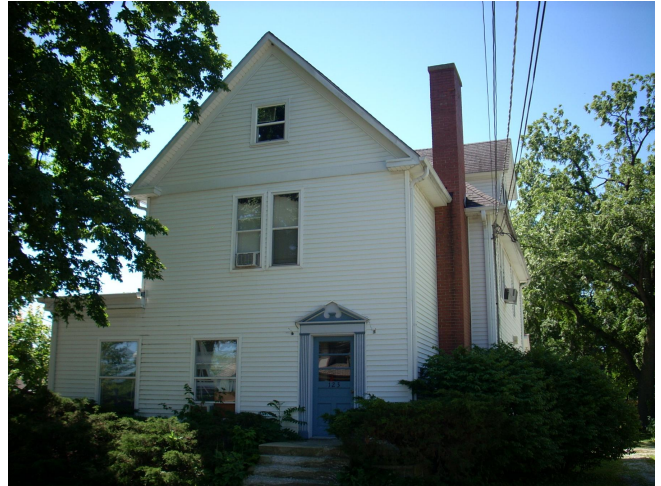
Photo Id: maple123

CATEGORY	Building	HISTORIC USE	Domestic - single dwelling
CONDITION	Good	SECONDARY STRUCTURE	-
INTEGRITY	Major alterations and additions	NR SECOND	-
CURRENT USE	Domestic - multiple dwelling

Replacement siding; original wraparound porch removed (post-1948); 1-story east side addition (may have originally been part of porch that was enclosed); replacement windows, most in original openings; 1st story front window in altered opening; replacement front door and surround, concrete stoop (1950s); concrete stoop and door at west elevation
