Historic Libertyville

BEGINNING STREET NUMBER	<input type="text" value="125"/>
END STREET NUMBER	<input type="text" value="-"/>
STREET # SUFFIX	<input type="text" value="-"/>
STREET NAME	<input type="text" value="Lake Street"/>
PIN	<input type="text" value=""/>
<u>LOCAL</u>	
WITHIN LOCAL DISTRICT?	<input type="text" value="No"/>
LOCAL DIST CONTRIB/NON-CONTRIB?	<input type="text" value="NC"/>
LOCAL LANDMARK?	<input type="text" value="No"/>
YEAR	<input type="text" value="-"/>
LOCAL LANDMARK ELIGIBLE?	<input type="text" value="No"/>
CRITERIA	<input type="text" value="-"/>

BEGINNING STREET NUMBER	126
END STREET NUMBER	-
STREET # SUFFIX	-
STREET NAME	Lake Street
PIN	
<u>LOCAL</u>	
WITHIN LOCAL DISTRICT?	No
LOCAL DIST CONTRIB/NON-CONTRIB?	C
LOCAL LANDMARK?	No
YEAR	-
LOCAL LANDMARK ELIGIBLE?	No
CRITERIA	-

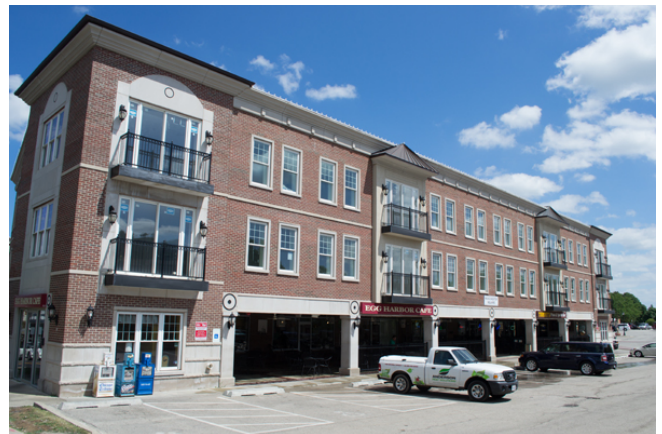
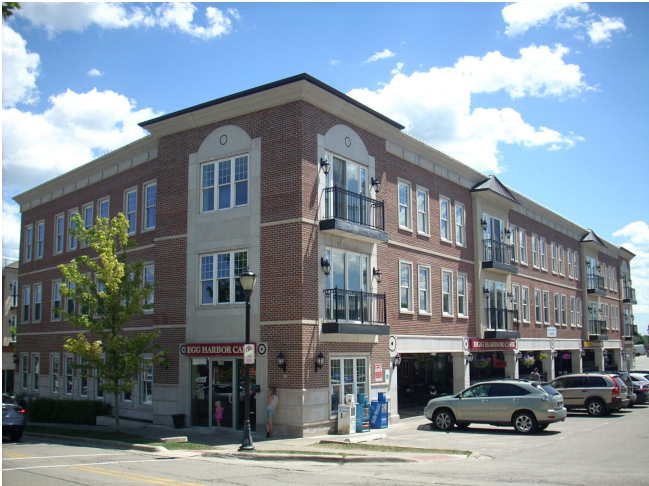
Photo Id: LakeSt125(2)

One Part Commercial Block

New Traditional

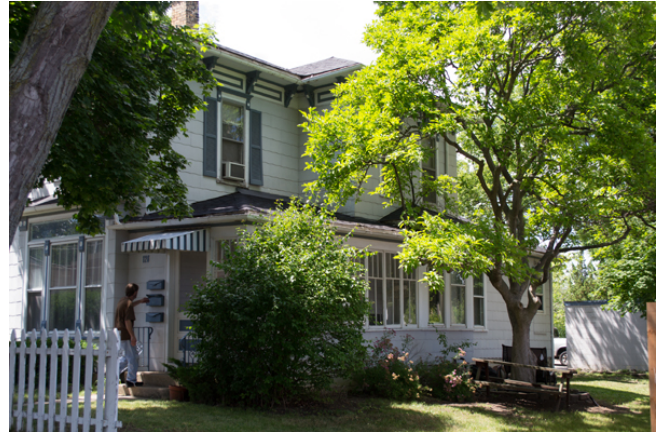
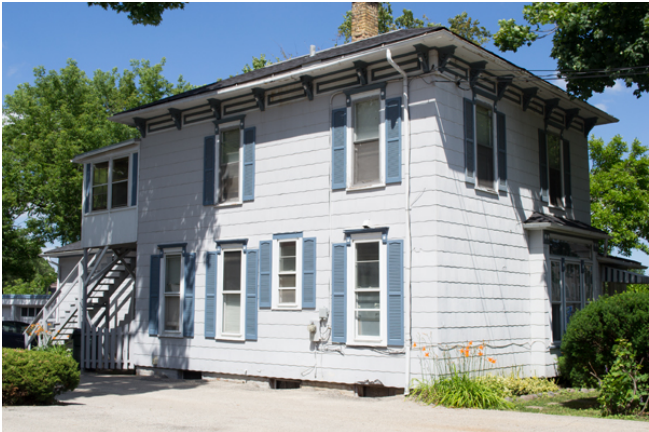
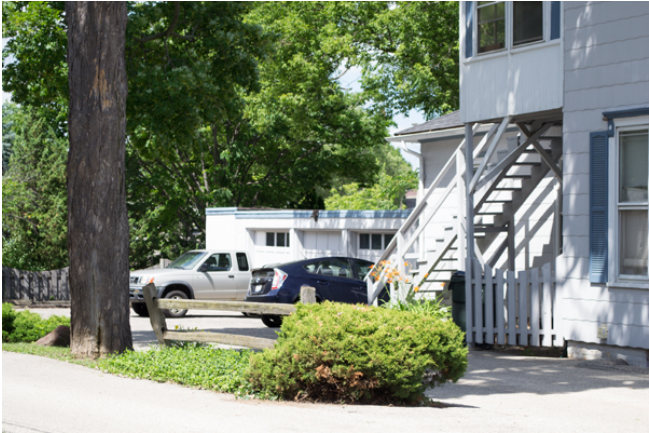
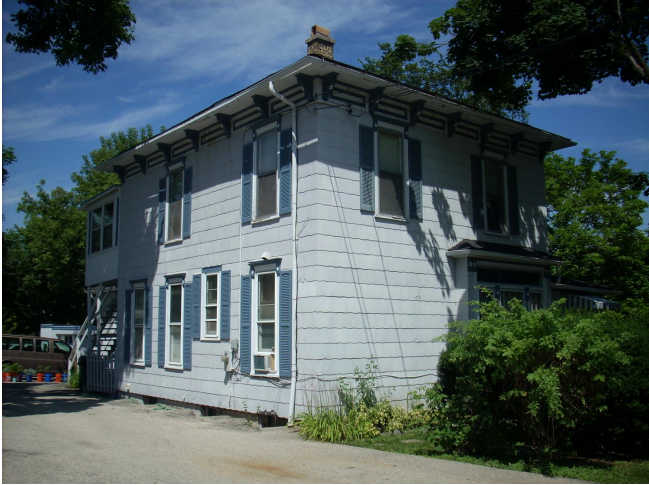
Photo Id: LakeSt126(2)

CATEGORY	Building	HISTORIC USE	Domestic - single dwelling
CONDITION	Good	SECONDARY STRUCTURE	Detached garage
INTEGRITY	Moderate alterations	NR SECOND	C
CURRENT USE	Domestic - multiple dwelling

Italianate

Shallow hipped roof; wood cornice with paneled frieze and scrolled brackets; classical lintels above window openings; southeast corner porch structure (enclosed); square oriel bay window on front facade; east side oriel window

Replacement windows in original openings (replacement windows in front bay are historic, dating from the 1920s or 30s); corner entry porch enclosed (historic alteration--c. 1920s-30s); 2-story rear/northwest addition; exterior staircase (1952)

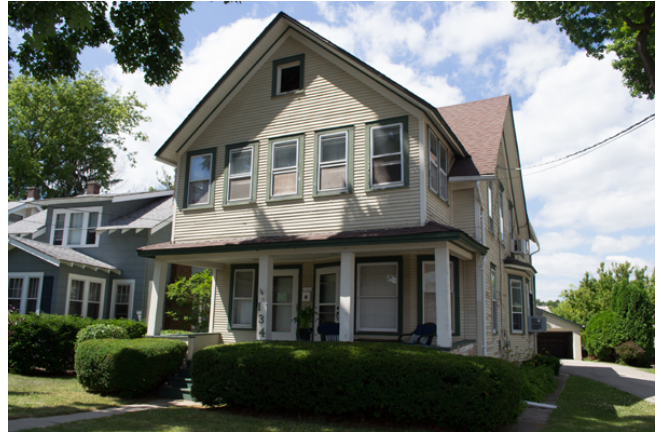
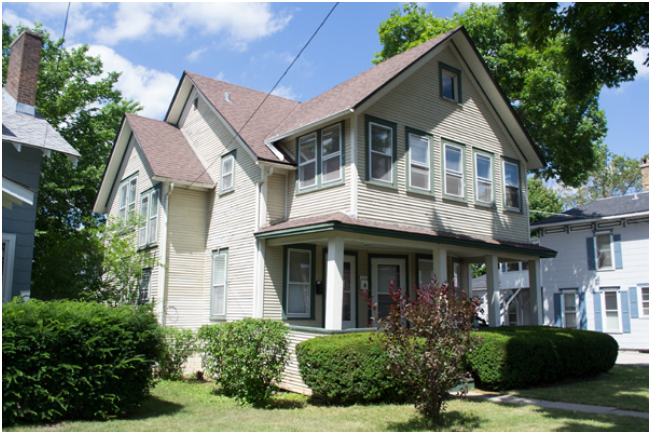
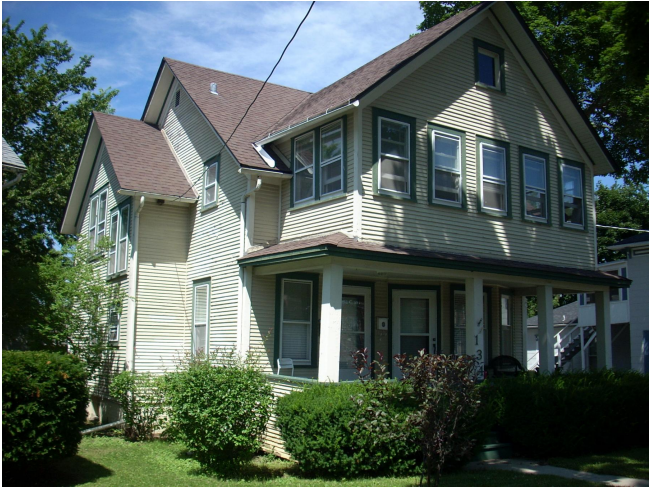
Photo Id: LakeSt134(2)

CATEGORY	Building	HISTORIC USE	Domestic - single dwelling
CONDITION	Good	SECONDARY STRUCTURE	Detached garage
INTEGRITY	Minor alterations and additions	NR SECOND	NC
CURRENT USE	Domestic - multiple dwelling

No Style

Broad side gable roof crossed with front gable roof; recessed entry porch under front gable bay; 2-story west side gable bay; three-sided 1st-story window bay on east facade

Replacement wood windows; second entrance set within three-sided window bay under porch (building converted to multifamily some time between 1924 and 1933)

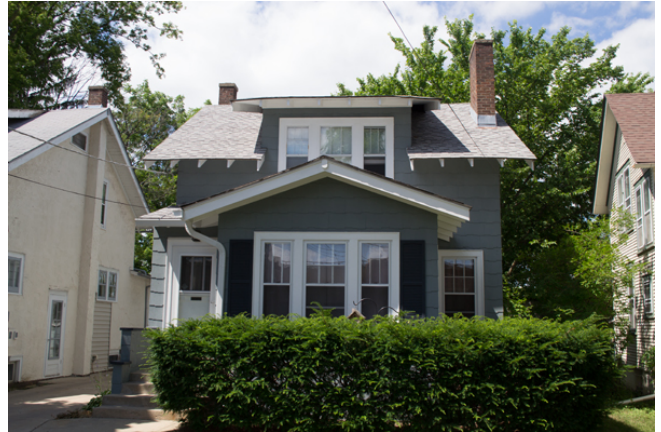
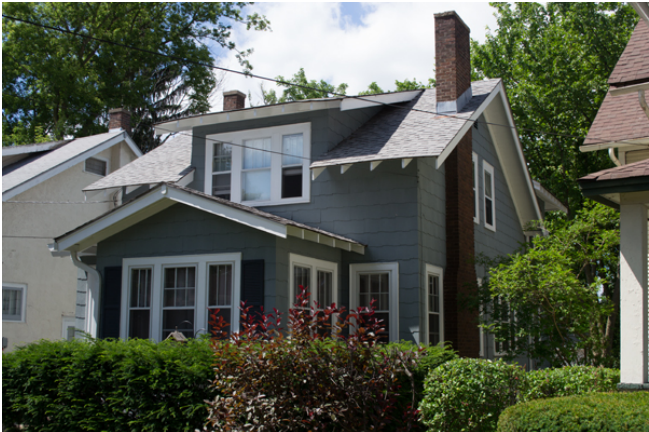
Photo Id: LakeSt138(1)

CATEGORY	Building	HISTORIC USE	Domestic - single dwelling
CONDITION	Fair	SECONDARY STRUCTURE	Detached garage
INTEGRITY	Minor alterations	NR SECOND	C
CURRENT USE	Domestic - single dwelling

Craftsman Bungalow

Charming Craftsman Bungalow with a very high degree of architectural integrity.

Side gable roof with overhanging eaves; shed-roof through-the-cornice dormer on front facade; projecting 1-story center gable bay on front facade, with attached west end, shed-roof entry bay; historic wood windows; historic front door

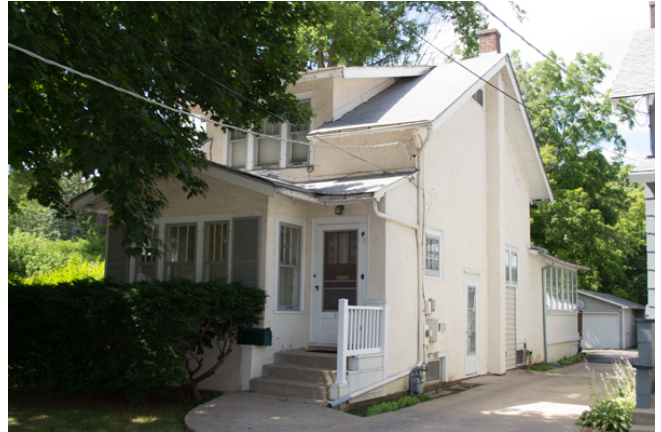
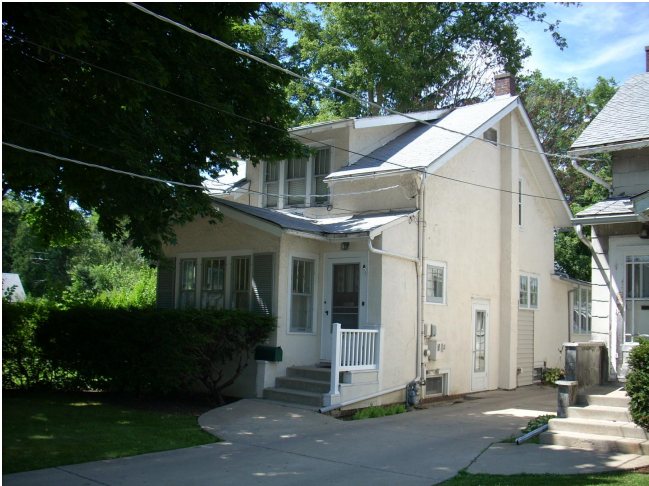
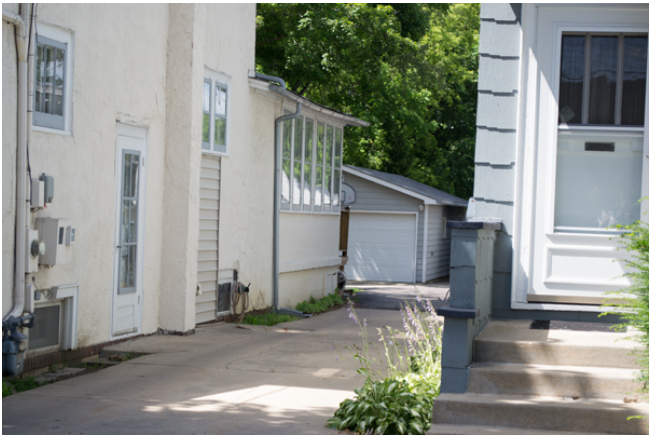
Photo Id: LakeSt140(1)

CATEGORY	Building	HISTORIC USE	Domestic - single dwelling
CONDITION	Fair	SECONDARY STRUCTURE	Detached garage
INTEGRITY	Minor alterations	NR SECOND	NC
CURRENT USE	Domestic - single dwelling

Bungalow

Side gable roof with overhanging eaves; shed-roof, through-the-cornice dormer on front facade; 1-story front gable center bay with attached east end shed-roof entry bay; historic wood double hung windows; historic front door

Aluminum siding on a portion of the east facade; replacement railing at front entry stoop; rear second-story addition; rear deck addition (1996)

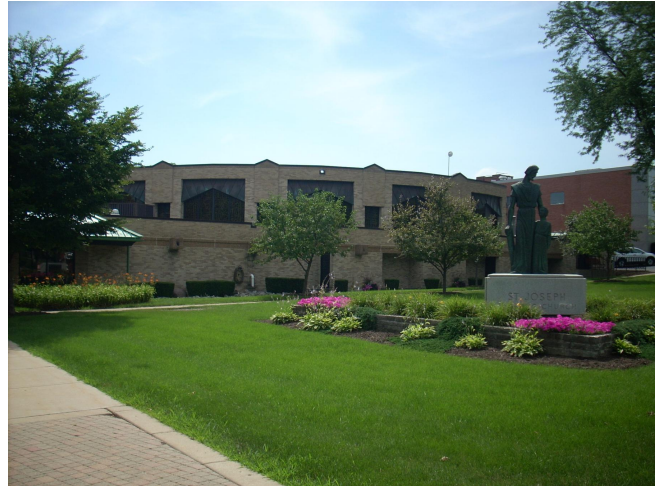
Photo Id: Maple121

CATEGORY	<input type="text" value="Building"/>	HISTORIC USE	<input type="text" value="Religion - religious facility"/>
CONDITION	<input type="text" value="Good"/>	SECONDARY STRUCTURE	<input type="text" value="-"/>
INTEGRITY	<input type="text" value="Moderate alterations and additions"/>	NR SECOND	<input type="text" value="-"/>
CURRENT USE	<input type="text" value="Religion - religious facility"/>

Neo-Expressionist

Round sanctuary space set atop ground-level brick base; stained glass windows regularly spaced at sanctuary level; 1-story projecting, polygonal entry bay at north side of church building

peaked metal roofs above pilasters between larger stained glass windows on sanctuary building removed (see 1970s Assessor photo); hipped and mansard metal standing seam roofs added to lower section of church building

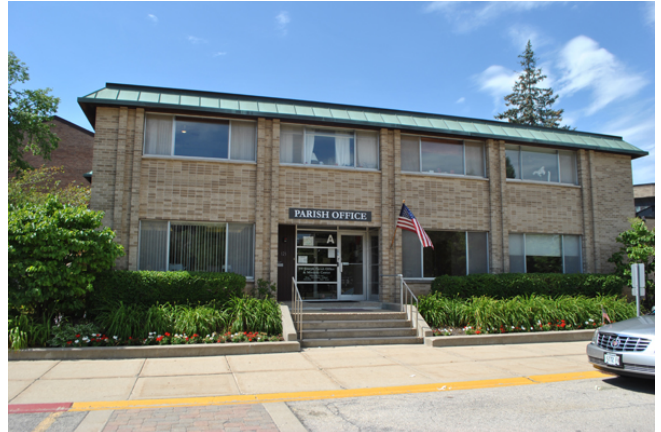
Photo Id: MapleAveE121(2)

CATEGORY	<input type="text" value="Building"/>
CONDITION	<input type="text" value="Good"/>
INTEGRITY	<input type="text" value="Minor alterations"/>
CURRENT USE	<input type="text" value="Religion - church office"/>

Institutional Modern

Variegated beige brick exterior; three-part windows separated by simple brick piers

Metal roof added (1990s)

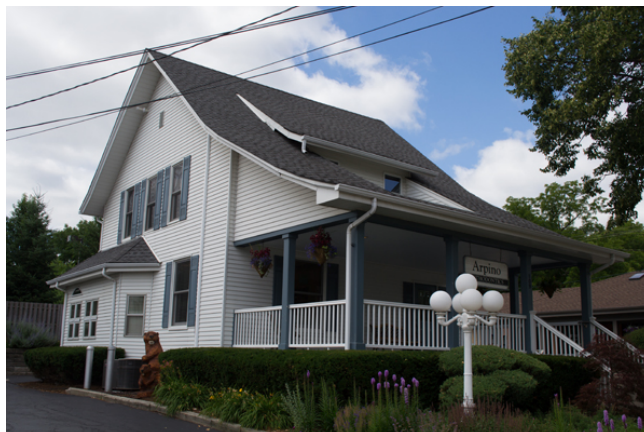
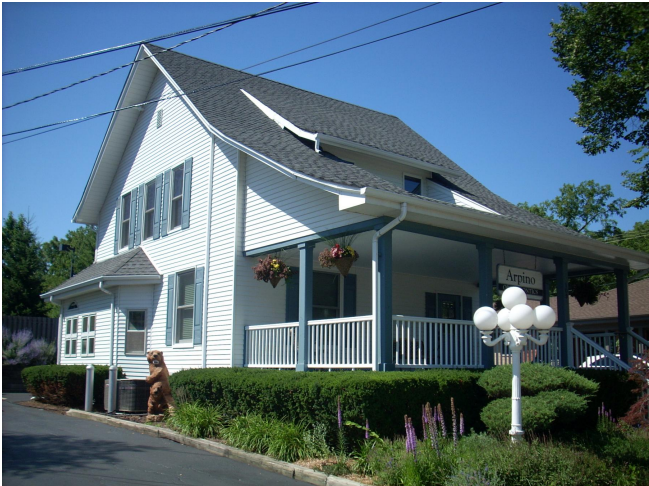
Photo Id: MapleAveW109(2)

CATEGORY	Building	HISTORIC USE	Domestic - single dwelling
CONDITION	Good	SECONDARY STRUCTURE	-
INTEGRITY	Major alterations and/or additions	NR SECOND	-
CURRENT USE	Commerce/trade - office

Replacement siding; replacement windows in original openings; shutters; replacement front porch (1983)

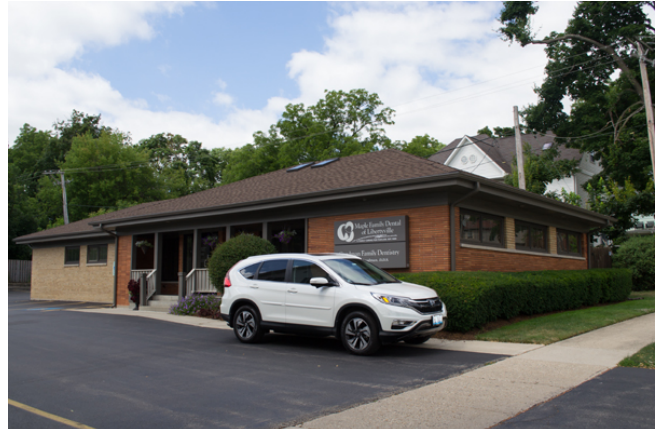
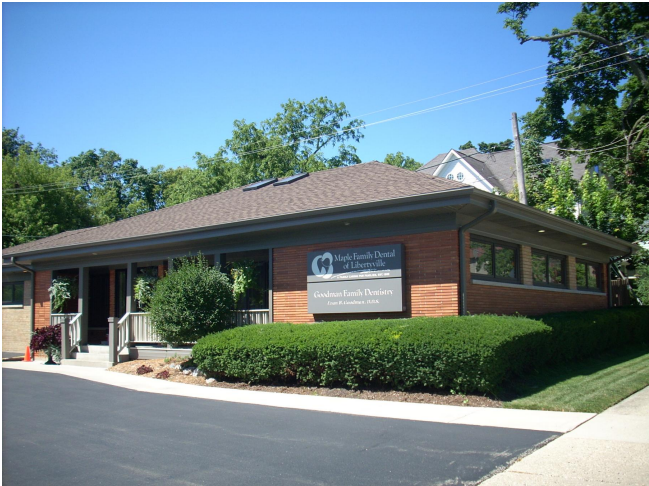
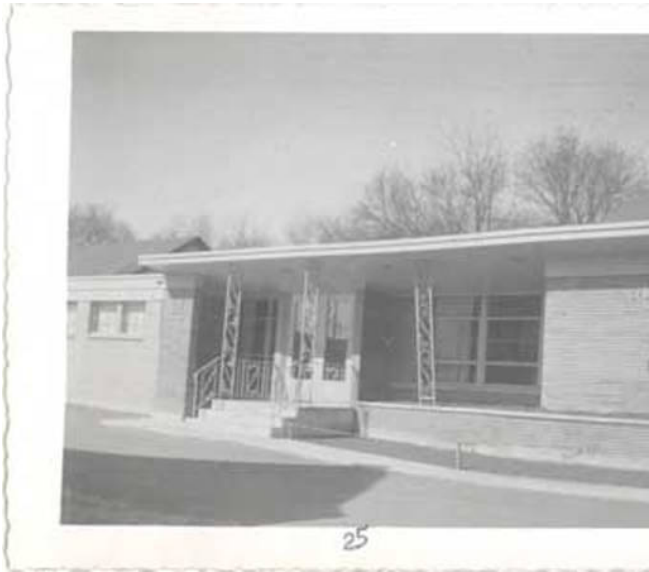
Photo Id: MapleAveW115

CATEGORY	<input type="text" value="Building"/>	HISTORIC USE	<input type="text" value="Commerce/trade - office"/>
CONDITION	<input type="text" value="Good"/>	SECONDARY STRUCTURE	<input type="text" value="-"/>
INTEGRITY	<input type="text" value="Minor alterations"/>	NR SECOND	<input type="text" value="-"/>
CURRENT USE	<input type="text" value="Commerce/trade - office"/>

Original flat roof changed to hipped; replacement front porch columns and railing; replacement windows in original openings; replacement front door; signage on east facade

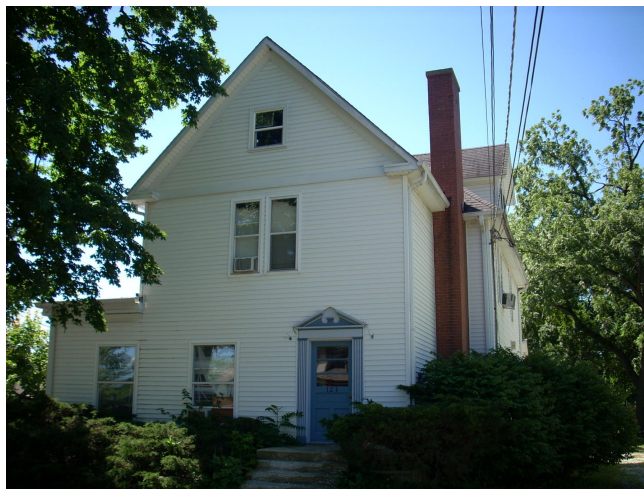
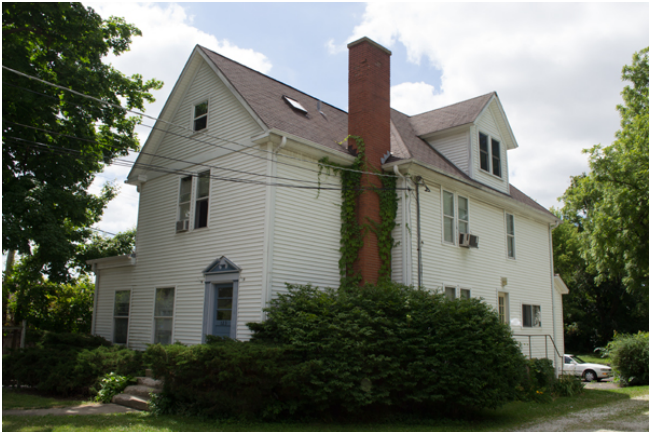
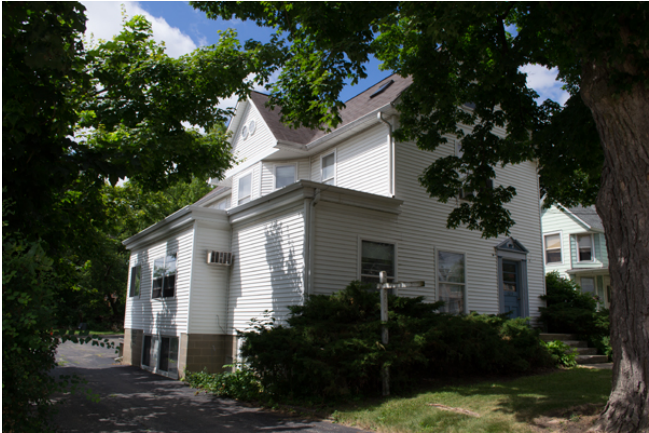
Photo Id: maple123

CATEGORY	<input type="text" value="Building"/>	HISTORIC USE	<input type="text" value="Domestic - single dwelling"/>
CONDITION	<input type="text" value="Good"/>	SECONDARY STRUCTURE	<input type="text" value="-"/>
INTEGRITY	<input type="text" value="Major alterations and additions"/>	NR SECOND	<input type="text" value="-"/>
CURRENT USE	<input type="text" value="Domestic - multiple dwelling"/>

Replacement siding; original wraparound porch removed (post-1948); 1-story east side addition (may have originally been part of porch that was enclosed); replacement windows, most in original openings; 1st story front window in altered opening; replacement front door and surround, concrete stoop (1950s); concrete stoop and door at west elevation
