Historic Libertyville

BEGINNING STREET NUMBER	130
END STREET NUMBER	-
STREET # SUFFIX	-
STREET NAME	W. Maple Avenue
PIN	
<u>LOCAL</u>	
WITHIN LOCAL DISTRICT?	No
LOCAL DIST CONTRIB/NON-CONTRIB?	C
LOCAL LANDMARK?	No
YEAR	-
LOCAL LANDMARK ELIGIBLE?	No
CRITERIA	-

Ramsey Historic Consultants

May-June 2016

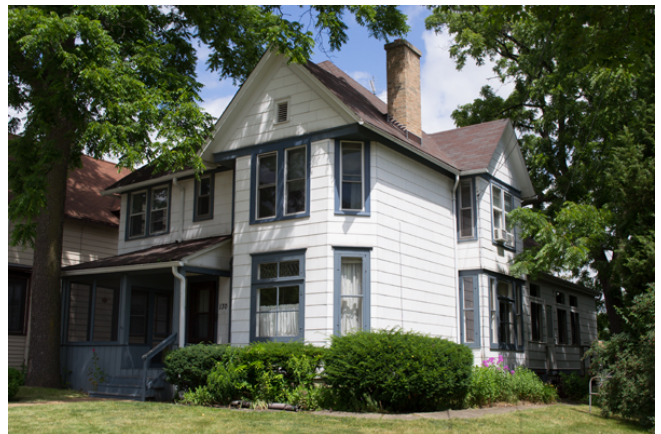
Photo Id: MapleAveW130(4)

CATEGORY	Building	HISTORIC USE	Domestic - single dwelling
CONDITION	Good	SECONDARY STRUCTURE	Detached garage
INTEGRITY	Moderate alterations and additions	NR SECOND	NC
CURRENT USE	Domestic - multiple dwelling

Queen Anne

Hipped roof; three-sided 2-story front bay with pent roof; 2-story square pent roof bay on east elevation; east side hipped roof porch structure north of bay (enclosed); wood windows on first story; classical lintels over window openings; beveled glass transom over window on 1st story of front bay

Replacement siding; wraparound front porch removed and replaced with smaller entry and west side porch (post-1948); east side porch enclosed (post-1948); 2nd story replacement windows in original openings

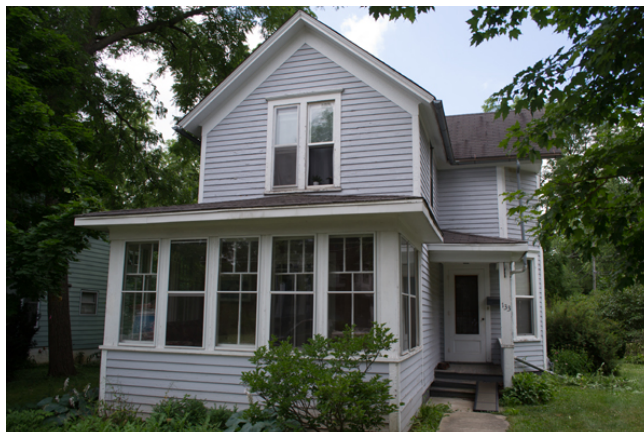
Photo Id: MapleAveW133(1)

CATEGORY	Building	HISTORIC USE	Domestic - single dwelling
CONDITION	Good	SECONDARY STRUCTURE	Detached garage
INTEGRITY	Minor alterations	NR SECOND	C
CURRENT USE	Domestic - single dwelling

Gabled Ell

Front gable bay intersected by west-side gable ell; with cutaway corners and sunburst ornament under gable; 2-story square gable bay on east facade; historic wood surrounds and lintels on window openings

Hipped roof front entry porch and front sun porch are historic alterations (replaced original wraparound front porch some time between 1924 and 1933); 1/1 replacement windows in original openings (not historic)

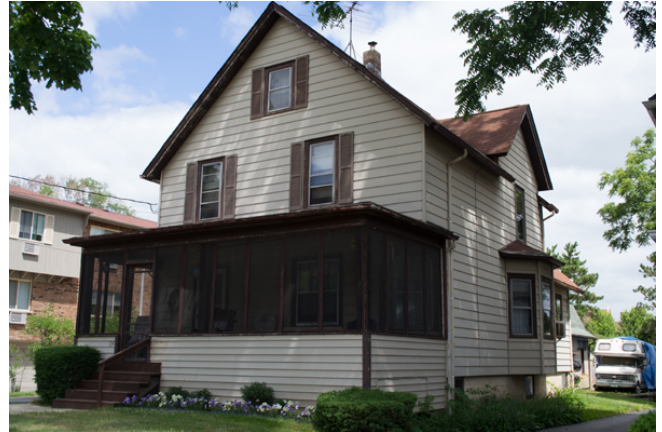
Photo Id: MapleAveW134(3)

CATEGORY	Building	HISTORIC USE	Domestic - single dwelling
CONDITION	Good	SECONDARY STRUCTURE	Detached garage
INTEGRITY	Minor alterations	NR SECOND	C
CURRENT USE	Domestic - single dwelling

Gable Front

Front gable roof and rectangular massing; east and west gables; east side three-sided window bay; wood windows

Replacement siding; front porch screened; shutters

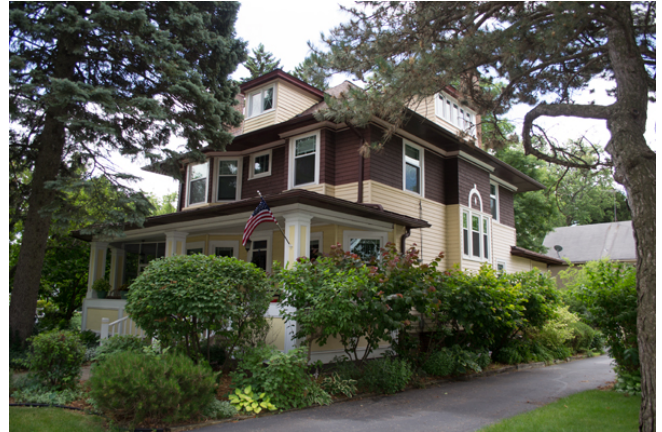
Photo Id: MapleAveW205(1)

CATEGORY	Building	HISTORIC USE	Domestic - single dwelling
CONDITION	Good	SECONDARY STRUCTURE	Detached garage
INTEGRITY	Minor alterations and additions	NR SECOND	C
CURRENT USE	Domestic - single dwelling

Queen Anne/Colonial Revival

Although altered, this turn-of-the-century Queen Anne with Colonial Revival detailing may be eligible for local landmark designation.

Flared hipped roof with overhanging eaves; front and side hipped roof dormers; hipped roof wraparound porch structure; three-sided and square window bays on front facade above porch; east side square oriel bay; 2-story three-sided bay on west elevation

Replacement windows in original openings; rear deck addition; one-story rear addition; east end of porch screened; replacement porch piers and front steps/railing on porch

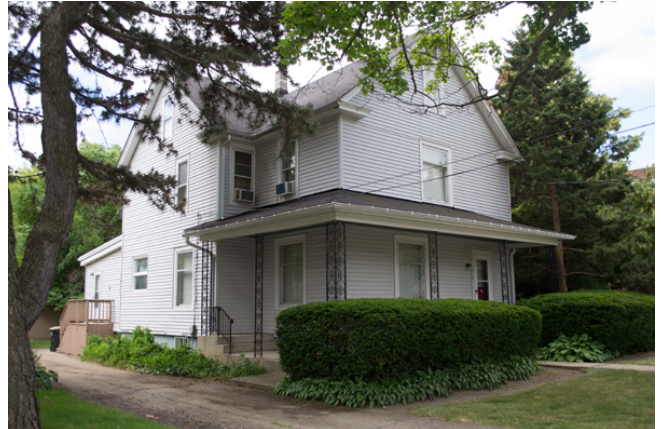
Photo Id: MapleAveW213(1)

CATEGORY	Building	HISTORIC USE	Domestic - single dwelling
CONDITION	Good	SECONDARY STRUCTURE	-
INTEGRITY	Minor alterations and additions	NR SECOND	-
CURRENT USE	Domestic - single dwelling

Gable Front

Front gable roof and rectangular massing; 2-story east side gable bay; some historic windows (1st and 2nd stories of front facade)

Replacement siding; some replacement windows in original openings on side elevation; new window under front gable; extensive alterations to porch (concrete base and steps, wrought iron railings); 1 story rear addition (1980); rear deck addition (1980)

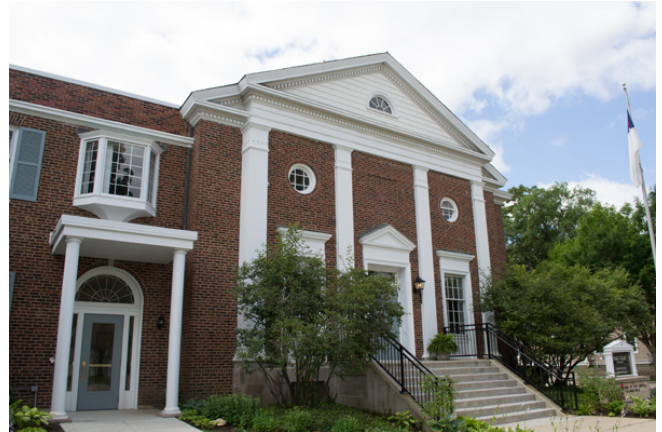
Photo Id: MapleAveW219(7)

CATEGORY	<input type="text" value="Building"/>	HISTORIC USE	<input type="text" value="Religion - religious facility"/>
CONDITION	<input type="text" value="Good"/>	SECONDARY STRUCTURE	<input type="text" value="-"/>
INTEGRITY	<input type="text" value="Major alterations and/or additions"/>	NR SECOND	<input type="text" value="-"/>
CURRENT USE	<input type="text" value="Religion - religious facility"/>

Colonial Revival

Original church building at northwest corner of lot--east end of front (north) facade features full-height pilasters and triangular pediment; three front entries with classical surrounds; 2-story west secondary entrance bay with triangular pediment; historic wood windows; office wing with flat roof and wood cornice

2-story educational building addition at east end of original building (1961); 2-story addition south of original church building (larger than original building and 1961 addition combined), with new sanctuary and offices--addition features a new main entrance with front portico and steeple along Douglas Avenue

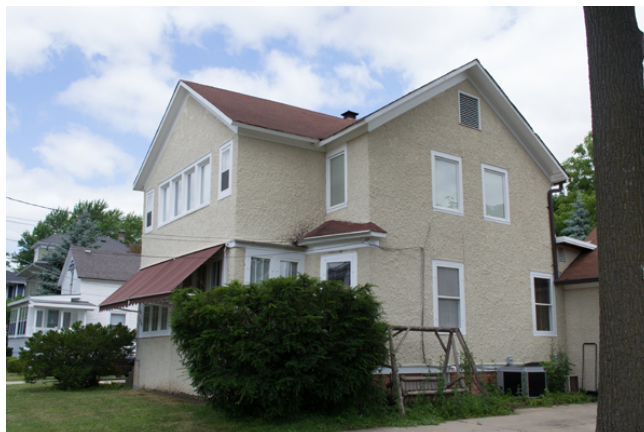
Photo Id: MapleAveW234(1)

CATEGORY	Building	HISTORIC USE	Domestic - single dwelling
CONDITION	Good	SECONDARY STRUCTURE	[attached garage]
INTEGRITY	Historic alterations and additions	NR SECOND	-
CURRENT USE	Domestic - single dwelling

2-story enclosed front porch addition (1920s--foundation is different than side gable section) with 3/1 windows on front facade; stucco cladding (1920s); single-light wood replacement windows throughout (not historically compatible type or configuration); 1-story rear addition and garage addition (2001)

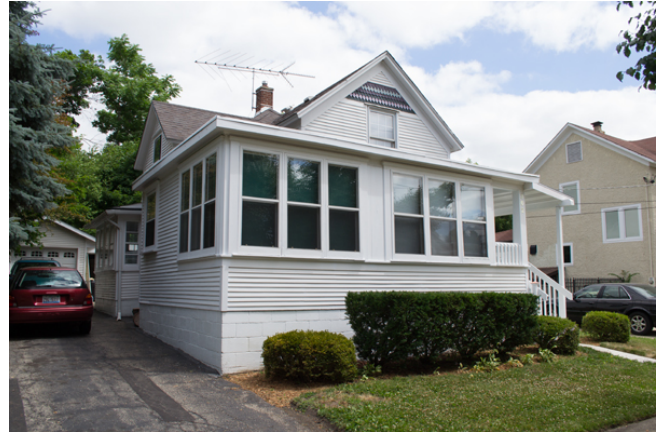
Photo Id: MapleAveW302(3)

CATEGORY	Building	HISTORIC USE	Domestic - single dwelling
CONDITION	Good	SECONDARY STRUCTURE	Detached garage
INTEGRITY	Historic additions/minor alterations	NR SECOND	NC
CURRENT USE	Domestic - single dwelling

Replacement front sun porch (historic--pre-1933); non-historic shed-roof entry porch at east end of front sun porch; northwest corner sun porch (historic--pre-1933); non-historic replacement windows in original openings on front and side elevations of house; one-story rear addition (historic--pre-1933)

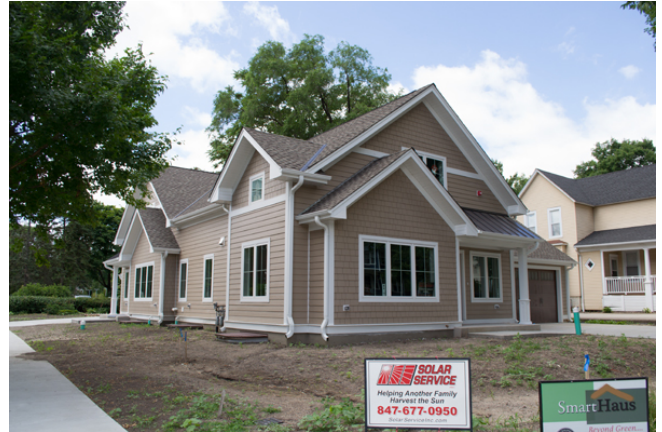
Photo Id: MapleAveW305(1)

CATEGORY	Building	HISTORIC USE	Domestic - single dwelling
CONDITION	Good	SECONDARY STRUCTURE	[attached garage]
INTEGRITY	Minor alterations and additions	NR SECOND	-
CURRENT USE	Domestic - single dwelling
