# Historic Libertyville

<b>BEGINNING STREET NUMBER</b>	308
<b>END STREET NUMBER</b>	-
<b>STREET # SUFFIX</b>	-
<b>STREET NAME</b>	W. Maple Avenue
<b>PIN</b>	
<b>LOCAL</b>	
<b>WITHIN LOCAL DISTRICT?</b>	No
<b>LOCAL DIST CONTRIB/NON-CONTRIB?</b>	C
<b>LOCAL LANDMARK?</b>	No
<b>YEAR</b>	-
<b>LOCAL LANDMARK ELIGIBLE?</b>	No
<b>CRITERIA</b>	-

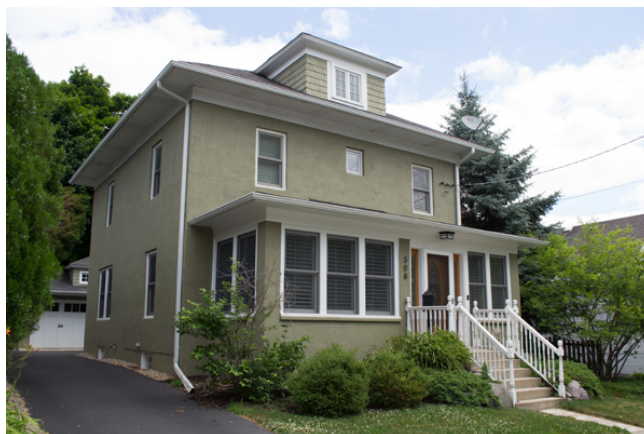
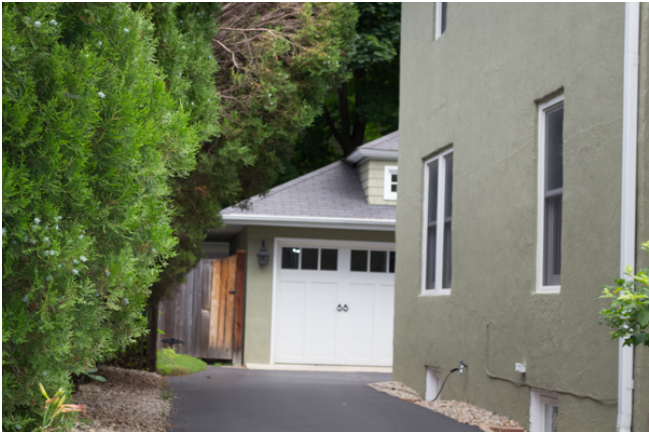
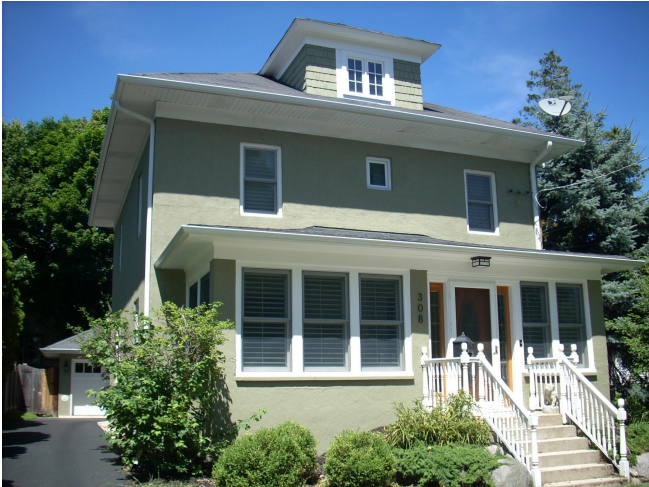
Photo Id: MapleAveW308(1)

<b>CATEGORY</b>	Building	<b>HISTORIC USE</b>	Domestic - single dwelling
<b>CONDITION</b>	Good	<b>SECONDARY STRUCTURE</b>	Detached garage
<b>INTEGRITY</b>	Moderate alterations	<b>NR SECOND</b>	NC
<b>CURRENT USE</b>	Domestic - single dwelling

American Foursquare

Hipped roof and rectangular massing; hipped roof front gable; hipped-roof full front porch structure

Stucco siding (post-1948); front porch enclosed with 1/1 windows, new door and sidelights; replacement windows in original openings; replacement front door; concrete front steps with wood railing

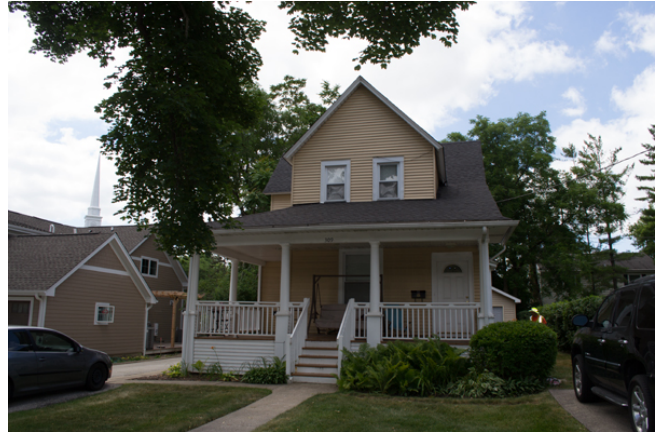
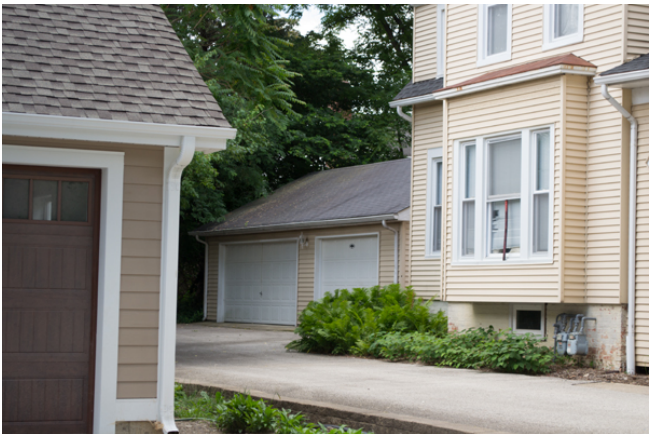
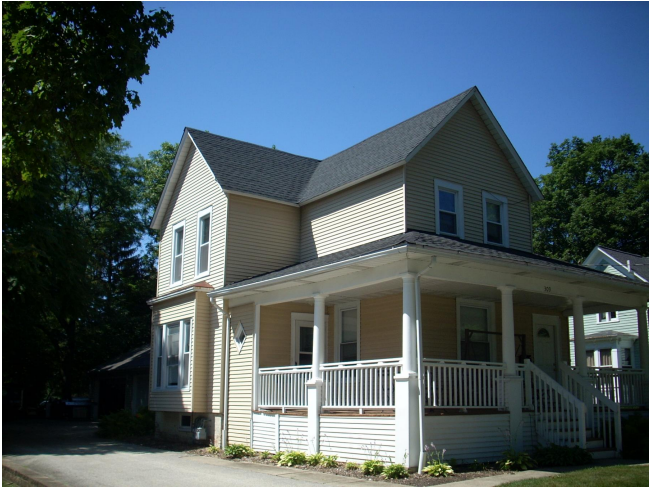
Photo Id: MapleAveW309(3)

Gabled Ell

Front gable bay intersected by east-side two-story gable ell; wraparound porch structure with hipped roof, supported by classical columns set on square piers; first-story three-sided west window bay; square oriel window bay on east facade

Replacement siding; replacement windows in original openings; alterations to front porch--replacement railings, ceiling; southeast corner porch enclosed, 2nd story addition added above (post-1948)

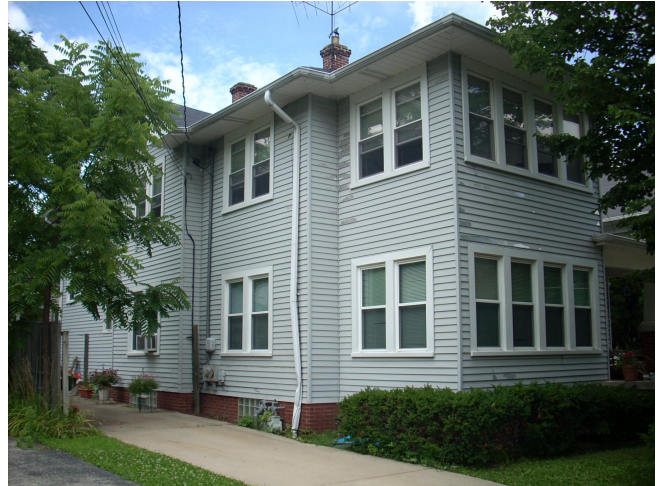
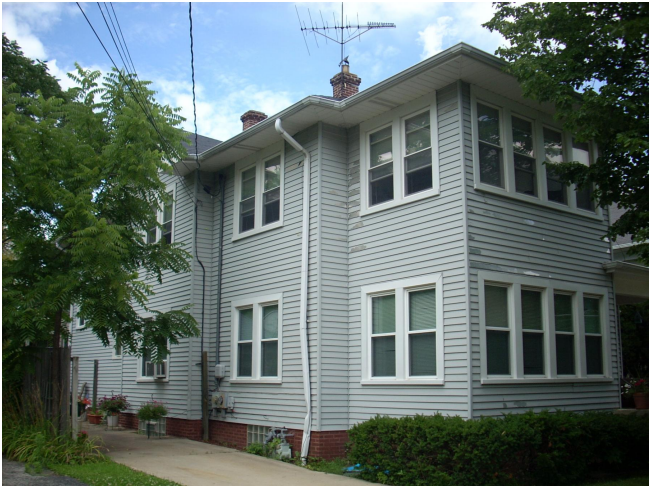
Photo Id: Maple312

Craftsman

Low pitched front hipped roof with overhanging eaves; north (rear) section of house features side gable roof; southeast corner entry porch with hipped roof and battered square column on brick pier; historic wood entry doors

Replacement siding (1955--permit indicates that house was originally stucco); replacement windows in original openings (1/1 on first and second stories, glass block in basement)

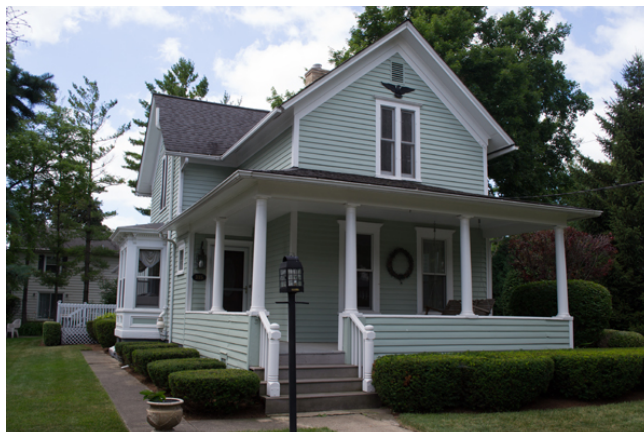
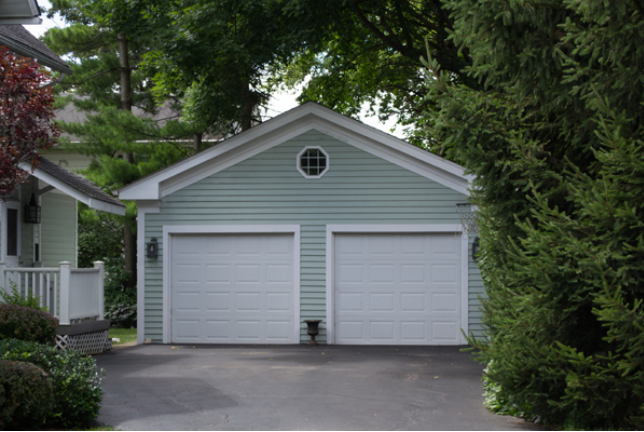
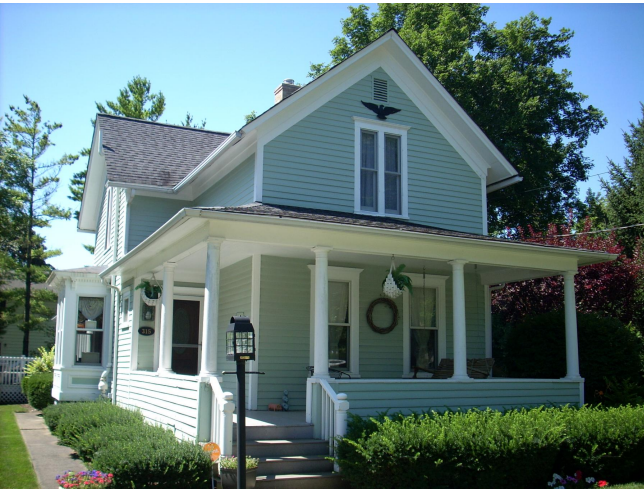
Photo Id: MapleAveW315(1)

Even with alterations to east porch and replacement windows, this Cross Form residence with Queen Anne and Italianate detailing may be eligible for local landmark designation.

Cross gable roofline, with 2-story front gable bay intersected by east and west projecting gable bays; wraparound front porch (likely an historic alteration from early 20th century); 1-story east window bay with classical cornice

Replacement windows in original openings; rear and southeast porches enclosed and connected (1982)

JB-06-303 (2006)--remove and replace side porch; 82-60 (5/3/1982)--porch extension, hanging of bay window; #581 (4/22/1953)--repair work on rear of house foundation; #2273 (5/20/1950)--transfer door and window to another location and repair roof under bay window

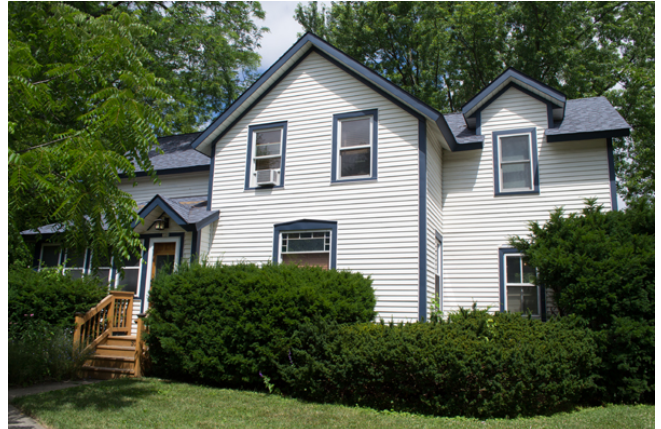
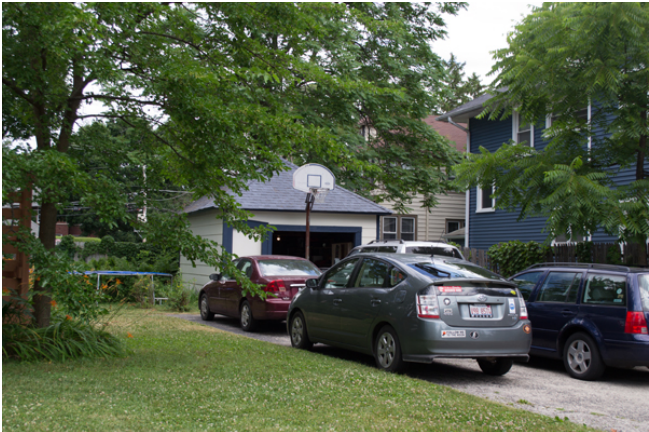
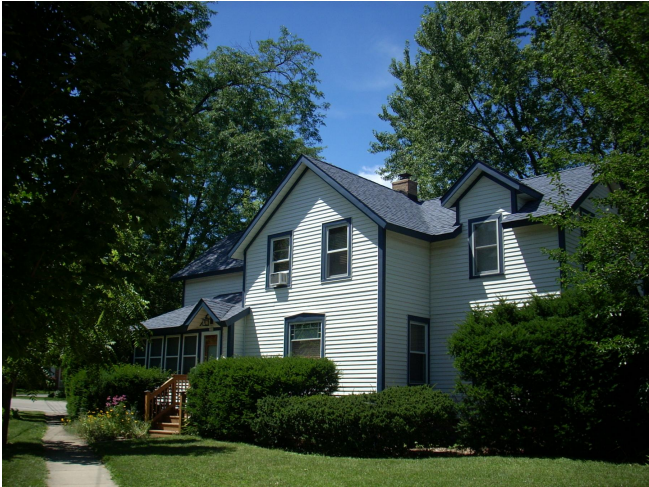
Photo Id: MapleAveW320(2)

Two-story south-facing gable bay intersected by two-story west side wing; historic window with multi-light upper sash on first story of south-facing bay

1/1 replacement windows in original openings; replacement front porch (later enclosed); 2nd story east addition (2007)

JRA-07-0031 (9/12/2007)--bedroom addition; #2360  
(8/17/1950)--remodel to two-family residence (\$2,000); #704  
(9/4/1953)--replace old steps with new

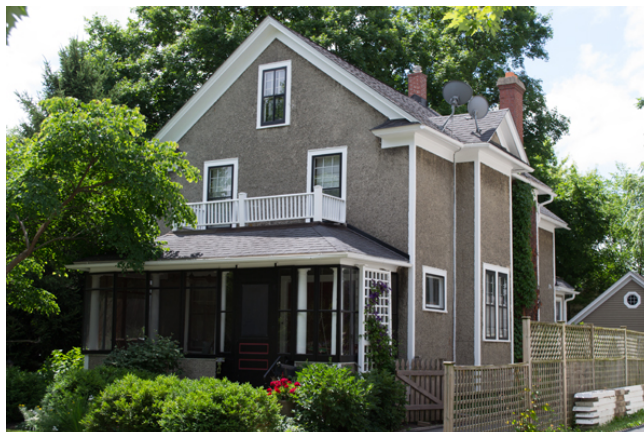
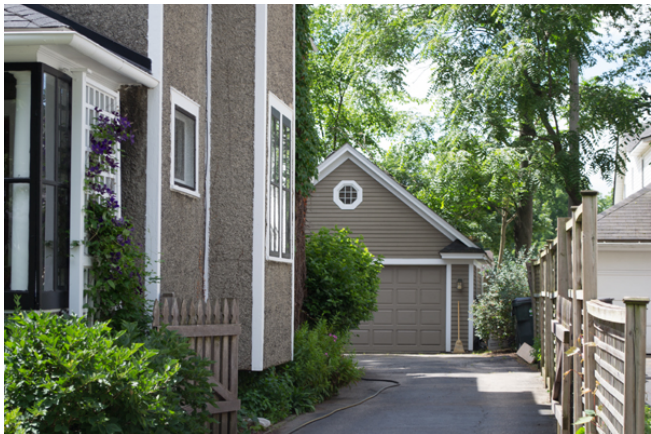
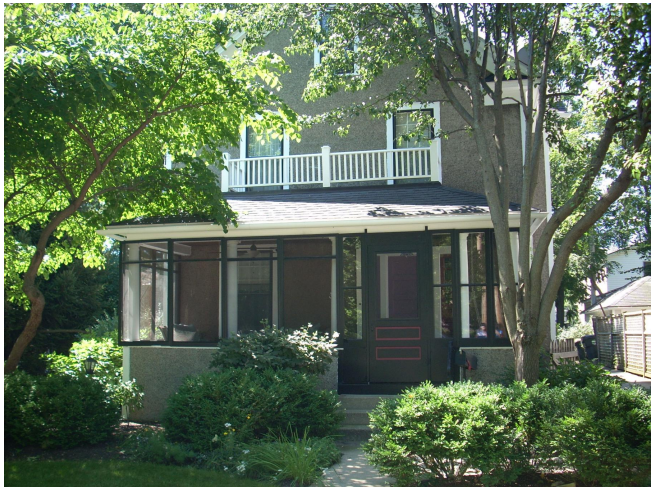
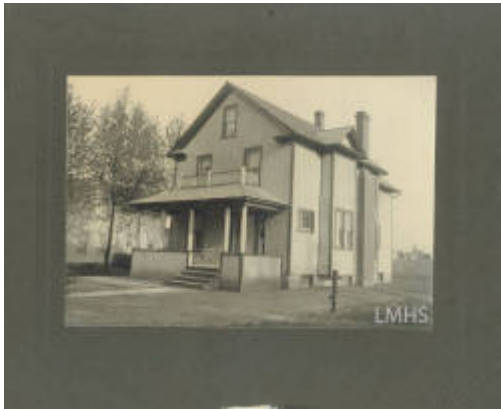
Photo Id: MapleAveW323(1)

Well-preserved Gable Front residence with Colonial Revival detailing.

Front gable roof with cornice returns; 2-story west side projecting bay; hipped-roof front porch with classical columns on stucco knee wall; historic front door and sidelights; historic wood windows

Replacement railings at roof of front porch; rear addition (2000)

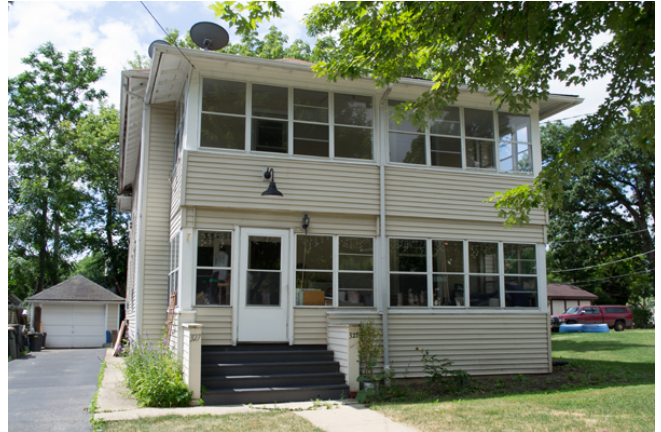
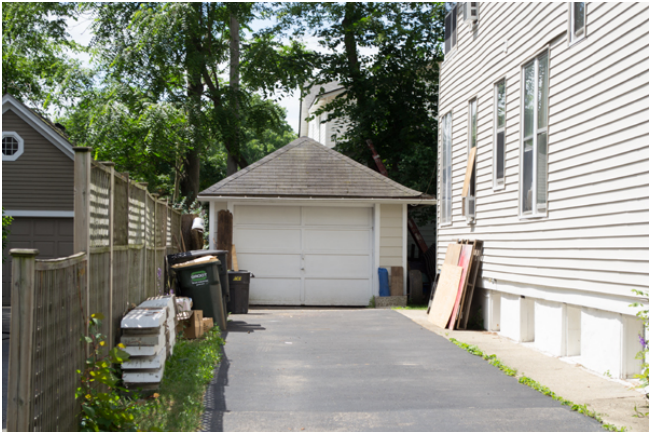
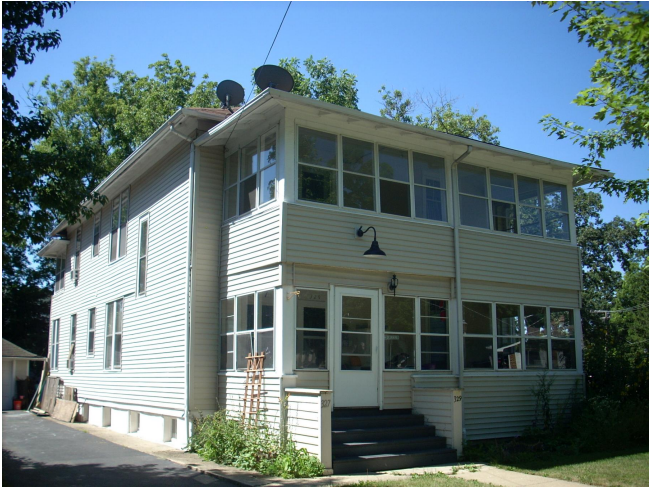
Photo Id: MapleAveW327-329(1)

<b>CATEGORY</b>	Building	<b>HISTORIC USE</b>	Domestic - multiple dwelling
<b>CONDITION</b>	Good	<b>SECONDARY STRUCTURE</b>	Detached garage
<b>INTEGRITY</b>	Moderate alterations	<b>NR SECOND</b>	C
<b>CURRENT USE</b>	Domestic - multiple dwelling

Replacement windows in front porch

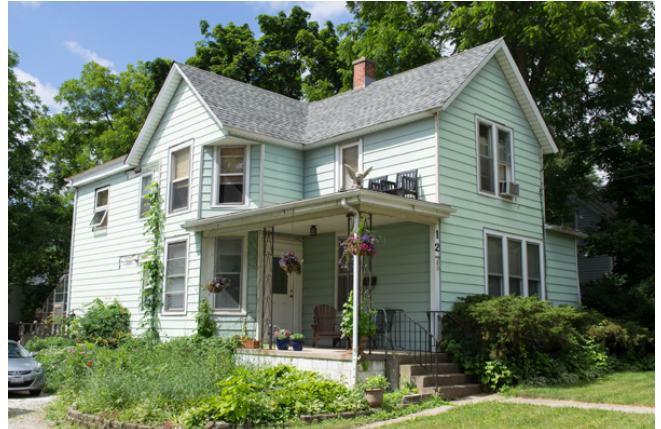
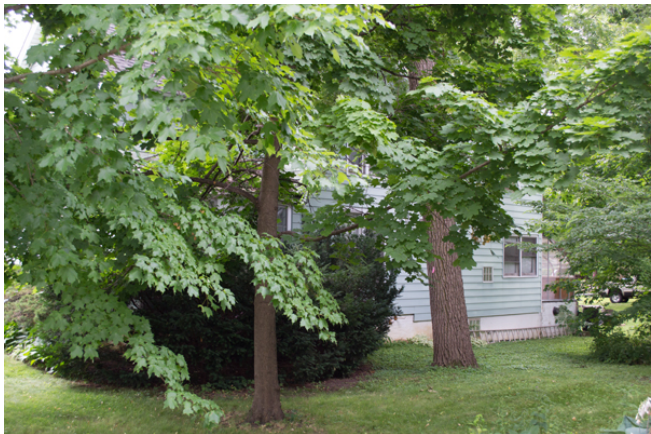
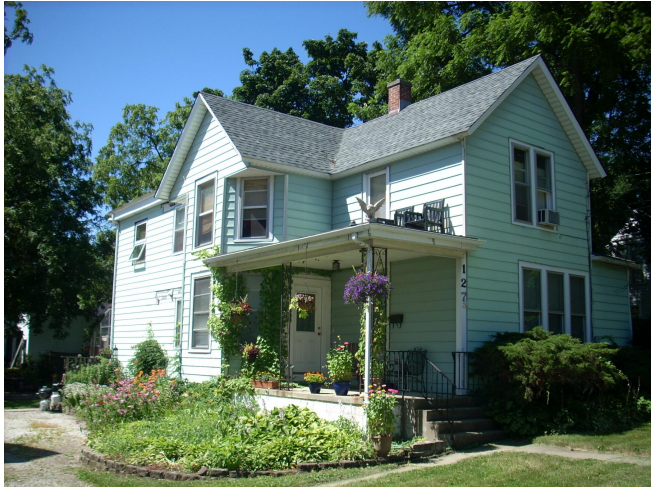
Photo Id: MapleAveW127(1)

<b>CATEGORY</b>	Building	<b>HISTORIC USE</b>	Domestic - single dwelling
<b>CONDITION</b>	Good	<b>SECONDARY STRUCTURE</b>	-
<b>INTEGRITY</b>	Minor alterations and additions	<b>NR SECOND</b>	-
<b>CURRENT USE</b>	Domestic - single dwelling

Replacement front porch; replacement siding (2003); 2-story rear addition; 1-story west side addition; replacement windows, most in original openings; three-part window at first story of front facade

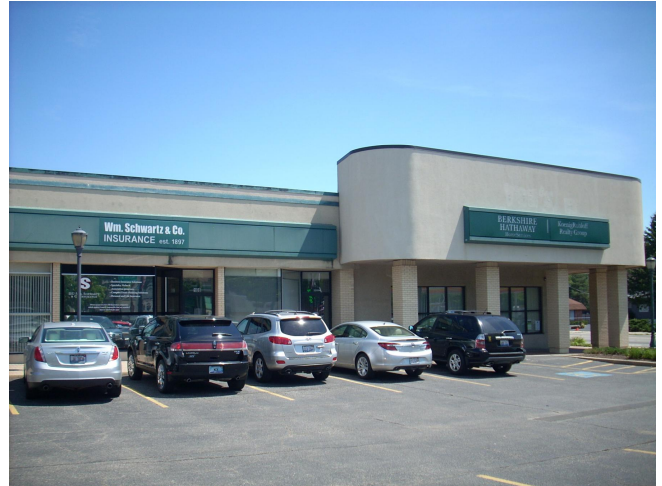
Photo Id: NMil100108

<b>CATEGORY</b>	Building
<b>CONDITION</b>	Good
<b>INTEGRITY</b>	Minor alterations
<b>CURRENT USE</b>	Commerce/Trade

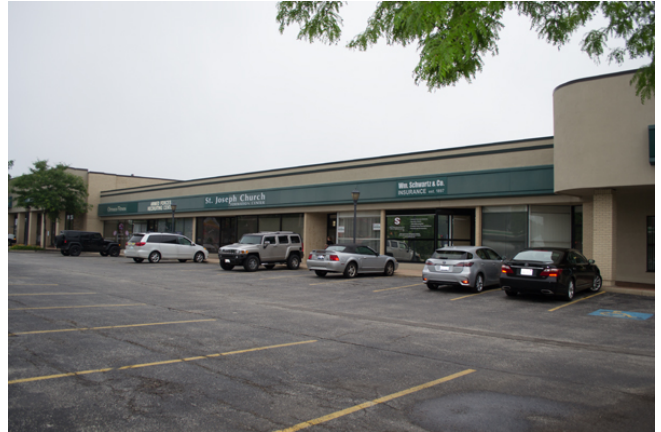
Photo Id: MilwaukeeAveN100-130(7)

<b>CATEGORY</b>	Building	<b>HISTORIC USE</b>	Commerce/Trade
<b>CONDITION</b>	Good	<b>SECONDARY STRUCTURE</b>	-
<b>INTEGRITY</b>	Minor alterations	<b>NR SECOND</b>	-
<b>CURRENT USE</b>	Commerce/Trade
