Historic Libertyville

BEGINNING STREET NUMBER	308
END STREET NUMBER	-
STREET # SUFFIX	-
STREET NAME	W. Maple Avenue
PIN	
<u>LOCAL</u>	
WITHIN LOCAL DISTRICT?	No
LOCAL DIST CONTRIB/NON-CONTRIB?	C
LOCAL LANDMARK?	No
YEAR	-
LOCAL LANDMARK ELIGIBLE?	No
CRITERIA	-

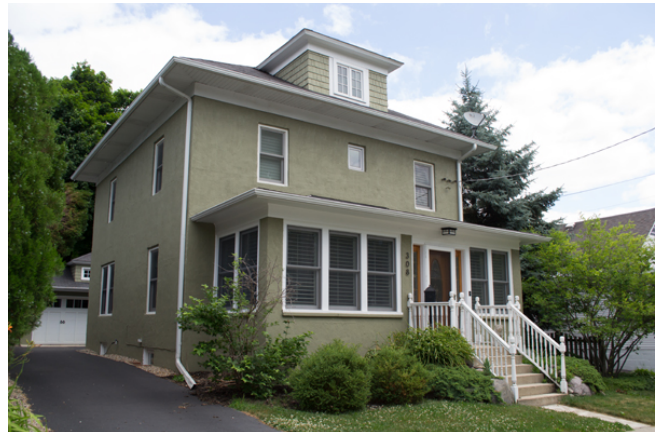
Photo Id: MapleAveW308(1)

CATEGORY	Building	HISTORIC USE	Domestic - single dwelling
CONDITION	Good	SECONDARY STRUCTURE	Detached garage
INTEGRITY	Moderate alterations	NR SECOND	NC
CURRENT USE	Domestic - single dwelling

American Foursquare

Hipped roof and rectangular massing; hipped roof front gable; hipped-roof full front porch structure

Stucco siding (post-1948); front porch enclosed with 1/1 windows, new door and sidelights; replacement windows in original openings; replacement front door; concrete front steps with wood railing

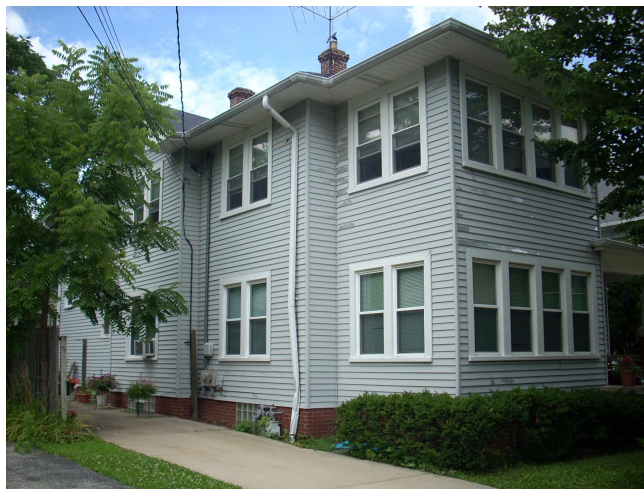
Photo Id: Maple312

Craftsman

Low pitched front hipped roof with overhanging eaves; north (rear) section of house features side gable roof; southeast corner entry porch with hipped roof and battered square column on brick pier; historic wood entry doors

Replacement siding (1955--permit indicates that house was originally stucco); replacement windows in original openings (1/1 on first and second stories, glass block in basement)

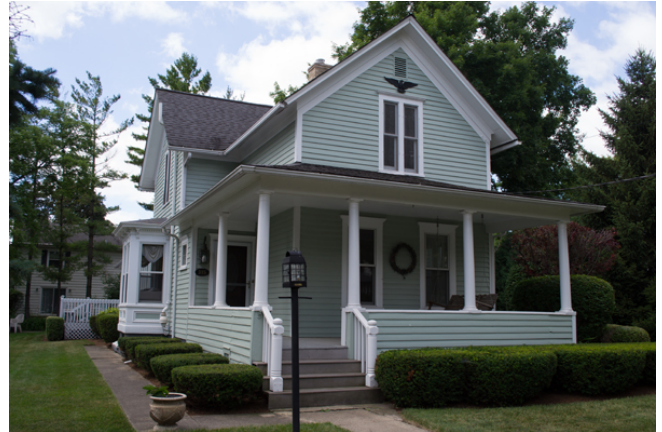
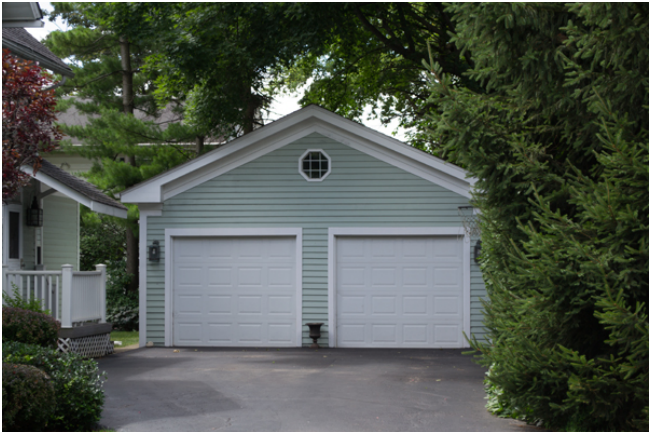
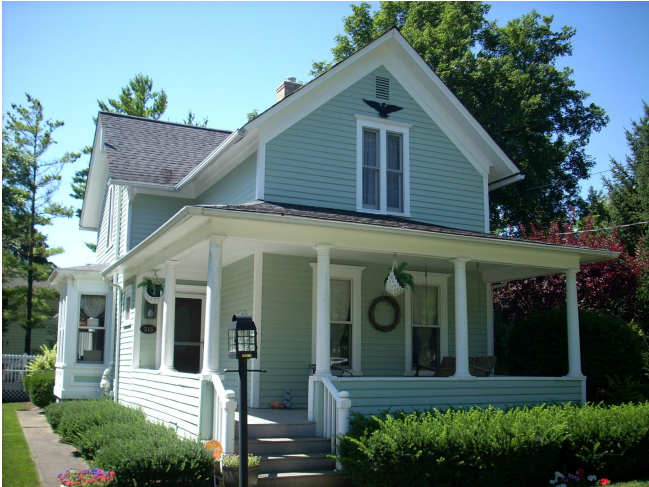
Photo Id: MapleAveW315(1)

Even with alterations to east porch and replacement windows, this Cross Form residence with Queen Anne and Italianate detailing may be eligible for local landmark designation.

Cross gable roofline, with 2-story front gable bay intersected by east and west projecting gable bays; wraparound front porch (likely an historic alteration from early 20th century); 1-story east window bay with classical cornice

Replacement windows in original openings; rear and southeast porches enclosed and connected (1982)

JB-06-303 (2006)--remove and replace side porch; 82-60 (5/3/1982)--porch extension, hanging of bay window; #581 (4/22/1953)--repair work on rear of house foundation; #2273 (5/20/1950)--transfer door and window to another location and repair roof under bay window

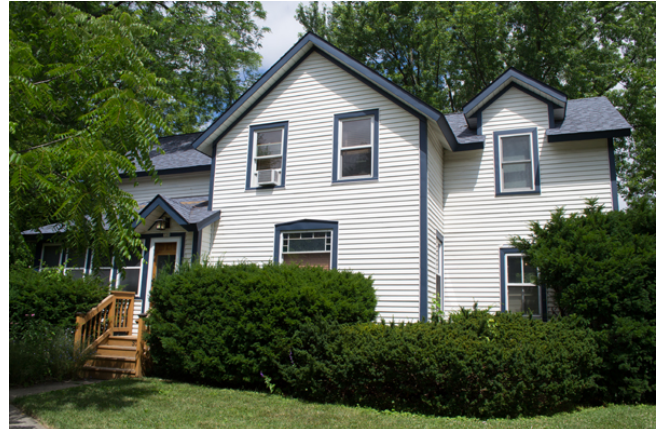
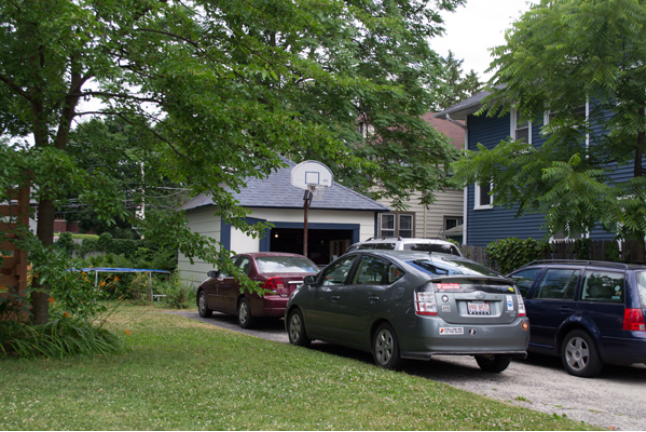
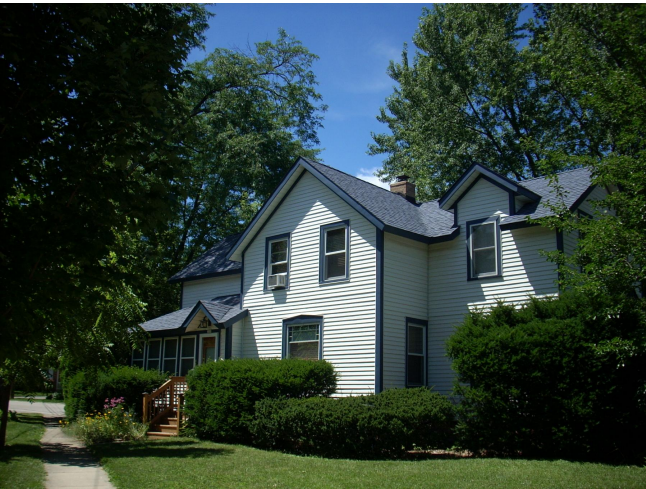
Photo Id: MapleAveW320(2)

Two-story south-facing gable bay intersected by two-story west side wing; historic window with multi-light upper sash on first story of south-facing bay

1/1 replacement windows in original openings; replacement front porch (later enclosed); 2nd story east addition (2007)

JRA-07-0031 (9/12/2007)--bedroom addition; #2360
(8/17/1950)--remodel to two-family residence (\$2,000); #704
(9/4/1953)--replace old steps with new

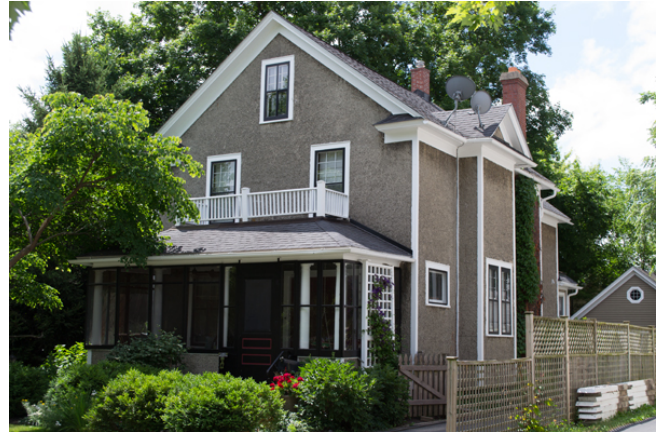
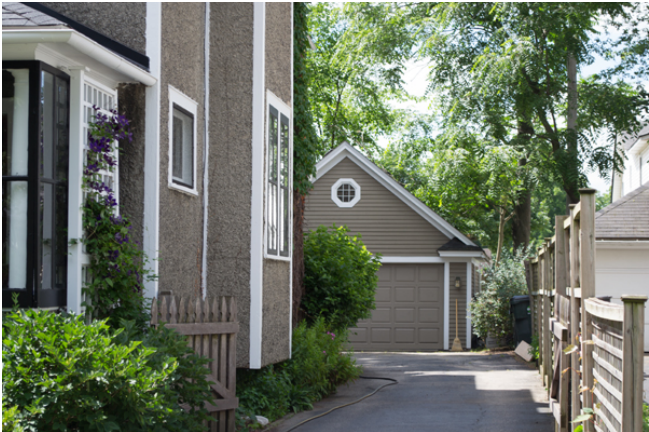
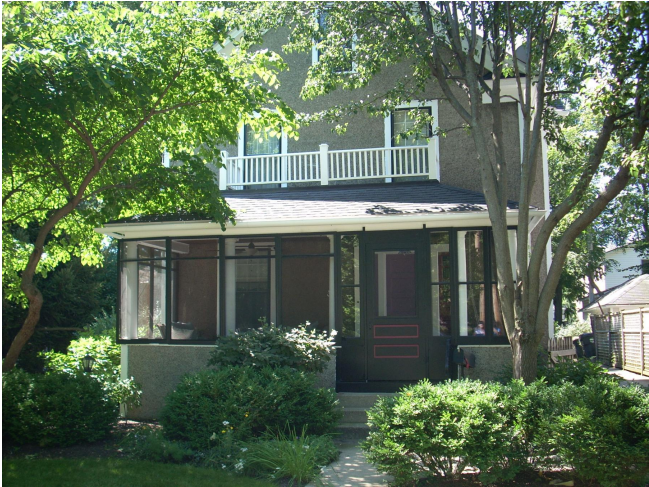
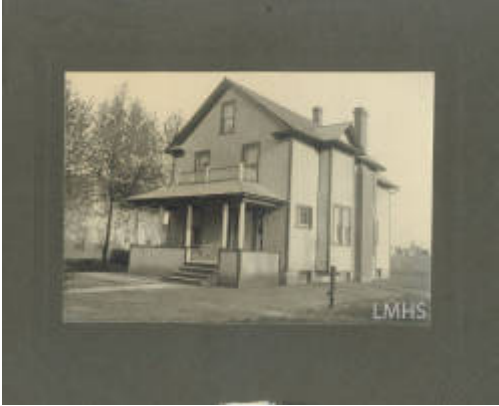
Photo Id: MapleAveW323(1)

Well-preserved Gable Front residence with Colonial Revival detailing.

Front gable roof with cornice returns; 2-story west side projecting bay; hipped-roof front porch with classical columns on stucco knee wall; historic front door and sidelights; historic wood windows

Replacement railings at roof of front porch; rear addition (2000)

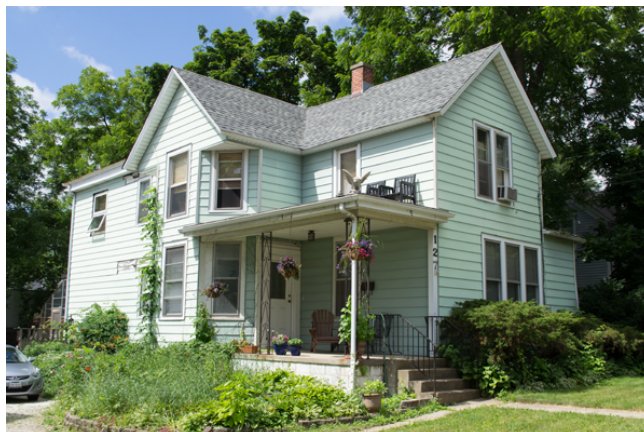
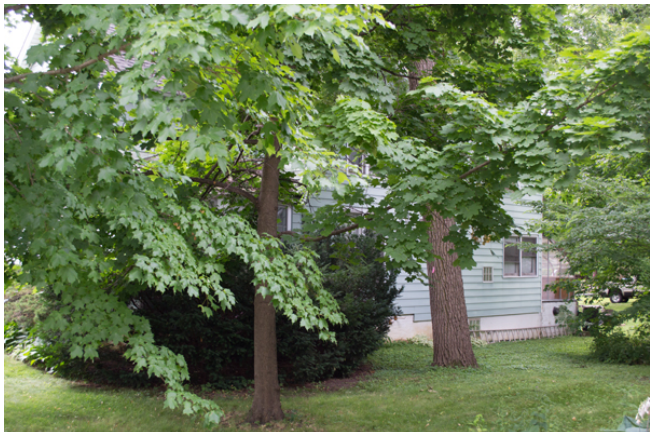
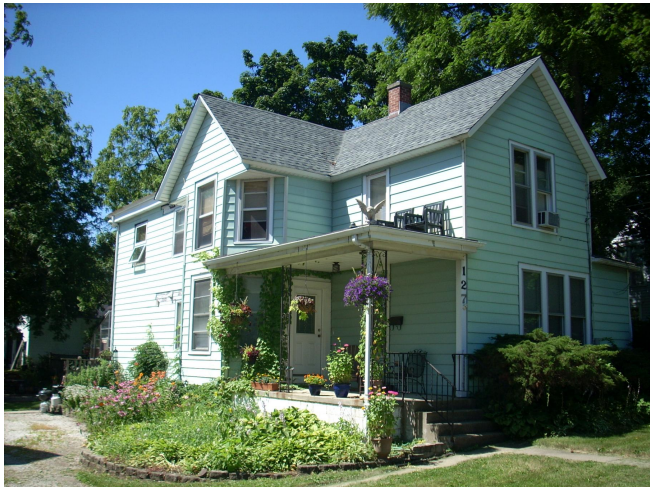
Photo Id: MapleAveW127(1)

Gabled Ell

Replacement front porch; replacement siding (2003); 2-story rear addition; 1-story west side addition; replacement windows, most in original openings; three-part window at first story of front facade

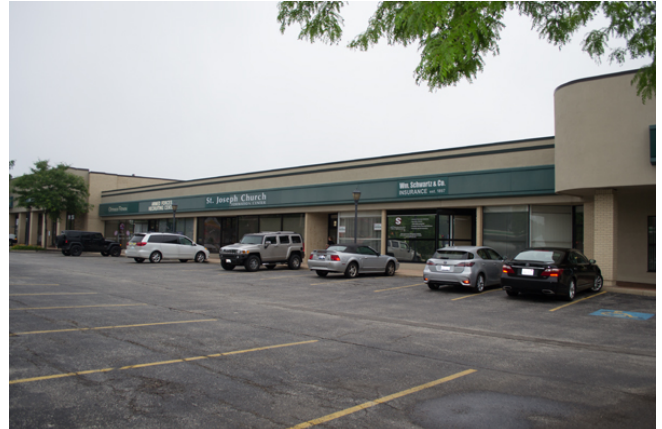
Photo Id: MilwaukeeAveN100-130(7)

CATEGORY	Building	HISTORIC USE	Commerce/Trade
CONDITION	Good	SECONDARY STRUCTURE	-
INTEGRITY	Minor alterations	NR SECOND	-
CURRENT USE	Commerce/Trade
