Historic Libertyville

BEGINNING STREET NUMBER	136
END STREET NUMBER	-
STREET # SUFFIX	-
STREET NAME	Newberry Avenue
PIN	
<u>LOCAL</u>	
WITHIN LOCAL DISTRICT?	No
LOCAL DIST CONTRIB/NON-CONTRIB?	C
LOCAL LANDMARK?	No
YEAR	-
LOCAL LANDMARK ELIGIBLE?	Potentially Eligible
CRITERIA	A

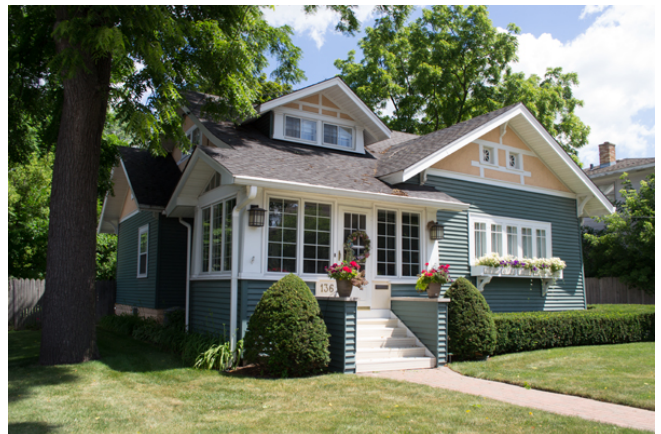
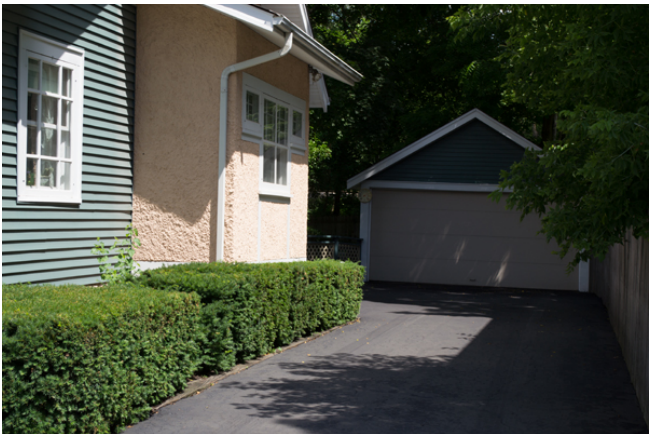
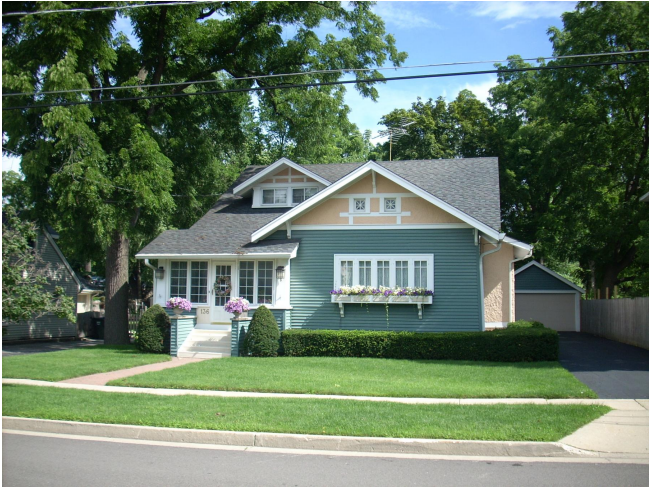
Photo Id: NewberryAve136(1)

CATEGORY	Building	HISTORIC USE	Domestic - single dwelling
CONDITION	Good	SECONDARY STRUCTURE	Detached garage
INTEGRITY	Minor alterations	NR SECOND	NC
CURRENT USE	Domestic - single dwelling

Side gable roof with L brackets under eaves; front gable bay with battered corners, decorative half timbering; east side oriel window bay; corner entry porch with battered square columns; gable front dormer

Replacement siding on sections of exterior; front porch enclosed; alterations to rear porch (replaced 1956, alterations 1970)

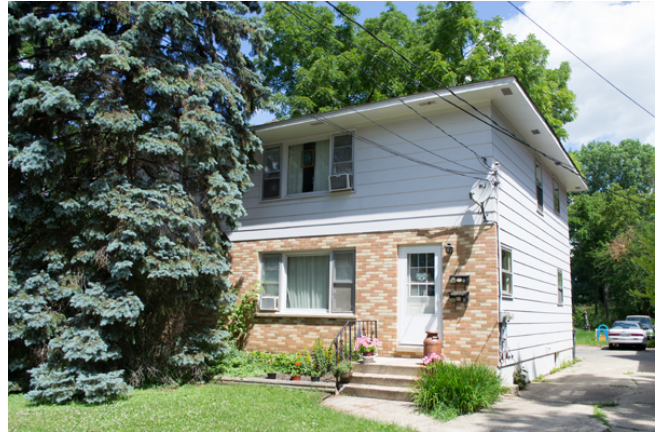
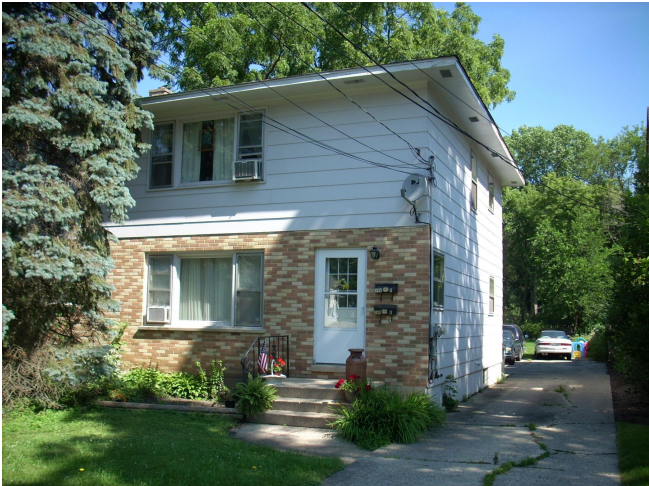
Photo Id: NewberryAve140

CATEGORY	<input type="text" value="Building"/>	HISTORIC USE	<input type="text" value="Domestic - multiple dwelling"/>
CONDITION	<input type="text" value="Good"/>	SECONDARY STRUCTURE	<input type="text" value="-"/>
INTEGRITY	<input type="text" value="Minor alterations"/>	NR SECOND	<input type="text" value="-"/>
CURRENT USE	<input type="text" value="Domestic - multiple dwelling"/>

Replacement siding; replacement front door

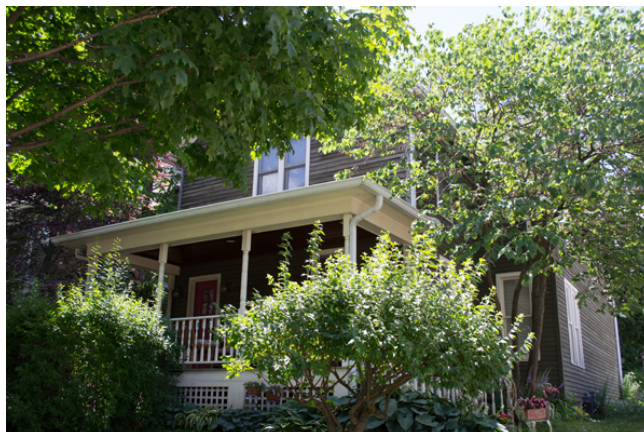
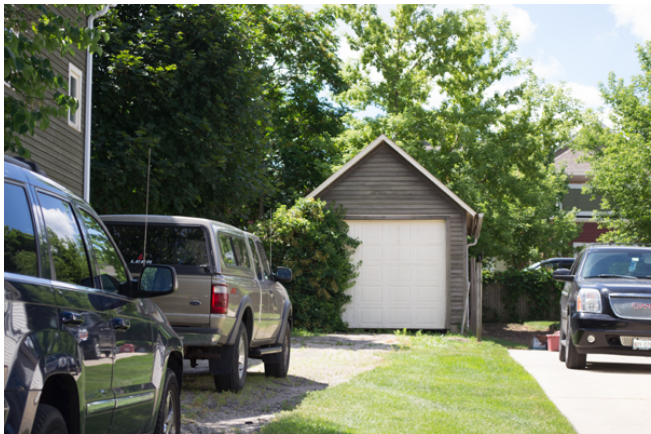
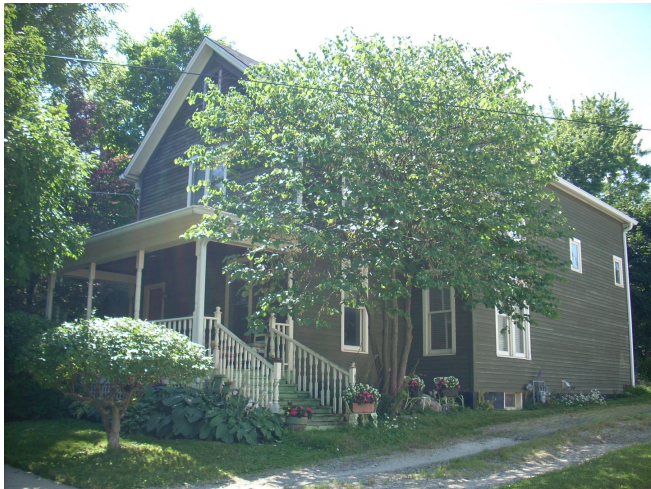
Photo Id: NewberryAve143(1)

Front gable roof; hipped full-front porch structure (historic, but not original-see 1912 and 1924 Sanborn maps); two-story west gable bay (altered)

Wood siding is replacement; replacement windows in original openings; replacement railings and columns on front porch; two-story rear and west addition (1993); replacement front door

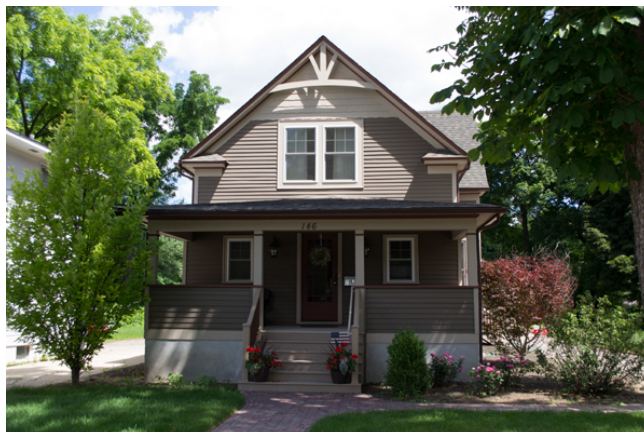
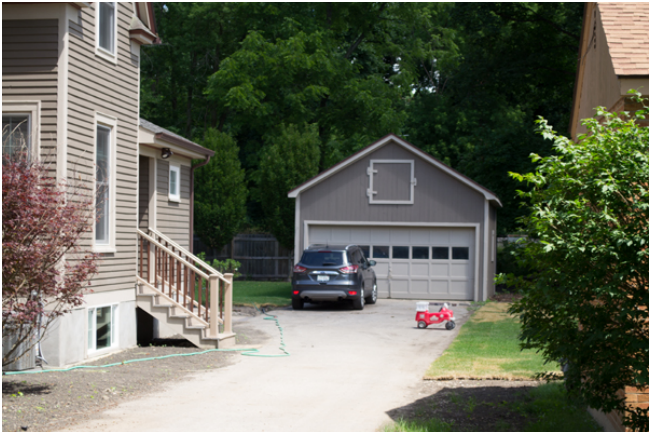
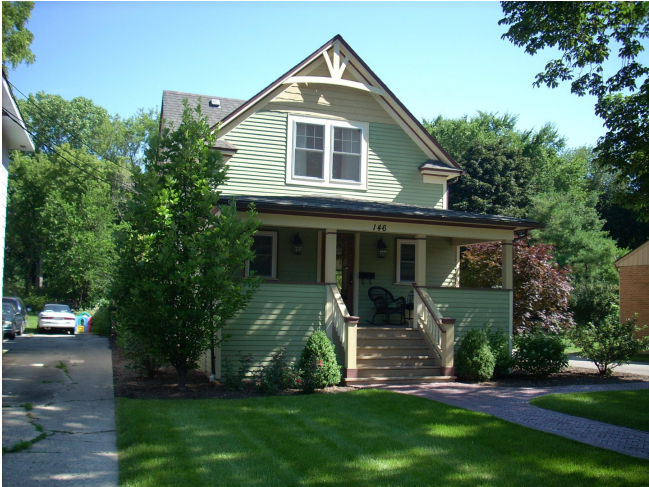
Photo Id: NewberryAve146(1)

CATEGORY	Building	HISTORIC USE	Domestic - single dwelling
CONDITION	Good	SECONDARY STRUCTURE	Detached garage
INTEGRITY	Moderate alterations	NR SECOND	NC
CURRENT USE	Domestic - single dwelling

Front gable roof; east-side gable bay; front porch structure with hipped roof

Exterior remodeling in 2012--replacement siding; replacement windows in original openings; replacement porch columns and step railings; rear porch enclosed (post-1948)

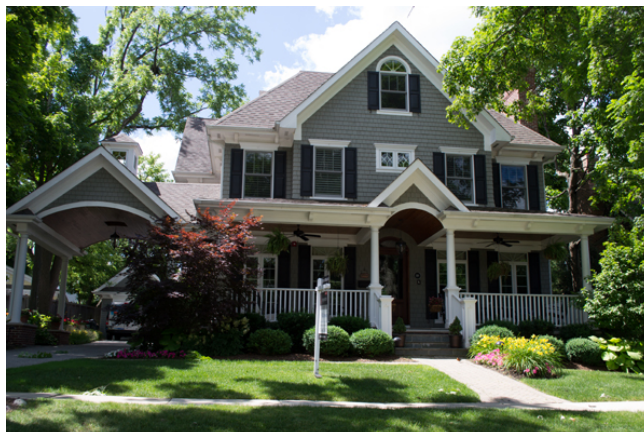
Photo Id: NewberryAve149(1)

CATEGORY	Building	HISTORIC USE	Domestic - single dwelling
CONDITION	Excellent	SECONDARY STRUCTURE	Detached garage
INTEGRITY	Not altered	NR SECOND	NC
CURRENT USE	Domestic - single dwelling

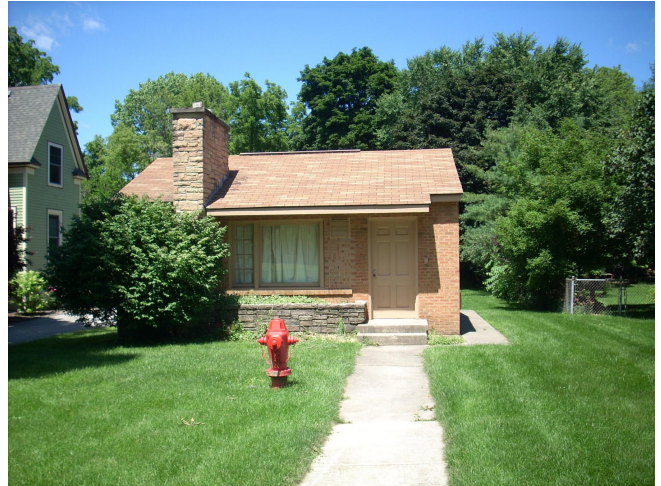
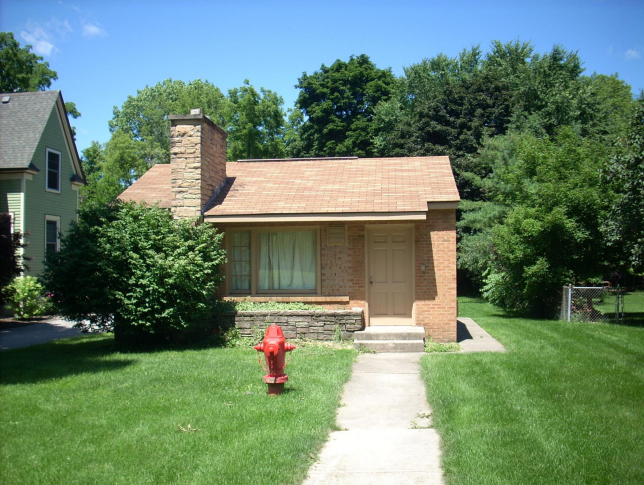
Photo Id: NewberryAve150

Materials (siding, windows, door) all appear original; stone chimney and front planter box

One casement windows on front facade bricked in

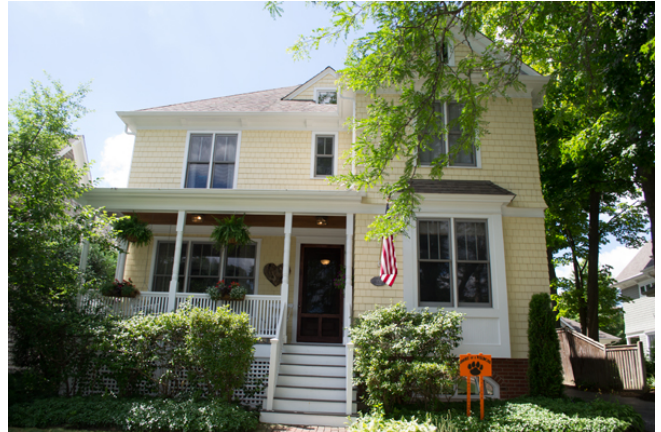
Photo Id: NewberryAve155(1)

CATEGORY	Building	HISTORIC USE	Domestic - single dwelling
CONDITION	Excellent	SECONDARY STRUCTURE	Detached garage
INTEGRITY	Not altered	NR SECOND	NC
CURRENT USE	Domestic - single dwelling

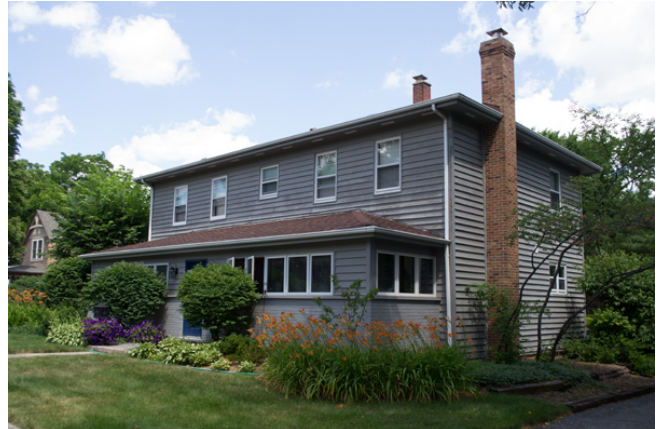
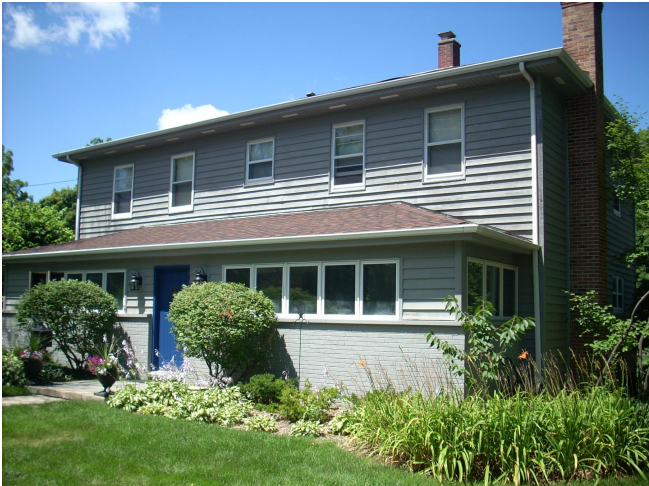
Photo Id: NewberryAve158(1)

Historic section of house at east

Original massing and roofline of house obscured by large, 2-story west side addition built in 1986; original porch removed and replaced with new enclosed porch; replacement siding; replacement windows in original openings

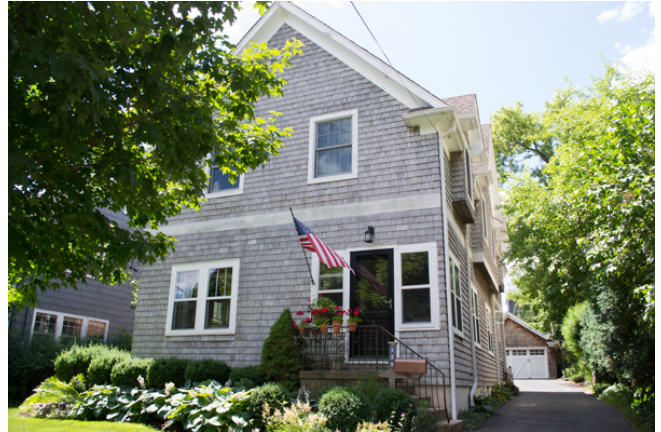
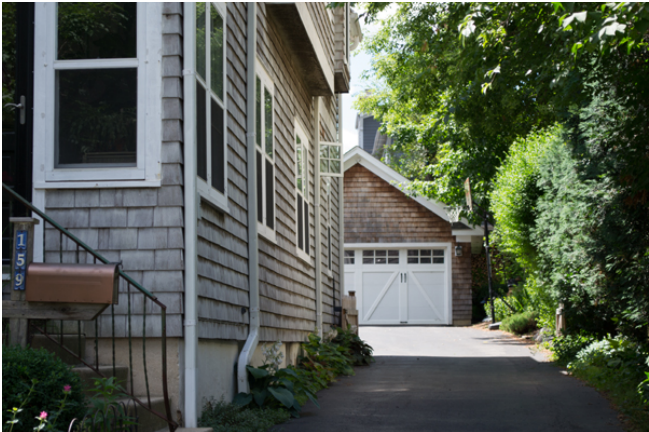
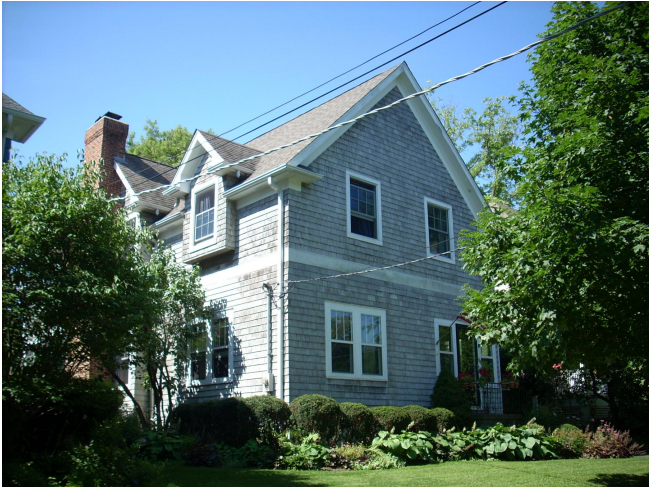
Photo Id: NewberryAve159(1)

CATEGORY	<input type="text" value="Building"/>	HISTORIC USE	<input type="text" value="Domestic - single dwelling"/>
CONDITION	<input type="text" value="Good"/>	SECONDARY STRUCTURE	<input type="text" value="Detached garage"/>
INTEGRITY	<input type="text" value="Major alterations and additions"/>	NR SECOND	<input type="text" value="NC"/>
CURRENT USE	<input type="text" value="Domestic - single dwelling"/>

Second story is non-historic addition (see 1948 Sanborn map); replacement siding

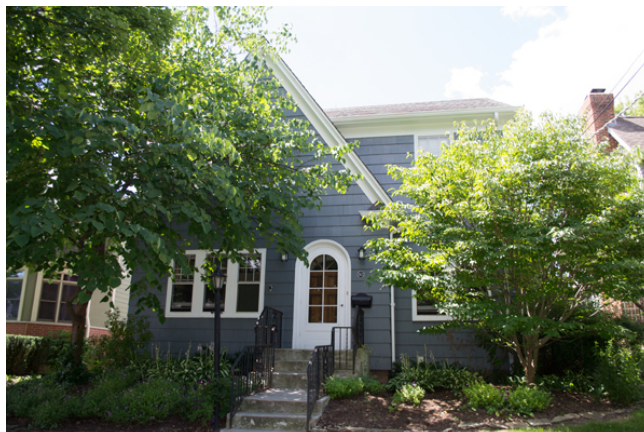
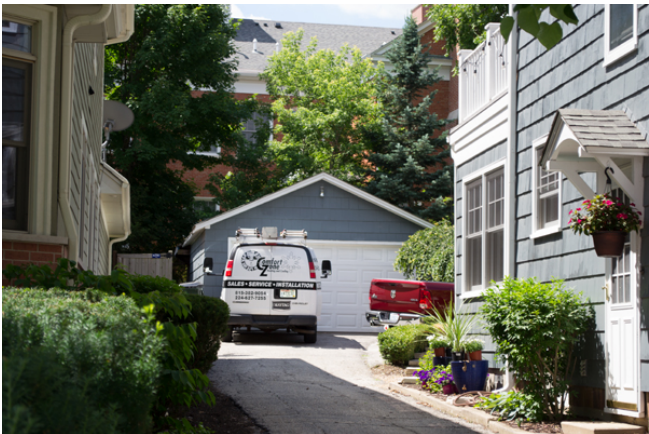
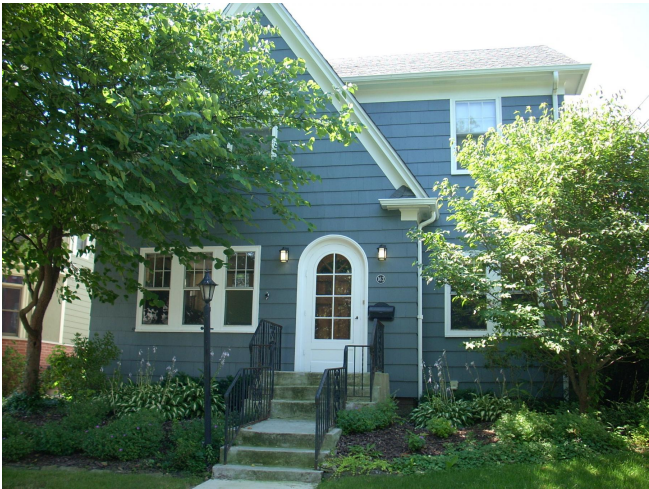
Photo Id: NewberryAve163(1)

CATEGORY	Building	HISTORIC USE	Domestic - single dwelling
CONDITION	Good	SECONDARY STRUCTURE	Detached garage
INTEGRITY	Minor alterations	NR SECOND	NC
CURRENT USE	Domestic - single dwelling

Replacement front door; rear porch enclosed (1955)
