Historic Libertyville

Ramsey Historic Consultants

May-June 2016

Downtown Libertyville

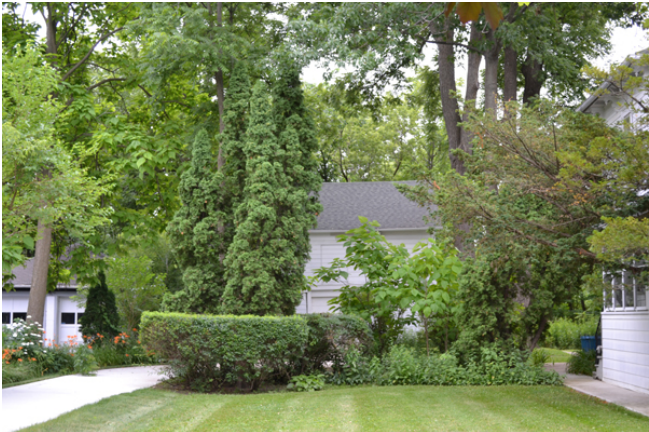
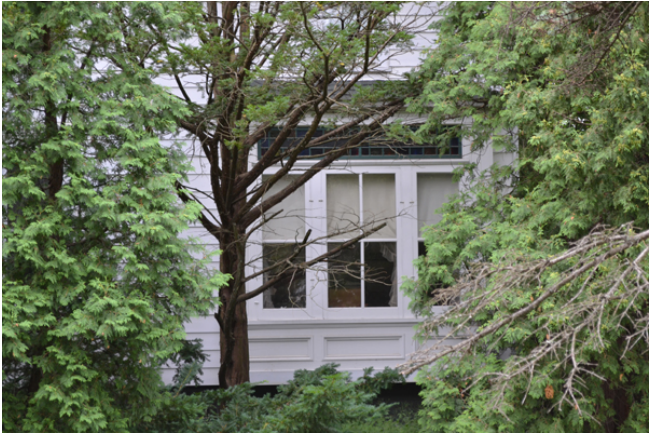
Photo Id: ParkAveW147(3)

CATEGORY	<input type="text" value="Building"/>	HISTORIC USE	<input type="text" value="Domestic - single dwelling"/>
CONDITION	<input type="text" value="Good"/>	SECONDARY STRUCTURE	<input type="text" value="Barn"/>
INTEGRITY	<input type="text" value="Moderate alterations"/>	NR SECOND	<input type="text" value="C"/>
CURRENT USE	<input type="text" value="Domestic - single dwelling"/>

Italianate

Hipped roof; wood cornice with paneled frieze and brackets with drop pendants; square front oriel bay with classical surround and historic wood windows; 1/1 wood windows on all facades with classical surrounds

Replacement siding (1976); Two-story rear addition; replacement front porch (later enclosed)

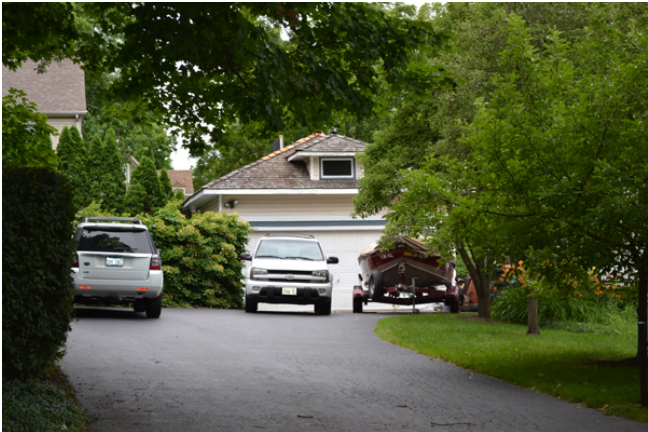
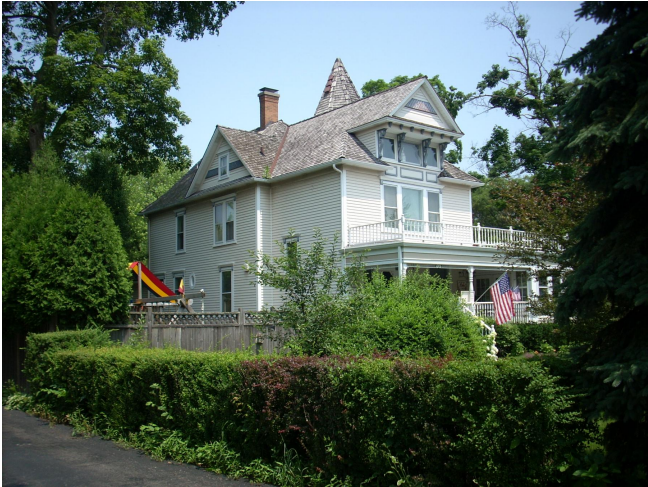
Photo Id: ParkAveW208(1)

CATEGORY	Building	HISTORIC USE	Domestic - single dwelling
CONDITION	Good	SECONDARY STRUCTURE	Detached garage
INTEGRITY	Moderate alterations	NR SECOND	NC
CURRENT USE	Domestic - single dwelling

Queen Anne

Despite alterations, this Queen Anne residence may be eligible for local landmark designation.

Hipped main roof with projecting front-gable through-the-cornice dormer on south facade (dormer features overhang supported by scrolled brackets); 2.5-story east side polygonal tower with pointed roof; wraparound front porch structure (not original, but historic--dates from between 1924 and 1933; partially enclosed)

Replacement siding (1991); wood-shingle roofing; east end of wraparound porch enclosed (post-1948); replacement railings on porch; one-story rear addition; replacement windows in original openings

90-399 (1/16/1991)--siding; 94-326 (6/1/1994)--roof; 94-579 (8/8/1994)--alterations; 99-369 (5/14/99)--alterations

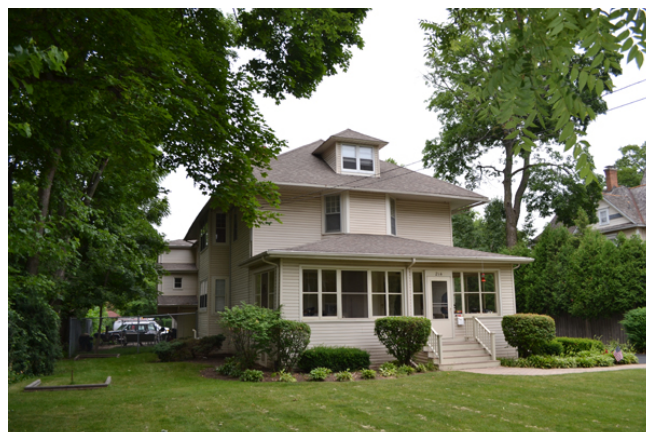
Photo Id: ParkAveW214

CATEGORY	<input type="text" value="Building"/>	HISTORIC USE	<input type="text" value="Domestic - single dwelling"/>
CONDITION	<input type="text" value="Good"/>	SECONDARY STRUCTURE	<input type="text" value="-"/>
INTEGRITY	<input type="text" value="Moderate alterations and additions"/>	NR SECOND	<input type="text" value="-"/>
CURRENT USE	<input type="text" value="Domestic - single dwelling"/>

American Foursquare

Hipped roof with overhanging eaves; hipped-roof front and side dormers; three-sided west bay; hipped-roof front porch; center three-sided bay above porch; original stucco cladding visible under porch

Large two-story rear addition (1953, 1982); front porch enclosed, with replacement front steps and railing; replacement siding (1994)

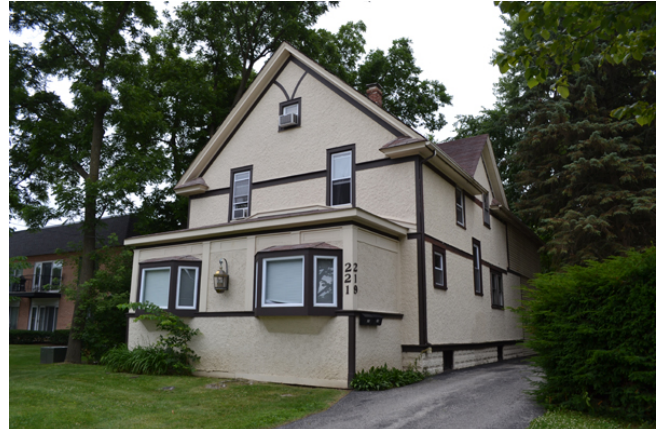
Photo Id: ParkAveW219-221(1)

CATEGORY	Building	HISTORIC USE	Domestic - single dwelling
CONDITION	Good	SECONDARY STRUCTURE	Detached garage; shed
INTEGRITY	Moderate alterations	NR SECOND	NC; NC
CURRENT USE	Domestic - multiple dwellings

Gable Front

Front gable roof; stucco with wood corner boards, string courses, and minimal decorative half-timbering; three-sided east window bay; east and west gables; some historic wood windows on side facades

Front porch enclosed

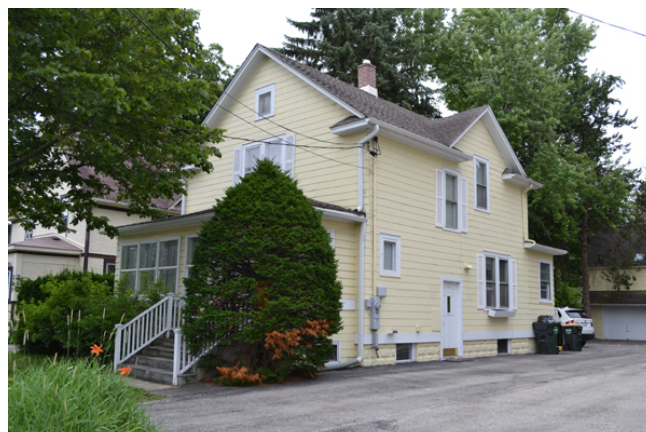
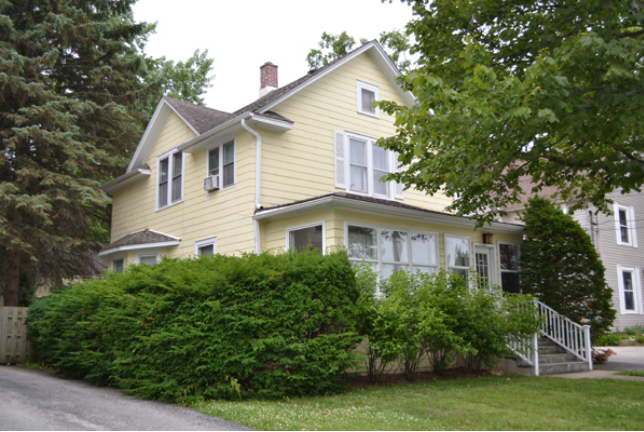
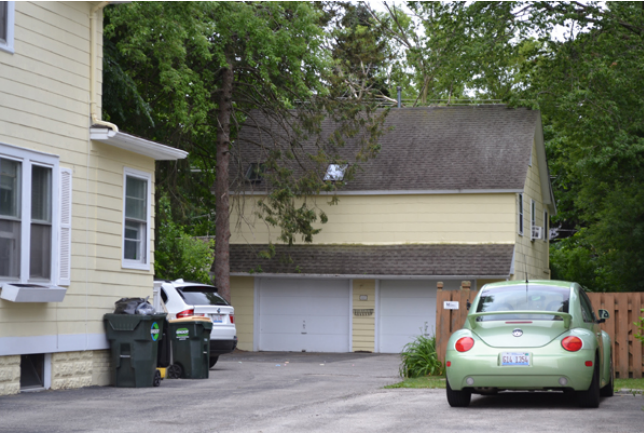
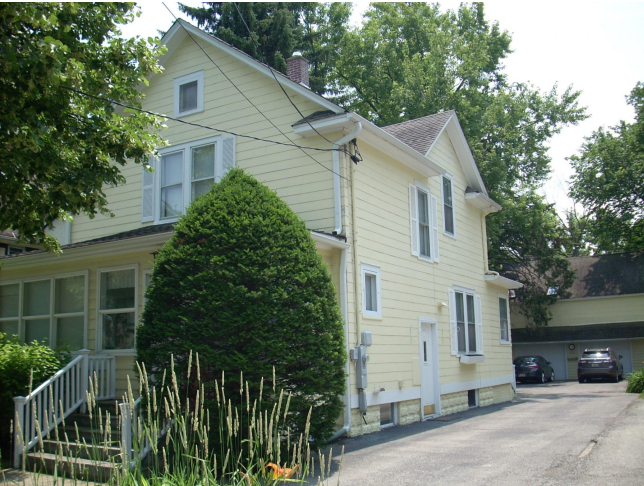
Photo Id: ParkAveW225(1)

CATEGORY	<input type="text" value="Building"/>	HISTORIC USE	<input type="text" value="Domestic - single dwelling"/>
CONDITION	<input type="text" value="Good"/>	SECONDARY STRUCTURE	<input type="text" value="Detached garage"/>
INTEGRITY	<input type="text" value="Minor alterations"/>	NR SECOND	<input type="text" value="C"/>
CURRENT USE	<input type="text" value="Domestic - multiple dwelling"/>

Gable Front

Front gable roof with cornice returns; hipped-roof front porch structure; gable through-the-cornice dormers on side facades; one-story, three-sided window bay on east facade

Replacement windows in original openings; front porch enclosed with aluminum/vinyl windows (1970); fixed shutters; concrete steps (1970)

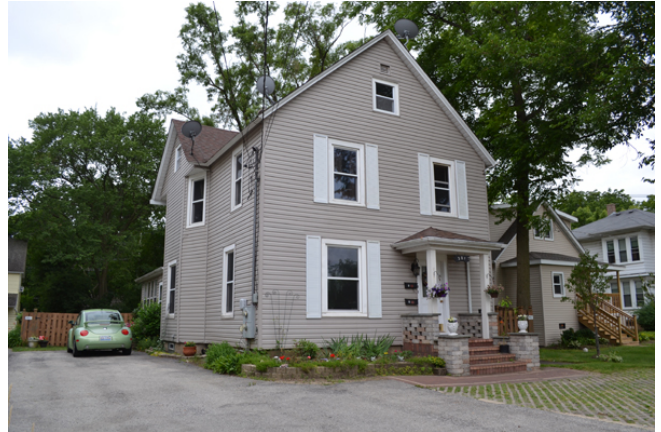
Photo Id: ParkAveW301

CATEGORY	<input type="text" value="Building"/>	HISTORIC USE	<input type="text" value="Domestic - single dwelling"/>
CONDITION	<input type="text" value="Good"/>	SECONDARY STRUCTURE	<input type="text" value="-"/>
INTEGRITY	<input type="text" value="Major alterations"/>	NR SECOND	<input type="text" value="-"/>
CURRENT USE	<input type="text" value="Domestic - multiple dwelling"/>

Replacement siding; replacement windows in downsized openings; fixed shutters; replacement front porch (post-1948); replacement door; one-story rear addition (may have originally been rear porch that was enclosed)

98-1122 (12/22/1998)--alterations to 2nd-floor dwelling;
#99-382 (5/19/1999)--alterations to eastern first floor
apartment; 2239 (4/3/1950)--residing walls and repair porch;
No Permit # (10/25/1957)--install outside stairway as rear exit
from 2nd-floor apartment

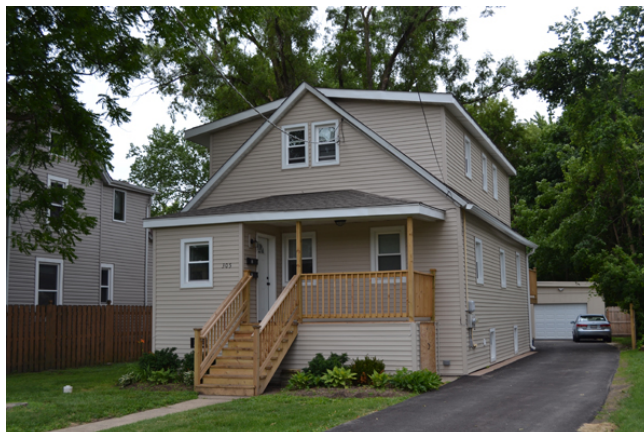
Photo Id: ParkAveW305

CATEGORY	Building	HISTORIC USE	Domestic - single dwelling
CONDITION	Good	SECONDARY STRUCTURE	Detached garage
INTEGRITY	Major alterations and additions	NR SECOND	NC
CURRENT USE	Domestic - multiple dwelling

Replacement siding (1970); replacement windows in original openings; wrought iron railings on porch; large shed-roof side dormer additions (1970); rear deck addition

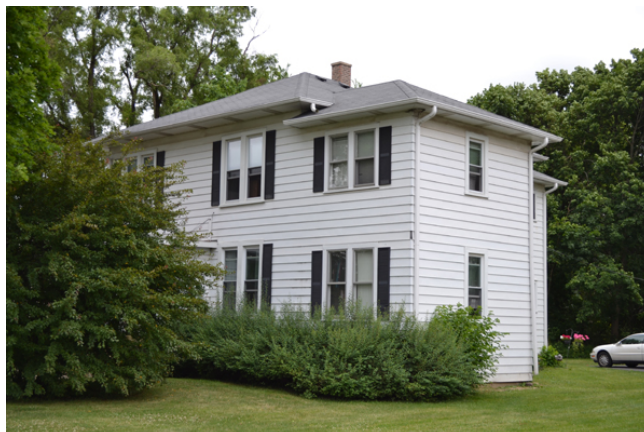
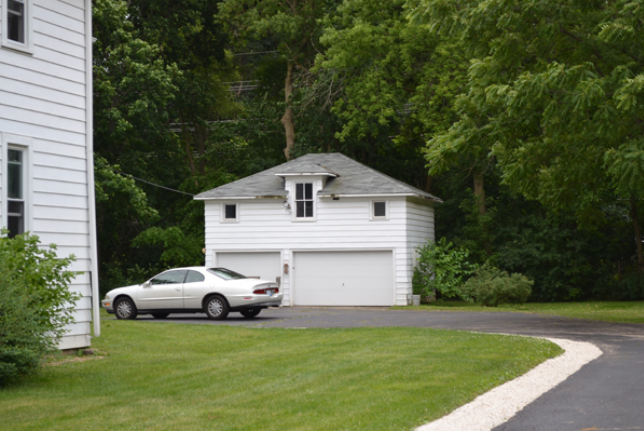
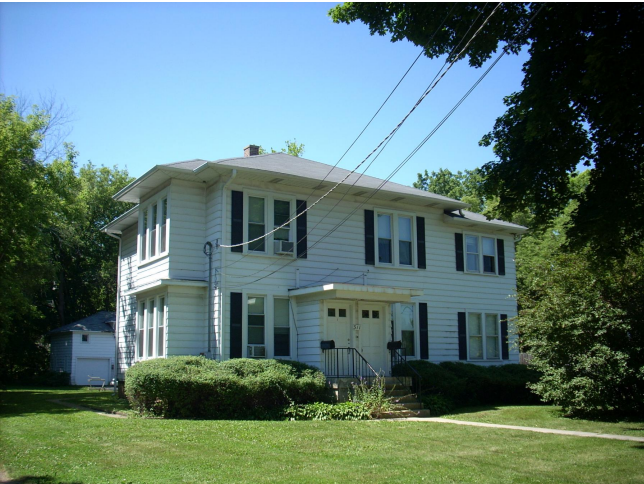
Photo Id: ParkAveW311(3)

CATEGORY	Building	HISTORIC USE	Domestic - single dwelling
CONDITION	Fair	SECONDARY STRUCTURE	Coach house
INTEGRITY	Major alterations	NR SECOND	C
CURRENT USE	Domestic - multiple dwelling

Replacement siding (1990); replacement windows in original openings (not historic); front entry bay addition (open porch addition built c. 1930 and later enclosed); fixed shutters; two-story west addition that is flush with front facade (historic addition--c. 1930)
