Historic Libertyville

BEGINNING STREET NUMBER	147
END STREET NUMBER	-
STREET # SUFFIX	-
STREET NAME	W. Park Avenue
PIN	
<u>LOCAL</u>	
WITHIN LOCAL DISTRICT?	No
LOCAL DIST CONTRIB/NON-CONTRIB?	C
LOCAL LANDMARK?	No
YEAR	-
LOCAL LANDMARK ELIGIBLE?	No
CRITERIA	-

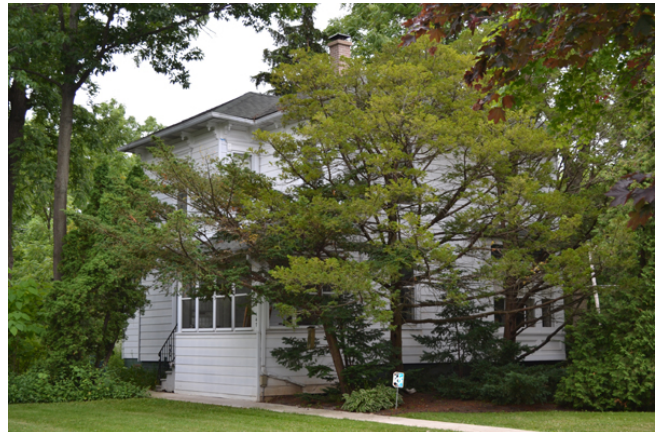
Photo Id: ParkAveW147(3)

CATEGORY	Building	HISTORIC USE	Domestic - single dwelling
CONDITION	Good	SECONDARY STRUCTURE	Barn
INTEGRITY	Moderate alterations	NR SECOND	C
CURRENT USE	Domestic - single dwelling

Italianate

Hipped roof; wood cornice with paneled frieze and brackets with drop pendants; square front oriel bay with classical surround and historic wood windows; 1/1 wood windows on all facades with classical surrounds

Replacement siding (1976); Two-story rear addition; replacement front porch (later enclosed)

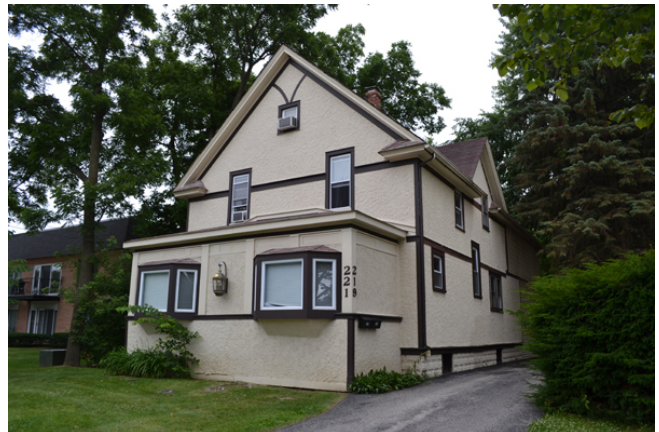
Photo Id: ParkAveW219-221(1)

CATEGORY	Building	HISTORIC USE	Domestic - single dwelling
CONDITION	Good	SECONDARY STRUCTURE	Detached garage; shed
INTEGRITY	Moderate alterations	NR SECOND	NC; NC
CURRENT USE	Domestic - multiple dwellings

Gable Front

Front gable roof; stucco with wood corner boards, string courses, and minimal decorative half-timbering; three-sided east window bay; east and west gables; some historic wood windows on side facades

Front porch enclosed

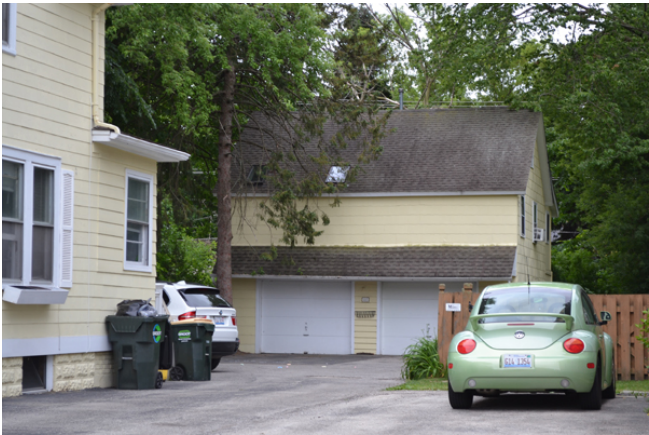
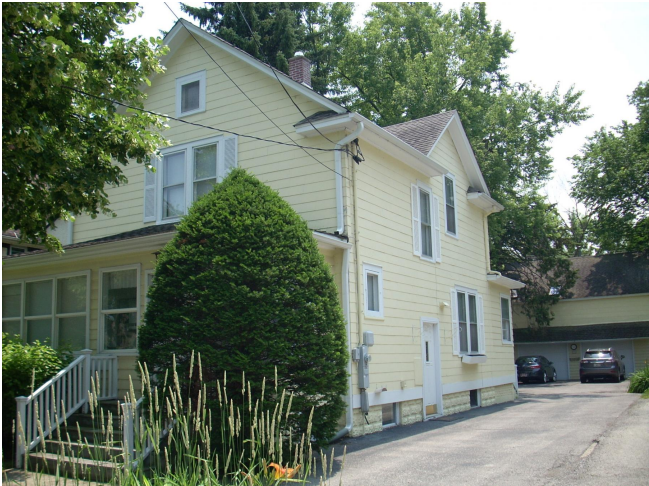
Photo Id: ParkAveW225(1)

Gable Front

Front gable roof with cornice returns; hipped-roof front porch structure; gable through-the-cornice dormers on side facades; one-story, three-sided window bay on east facade

Replacement windows in original openings; front porch enclosed with aluminum/vinyl windows (1970); fixed shutters; concrete steps (1970)

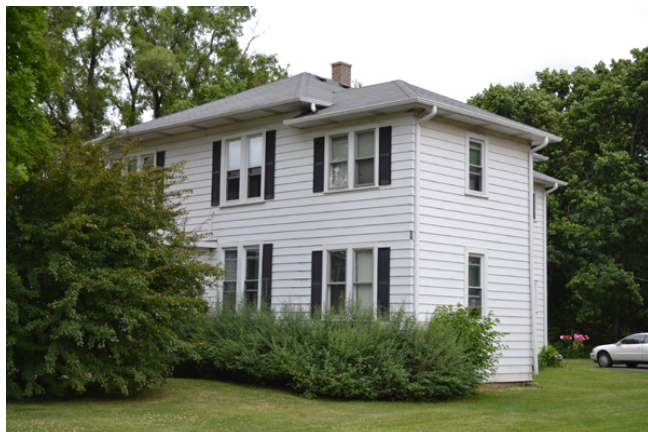
Photo Id: ParkAveW311(3)

CATEGORY	Building	HISTORIC USE	Domestic - single dwelling
CONDITION	Fair	SECONDARY STRUCTURE	Coach house
INTEGRITY	Major alterations	NR SECOND	C
CURRENT USE	Domestic - multiple dwelling

Replacement siding (1990); replacement windows in original openings (not historic); front entry bay addition (open porch addition built c. 1930 and later enclosed); fixed shutters; two-story west addition that is flush with front facade (historic addition--c. 1930)
