Historic Libertyville

Ramsey Historic Consultants

May-June 2016

Downtown Libertyville

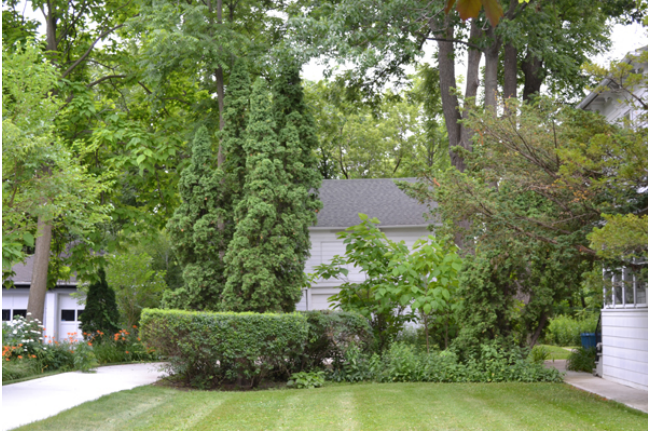
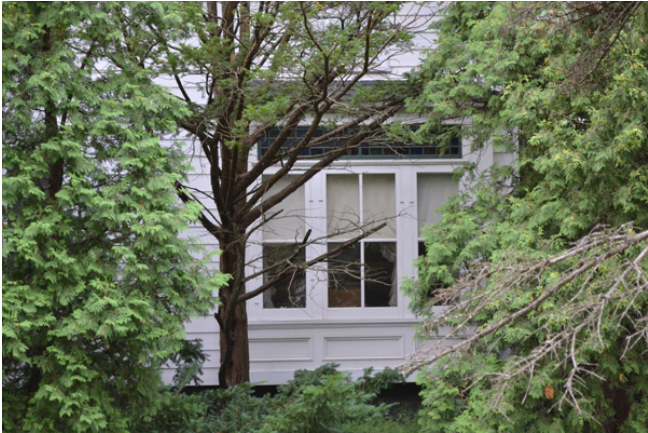
Photo Id: ParkAveW147(3)

Italianate

Hipped roof; wood cornice with paneled frieze and brackets with drop pendants; square front oriel bay with classical surround and historic wood windows; 1/1 wood windows on all facades with classical surrounds

Replacement siding (1976); Two-story rear addition; replacement front porch (later enclosed)

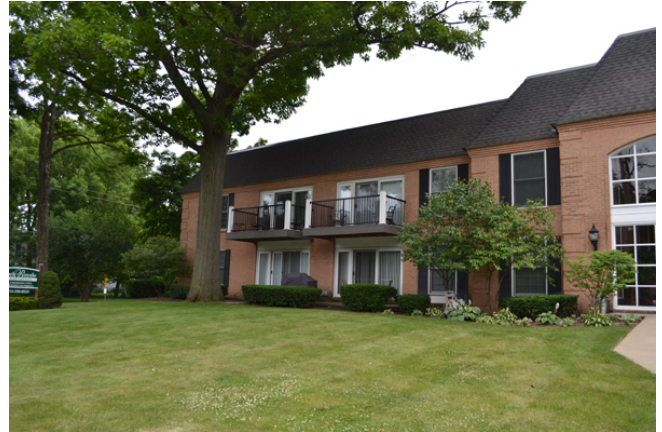
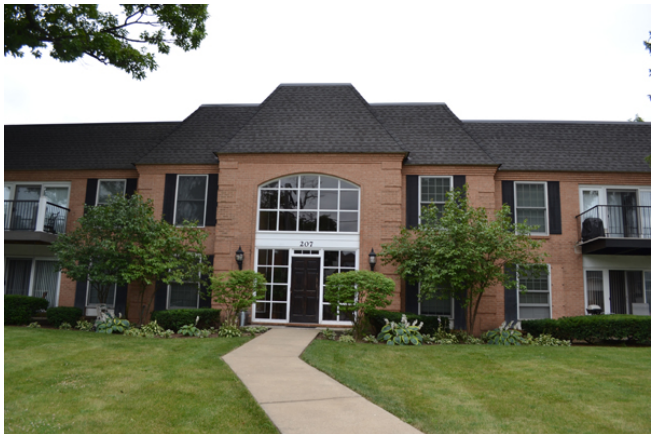
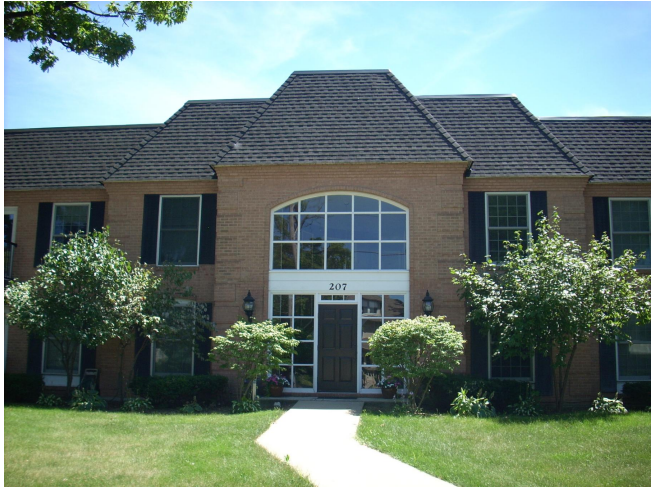
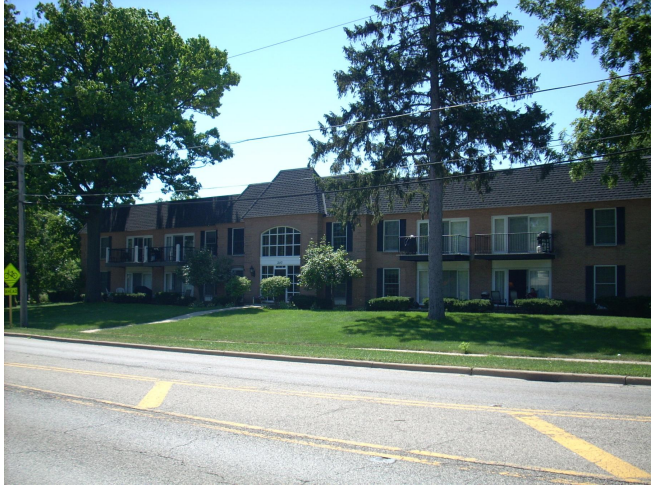
Photo Id: ParkAveW207(4)

New Traditional

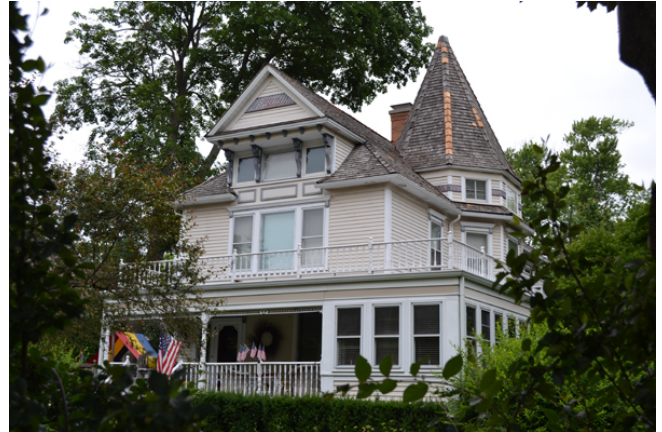
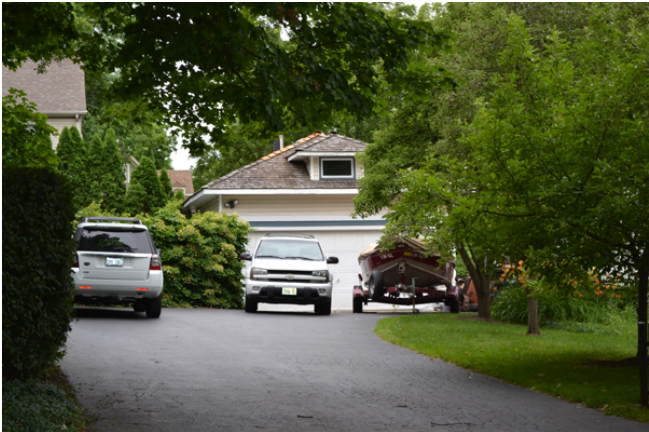
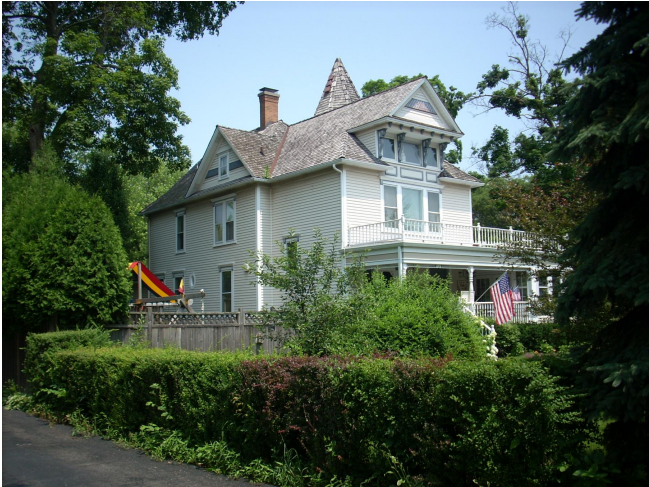
Photo Id: ParkAveW208(1)

Queen Anne

Despite alterations, this Queen Anne residence may be eligible for local landmark designation.

Hipped main roof with projecting front-gable through-the-cornice dormer on south facade (dormer features overhang supported by scrolled brackets); 2.5-story east side polygonal tower with pointed roof; wraparound front porch structure (not original, but historic--dates from between 1924 and 1933; partially enclosed)

Replacement siding (1991); wood-shingle roofing; east end of wraparound porch enclosed (post-1948); replacement railings on porch; one-story rear addition; replacement windows in original openings

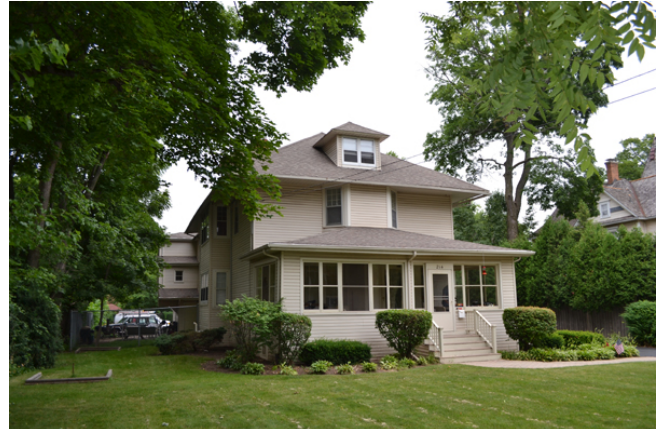
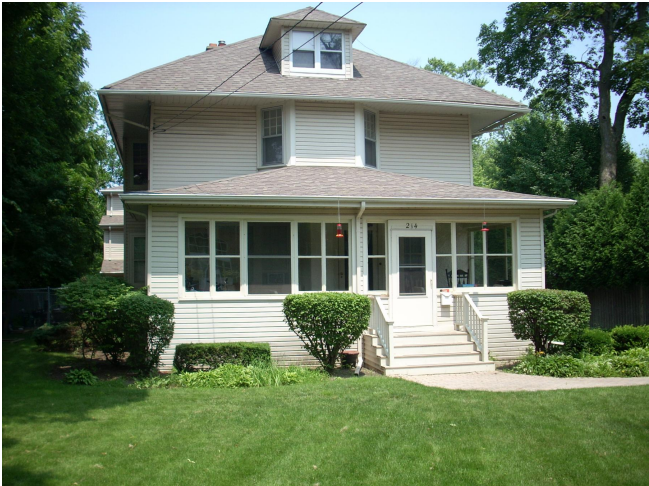
Photo Id: ParkAveW214

American Foursquare

Hipped roof with overhanging eaves; hipped-roof front and side dormers; three-sided west bay; hipped-roof front porch; center three-sided bay above porch; original stucco cladding visible under porch

Large two-story rear addition (1953, 1982); front porch enclosed, with replacement front steps and railing; replacement siding (1994)

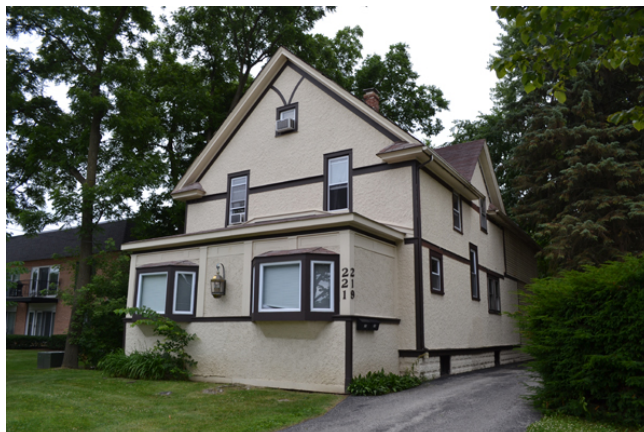
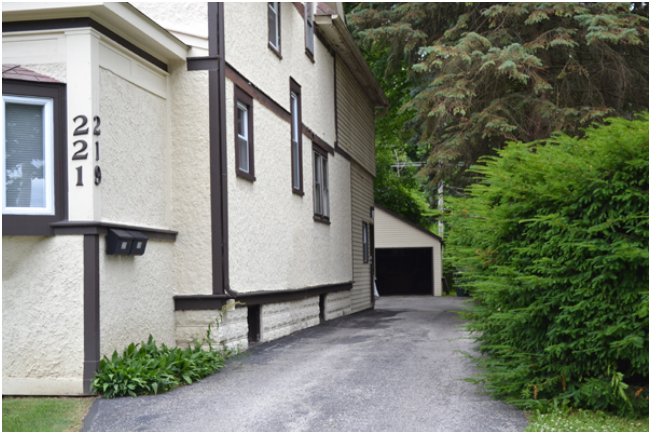
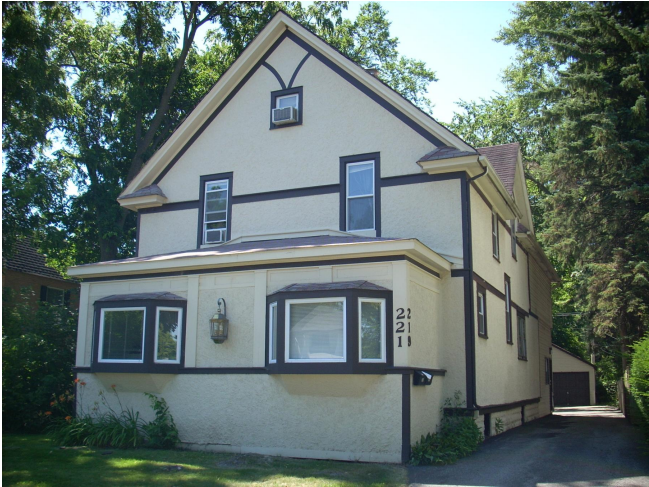
Photo Id: ParkAveW219-221(1)

Gable Front

Front gable roof; stucco with wood corner boards, string courses, and minimal decorative half-timbering; three-sided east window bay; east and west gables; some historic wood windows on side facades

Front porch enclosed

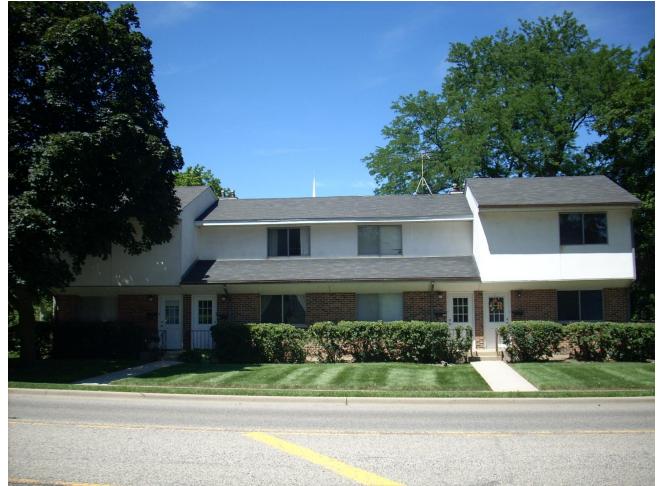
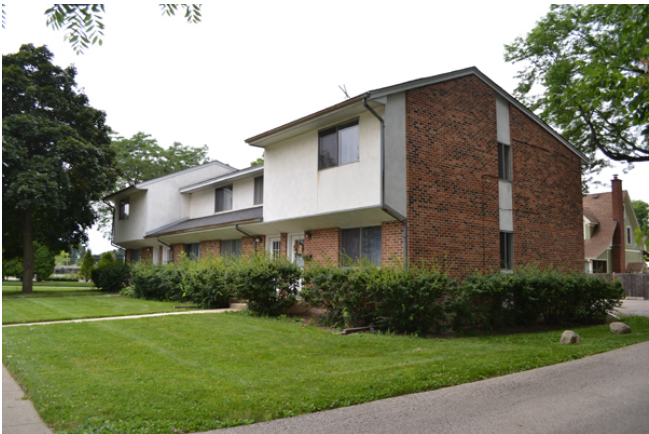
Photo Id: WPark220-224

Contemporary

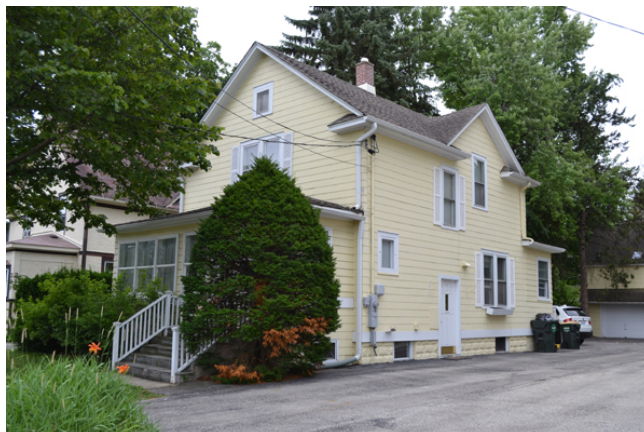
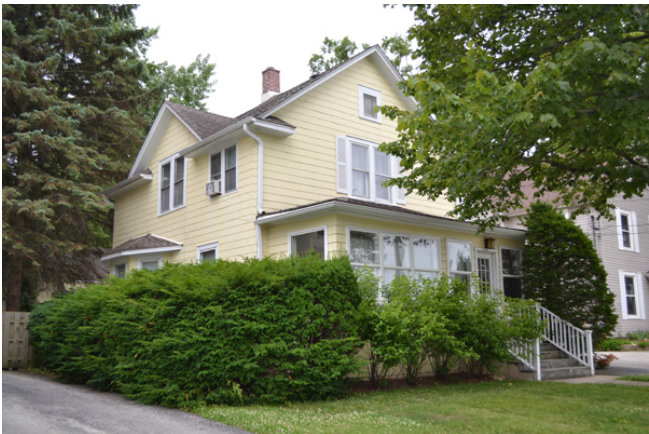
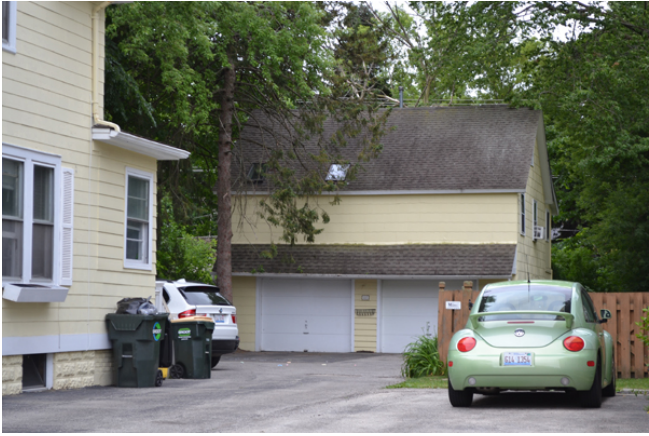
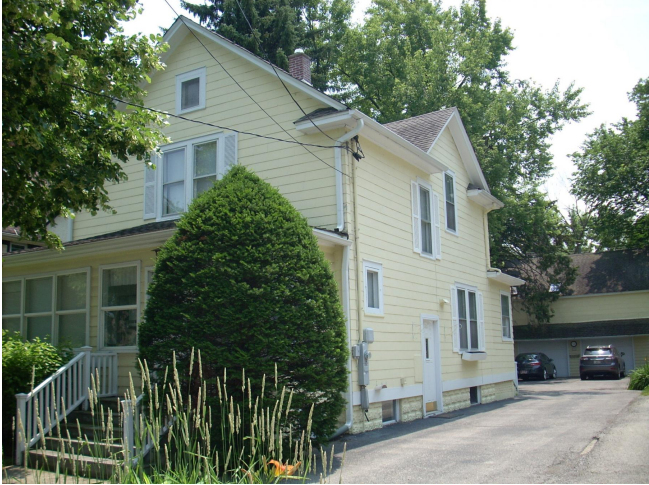
Photo Id: ParkAveW225(1)

Gable Front

Replacement windows in original openings; front porch enclosed with aluminum/vinyl windows (1970); fixed shutters; concrete steps (1970)

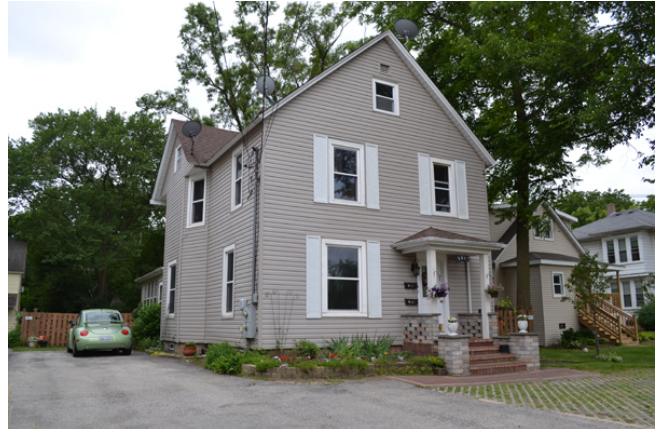
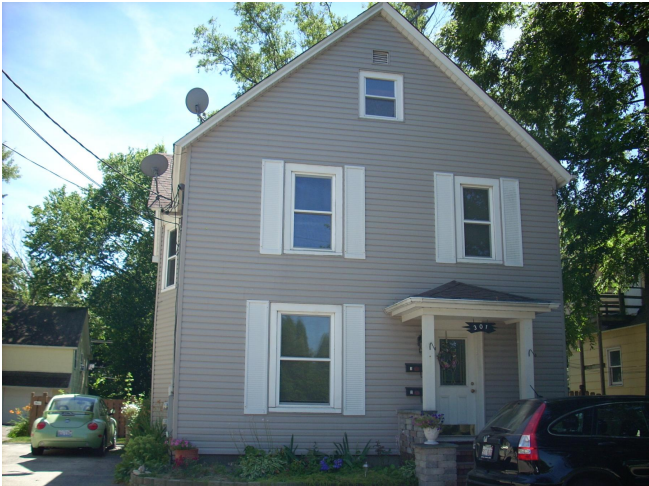
Photo Id: ParkAveW301

Replacement siding; replacement windows in downsized openings; fixed shutters; replacement front porch (post-1948); replacement door; one-story rear addition (may have originally been rear porch that was enclosed)

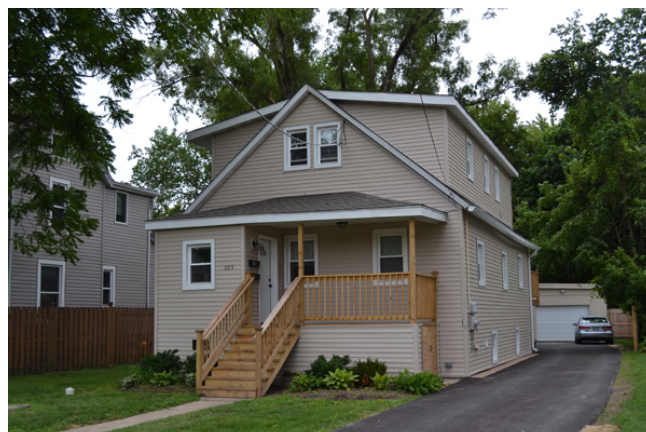
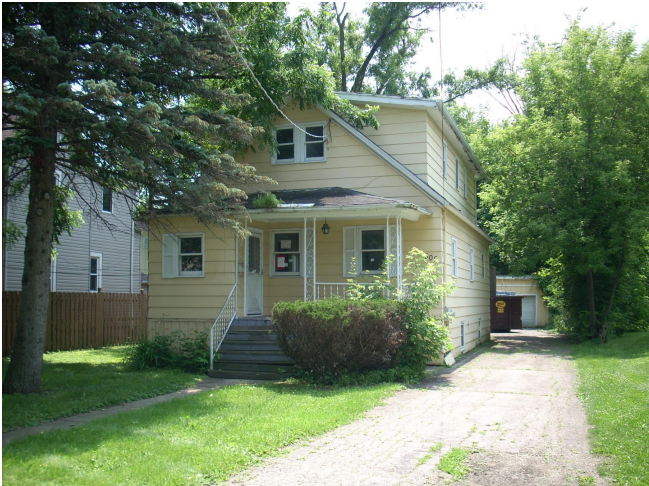
Photo Id: ParkAveW305

Replacement siding (1970); replacement windows in original openings; wrought iron railings on porch; large shed-roof side dormer additions (1970); rear deck addition

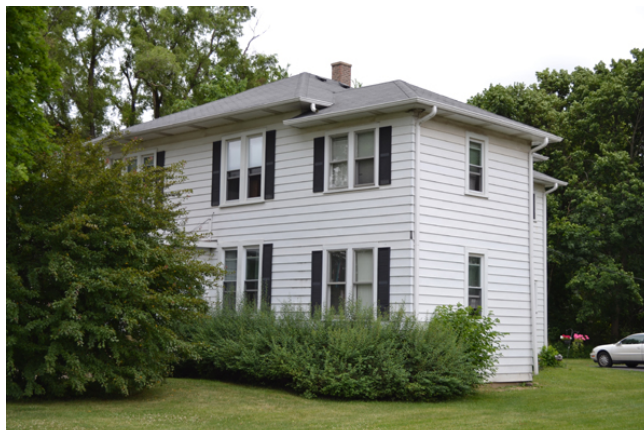
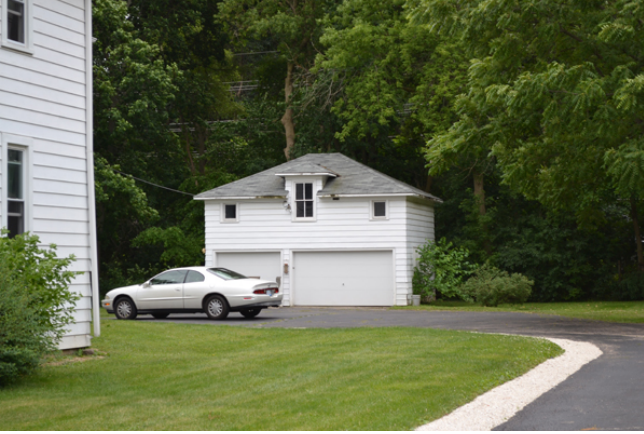
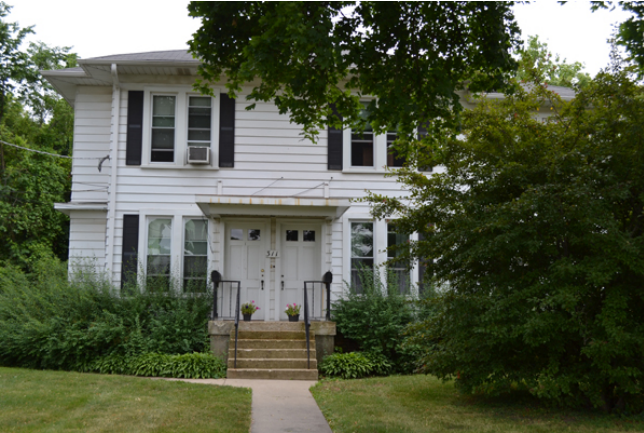
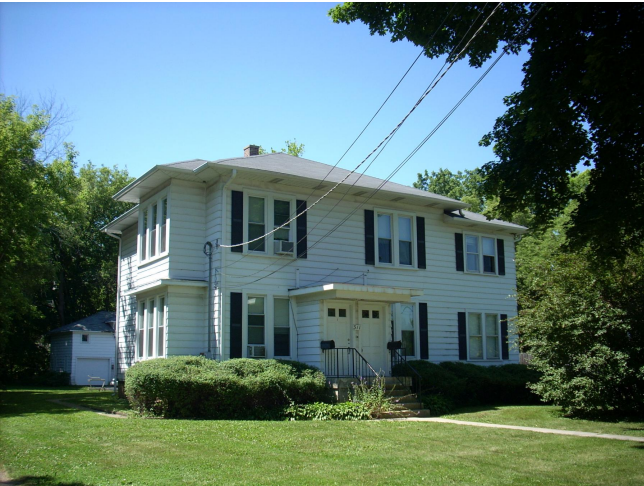
Photo Id: ParkAveW311(3)

CATEGORY	Building	HISTORIC USE	Domestic - single dwelling
CONDITION	Fair	SECONDARY STRUCTURE	Coach house
INTEGRITY	Major alterations	NR SECOND	C
CURRENT USE	Domestic - multiple dwelling

Replacement siding (1990); replacement windows in original openings (not historic); front entry bay addition (open porch addition built c. 1930 and later enclosed); fixed shutters; two-story west addition that is flush with front facade (historic addition--c. 1930)
