Historic Libertyville

BEGINNING STREET NUMBER	315
END STREET NUMBER	-
STREET # SUFFIX	-
STREET NAME	W. Park Avenue
PIN	
<u>LOCAL</u>	
WITHIN LOCAL DISTRICT?	No
LOCAL DIST CONTRIB/NON-CONTRIB?	C
LOCAL LANDMARK?	No
YEAR	-
LOCAL LANDMARK ELIGIBLE?	No
CRITERIA	-

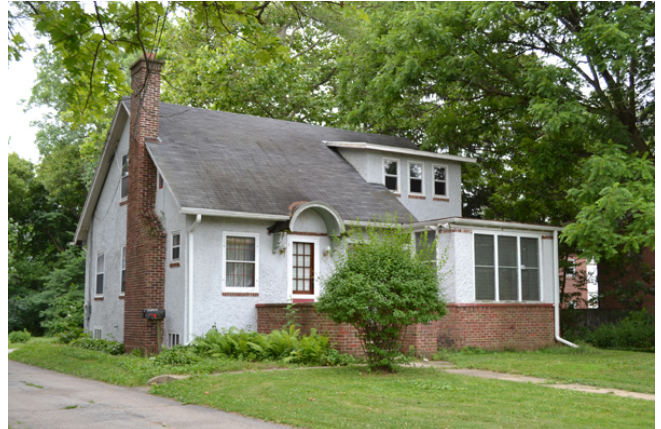
Photo Id: ParkAveW411(1)

CATEGORY	<input type="text" value="Building"/>	HISTORIC USE	<input type="text" value="Domestic - single dwelling"/>
CONDITION	<input type="text" value="Good"/>	SECONDARY STRUCTURE	<input type="text" value="Detached garage"/>
INTEGRITY	<input type="text" value="Minor alterations"/>	NR SECOND	<input type="text" value="C"/>
CURRENT USE	<input type="text" value="Domestic - single dwelling"/>

Craftsman Bungalow

Side gable roof with overhanging eaves; shed-roof, through-the-cornice dormer; brick knee walls surrounding front terrace; west end sun porch; historic front door with barrel arch canopy; historic wood windows; brick rowlock sills; east side brick chimney

Jalousie windows in sun porch; exterior re-stuccoed

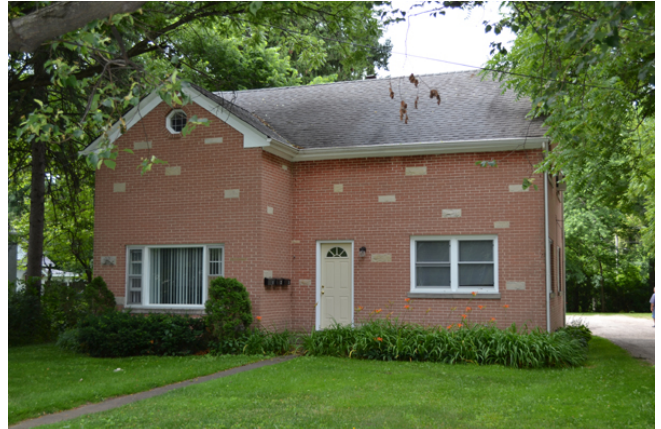
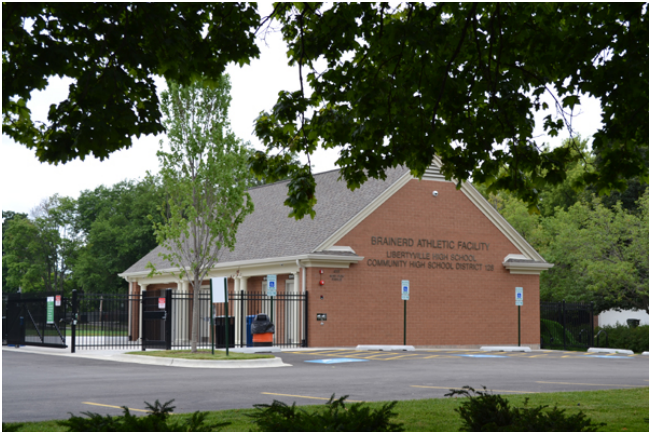
Photo Id: ParkAveW419

CATEGORY	Building	HISTORIC USE	Domestic - single dwelling
CONDITION	Good	SECONDARY STRUCTURE	[attached garage]
INTEGRITY	Major alterations and additions	NR SECOND	-
CURRENT USE	Domestic - multiple dwelling

No Style (altered)

Replacement 1/1 windows on first story and side elevations; 2-story rear addition with garage (not historic); possible 2nd story addition at front of house (not historic)

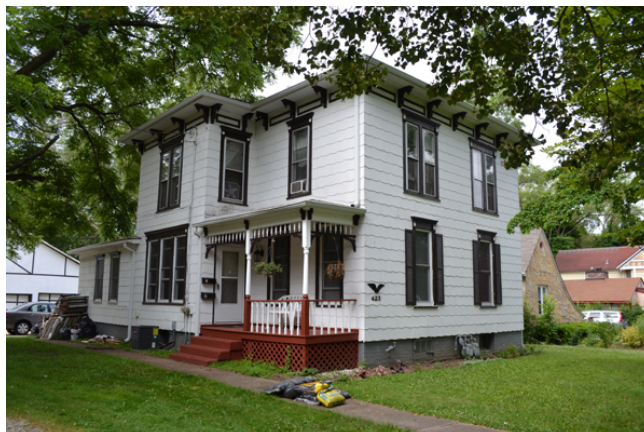
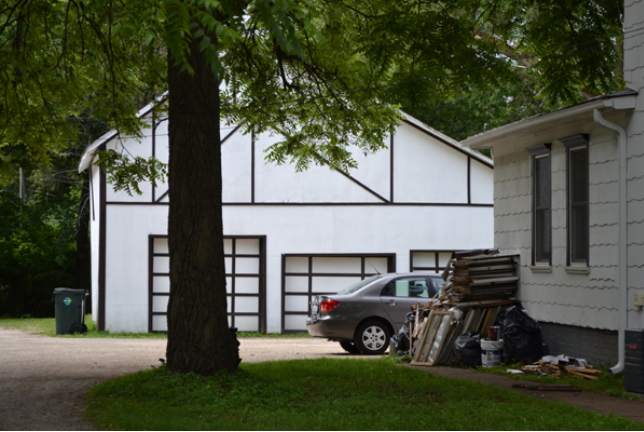
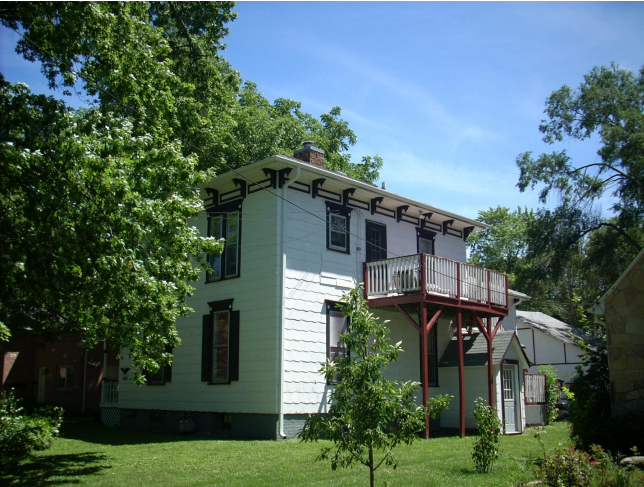
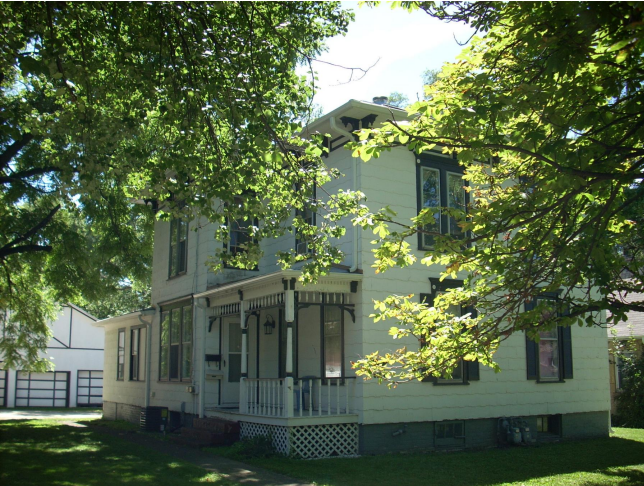
Photo Id: ParkAveW423(1)

CATEGORY	<input type="text" value="Building"/>	HISTORIC USE	<input type="text" value="Domestic - single dwelling"/>
CONDITION	<input type="text" value="Good"/>	SECONDARY STRUCTURE	<input type="text" value="Barn"/>
INTEGRITY	<input type="text" value="Minor alterations and additions"/>	NR SECOND	<input type="text" value="C"/>
CURRENT USE	<input type="text" value="Domestic - multiple dwelling"/>

Replacement siding; some 1/1 replacement windows in original openings; replacement railing and deck on porch; replacement front door; rear east porch enclosed; fixed shutters; one-story west addition; west side stair addition

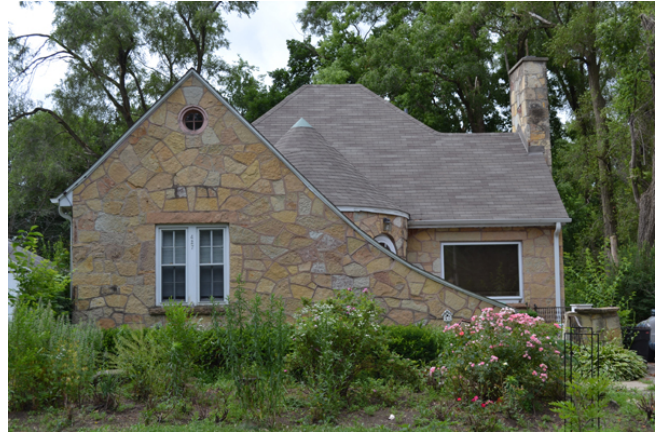
Photo Id: ParkAveW427(1)

CATEGORY	<input type="text" value="Building"/>	HISTORIC USE	<input type="text" value="Domestic - single dwelling"/>
CONDITION	<input type="text" value="Good"/>	SECONDARY STRUCTURE	<input type="text" value="Detached garage"/>
INTEGRITY	<input type="text" value="Minor alterations and additions"/>	NR SECOND	<input type="text" value="NC"/>
CURRENT USE	<input type="text" value="Domestic - single dwelling"/>

Aluminum on east side shed-roof dormer and under eaves

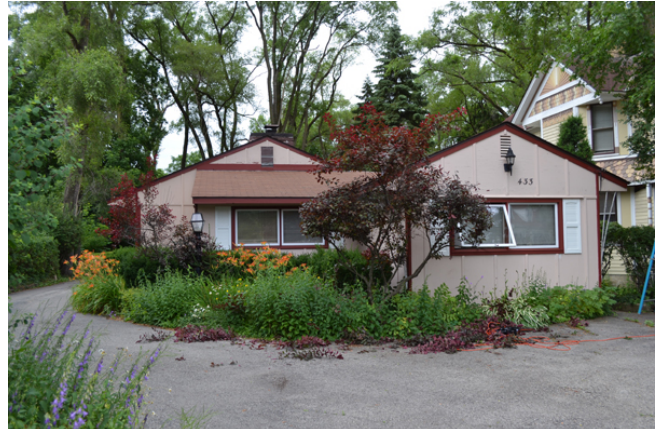
Photo Id: ParkAveW433

CATEGORY	<input type="text" value="Building"/>	HISTORIC USE	<input type="text" value="Domestic - single dwelling"/>
CONDITION	<input type="text" value="Good"/>	SECONDARY STRUCTURE	<input type="text" value="Detached garage"/>
INTEGRITY	<input type="text" value="Moderate alterations and additions"/>	NR SECOND	<input type="text" value="NC"/>
CURRENT USE	<input type="text" value="Domestic - single dwelling"/>

One-story shed-roof front addition (1970)
