Historic Libertyville

BEGINNING STREET NUMBER	315
END STREET NUMBER	-
STREET # SUFFIX	-
STREET NAME	W. Park Avenue
PIN	
<u>LOCAL</u>	
WITHIN LOCAL DISTRICT?	No
LOCAL DIST CONTRIB/NON-CONTRIB?	C
LOCAL LANDMARK?	No
YEAR	-
LOCAL LANDMARK ELIGIBLE?	No
CRITERIA	-

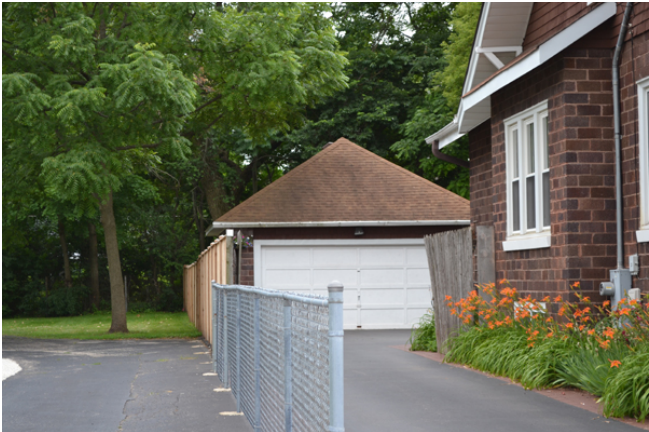
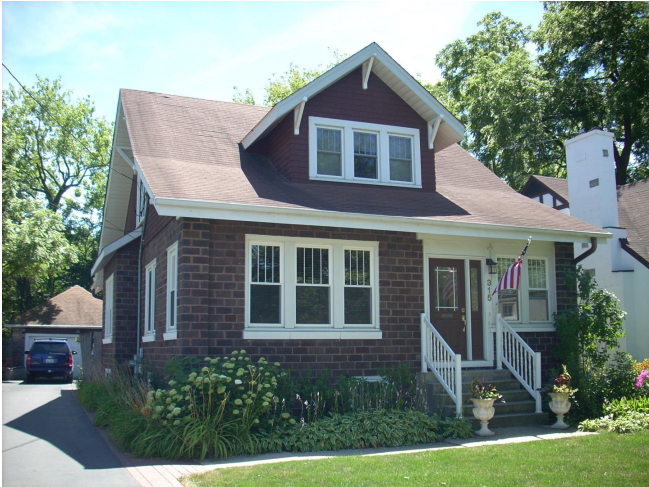
Photo Id: ParkAveW315(2)

CATEGORY	Building	HISTORIC USE	Domestic - single dwelling
CONDITION	Good	SECONDARY STRUCTURE	Detached garage
INTEGRITY	Minor alterations	NR SECOND	C
CURRENT USE	Domestic - single dwelling

Craftsman Bungalow

Side gable roof with overhanging eaves and L brackets; gable front dormer; inset corner entry porch with brick pier and knee walls; she-roof square window bay on east facade; oversized brick and wood shingle exterior

Replacement windows in original openings; front porch enclosed

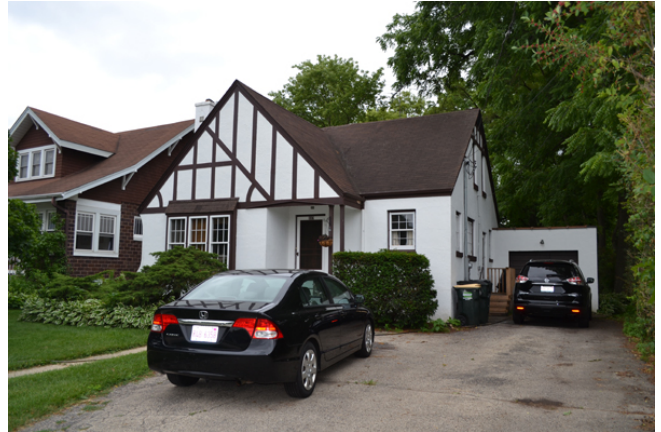
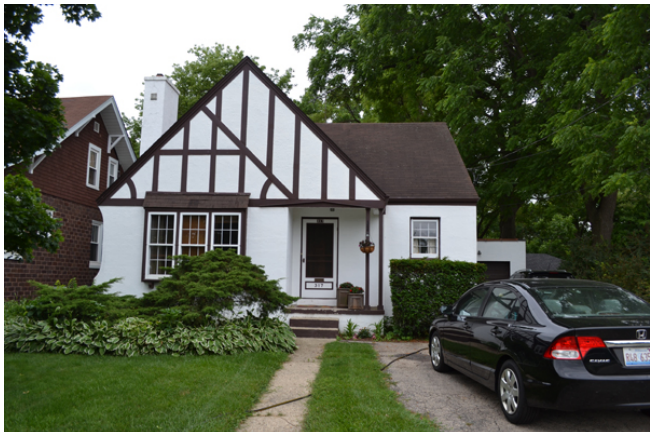
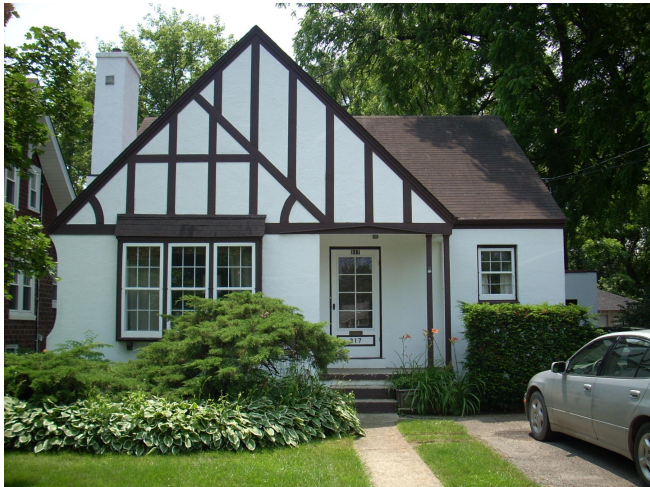
Photo Id: ParkAveW317(2)

CATEGORY	Building	HISTORIC USE	Domestic - single dwelling
CONDITION	Good	SECONDARY STRUCTURE	[attached garage]
INTEGRITY	Minor alterations	NR SECOND	-
CURRENT USE	Domestic - single dwelling

Tudor Revival

Modest but nicely detailed Tudor Revival cottage from the early post-war period.

Side gable roof; broad front gable bay with decorative half timbering; inset corner entry porch with square wood supports; east end chimney; three-sided oriel bay on east facade; historic wood plank door; wood windows; garage bay at west facade

Replacement front steps to west side entry

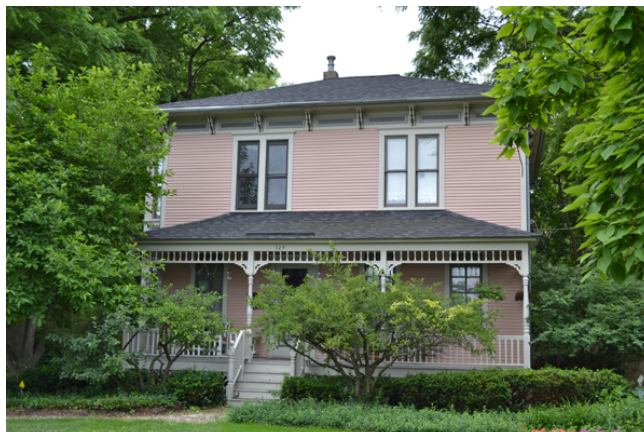
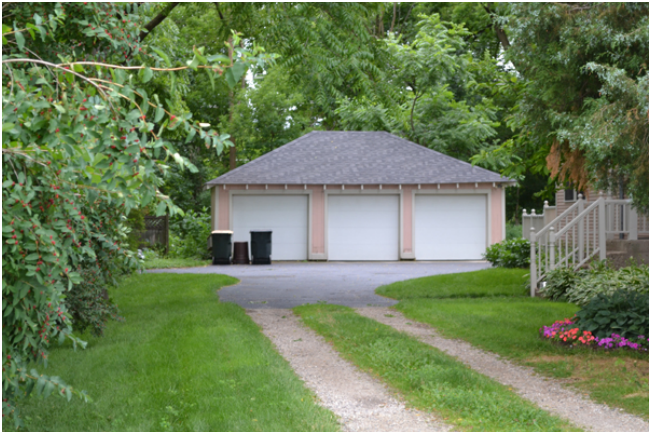
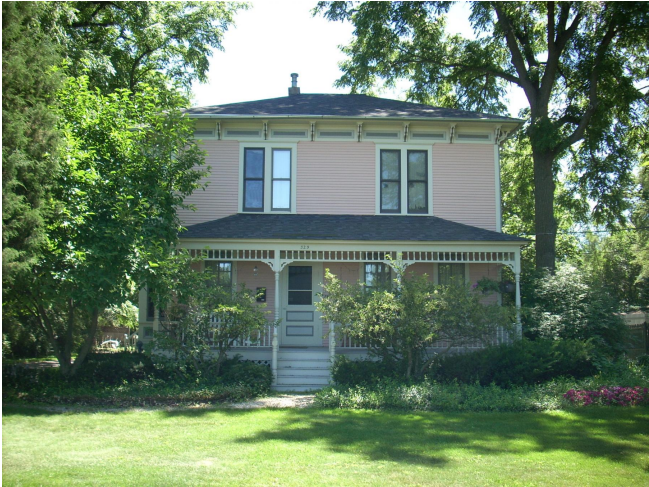
Photo Id: ParkAveW329(1)

CATEGORY	<input type="text" value="Building"/>	HISTORIC USE	<input type="text" value="Domestic - single dwelling"/>
CONDITION	<input type="text" value="Good"/>	SECONDARY STRUCTURE	<input type="text" value="Detached garage"/>
INTEGRITY	<input type="text" value="Minor alterations"/>	NR SECOND	<input type="text" value="C"/>
CURRENT USE	<input type="text" value="Domestic - single dwelling"/>

Folk Victorian

Handsome Folk Victorian residence from the late 19th century. Notable features include cornice with paneled frieze and scrolled brackets, hipped-roof front porch, and two-story east side bay.

Hipped roof; cornice with paneled frieze and brackets; hipped roof porch with turned porch columns and railings and spindlework frieze (may be early alteration from the 1890s); two-story, three-sided bay on east facade; some windows on first floor appear to be historic wood double hung windows

Second-story windows are wood replacement; rear deck addition (1996)

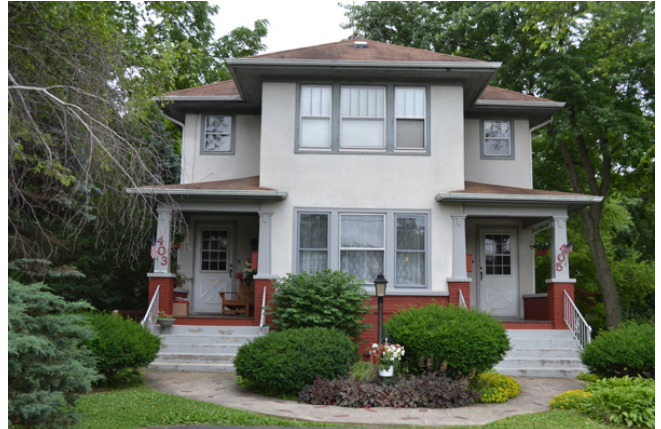
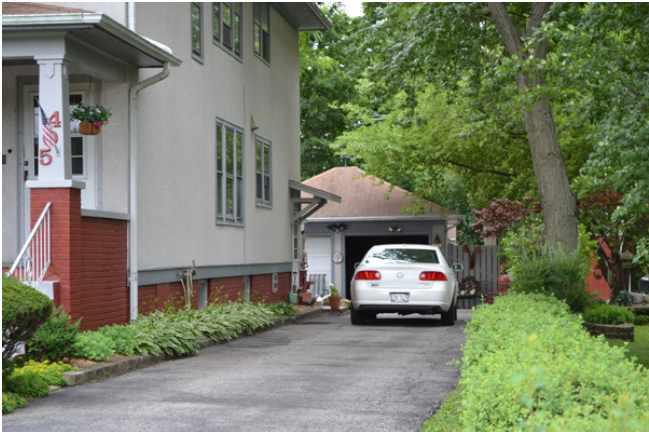
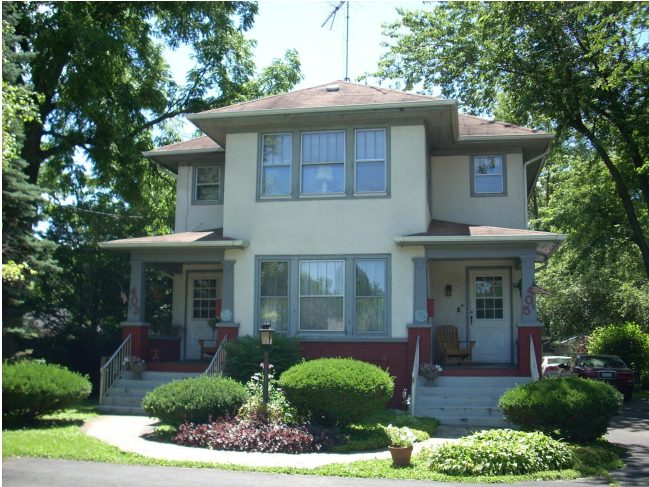
Photo Id: ParkAveW403-405(1)

CATEGORY	Building	HISTORIC USE	Domestic - multiple dwelling
CONDITION	Good	SECONDARY STRUCTURE	Detached garage
INTEGRITY	Minor alterations	NR SECOND	C
CURRENT USE	Domestic - multiple dwelling

Craftsman

Fine Craftsman duplex with mirror-image entry porches on either side of a central hipped-roof bay.

Two-story hipped front bay flanked by matching entry porches (porches feature brick knee walls, battered piers, hipped roof); overhanging eaves; stucco cladding; west secondary entrance with shed canopy; historic wood windows

Replacement railings on front steps

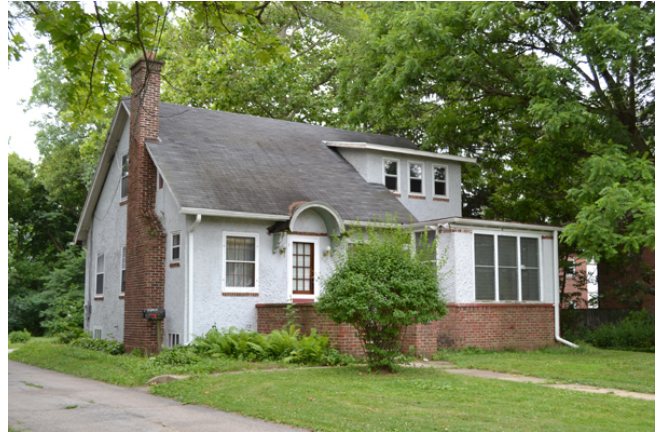
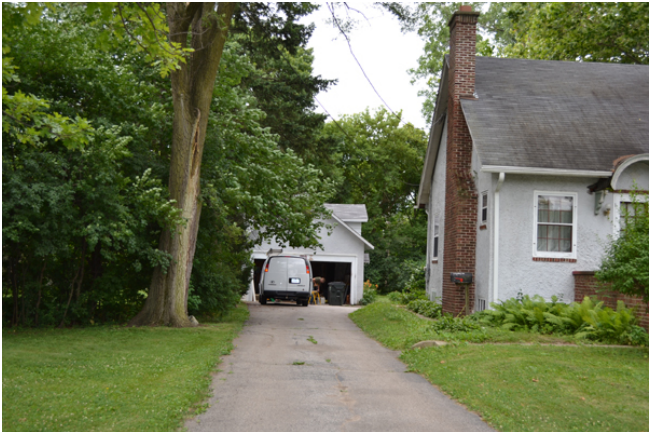
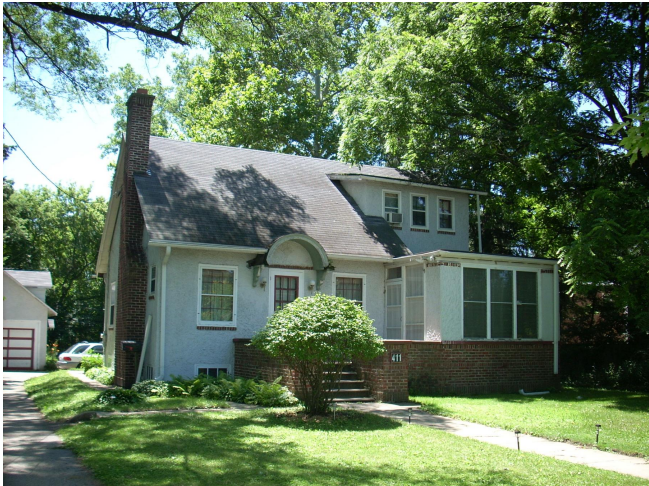
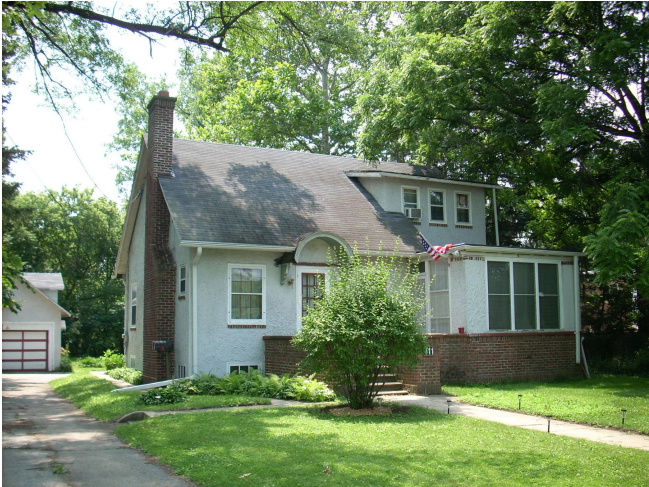
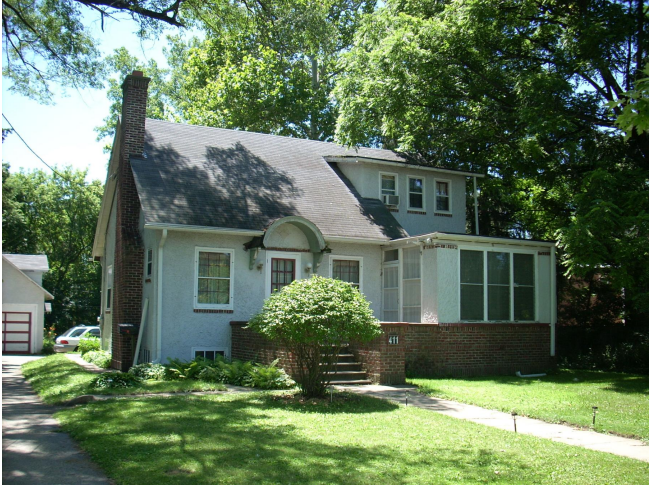
Photo Id: ParkAveW411(1)

CATEGORY	<input type="text" value="Building"/>	HISTORIC USE	<input type="text" value="Domestic - single dwelling"/>
CONDITION	<input type="text" value="Good"/>	SECONDARY STRUCTURE	<input type="text" value="Detached garage"/>
INTEGRITY	<input type="text" value="Minor alterations"/>	NR SECOND	<input type="text" value="C"/>
CURRENT USE	<input type="text" value="Domestic - single dwelling"/>

Craftsman Bungalow

Side gable roof with overhanging eaves; shed-roof, through-the-cornice dormer; brick knee walls surrounding front terrace; west end sun porch; historic front door with barrel arch canopy; historic wood windows; brick rowlock sills; east side brick chimney

Jalousie windows in sun porch; exterior re-stuccoed

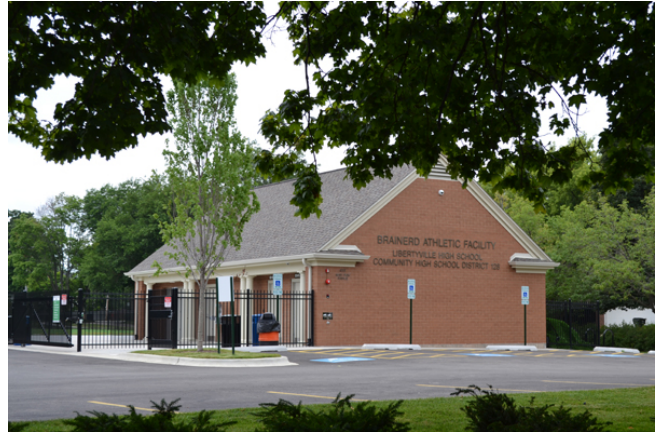
Photo Id: ParkAveW416(2)

CATEGORY	<input type="text" value="Building"/>	HISTORIC USE	<input type="text" value="Recreation and Culture - field house"/>
CONDITION	<input type="text" value="Excellent"/>	SECONDARY STRUCTURE	<input type="text" value="-"/>
INTEGRITY	<input type="text" value="Not altered"/>	NR SECOND	<input type="text" value="-"/>
CURRENT USE	<input type="text" value="Recreation and Culture - field house"/>

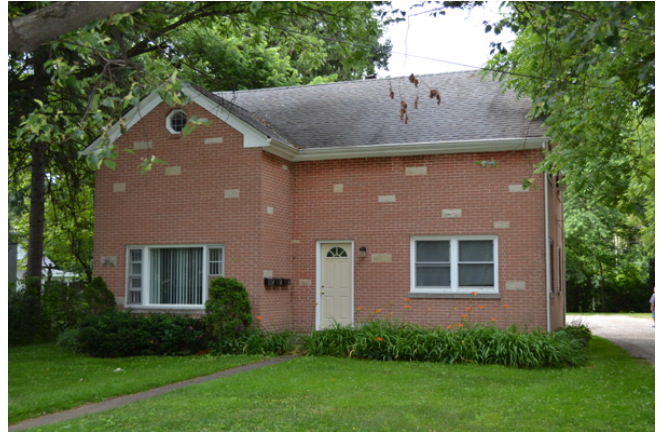
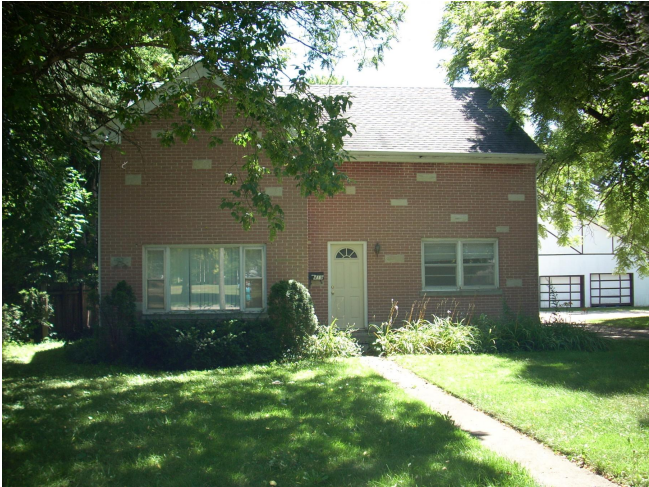
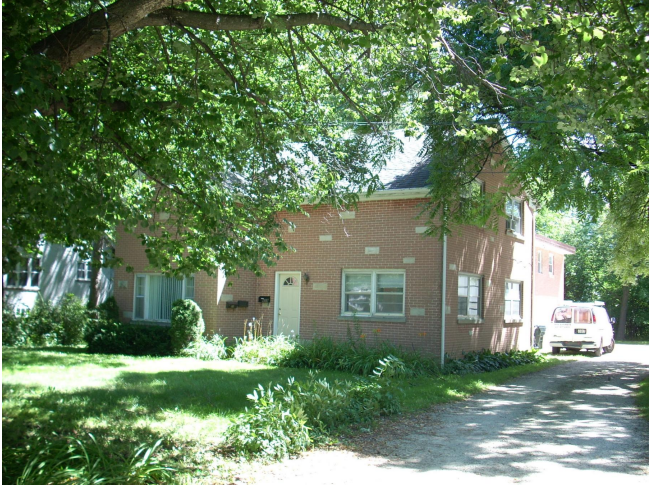
Photo Id: ParkAveW419

CATEGORY	<input type="text" value="Building"/>	HISTORIC USE	<input type="text" value="Domestic - single dwelling"/>
CONDITION	<input type="text" value="Good"/>	SECONDARY STRUCTURE	<input type="text" value="[attached garage]"/>
INTEGRITY	<input type="text" value="Major alterations and additions"/>	NR SECOND	<input type="text" value="-"/>
CURRENT USE	<input type="text" value="Domestic - multiple dwelling"/>

No Style (altered)

Replacement 1/1 windows on first story and side elevations; 2-story rear addition with garage (not historic); possible 2nd story addition at front of house (not historic)

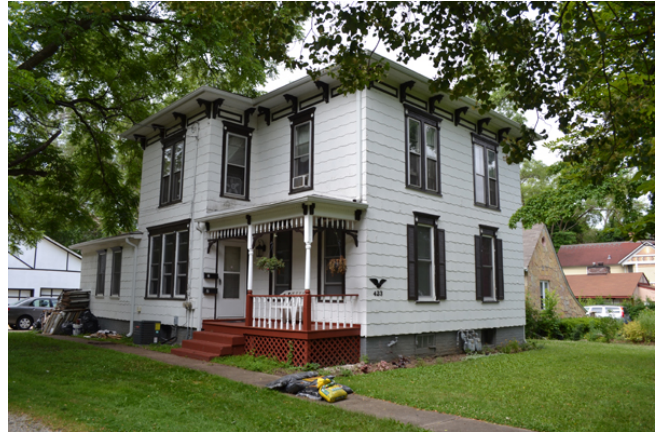
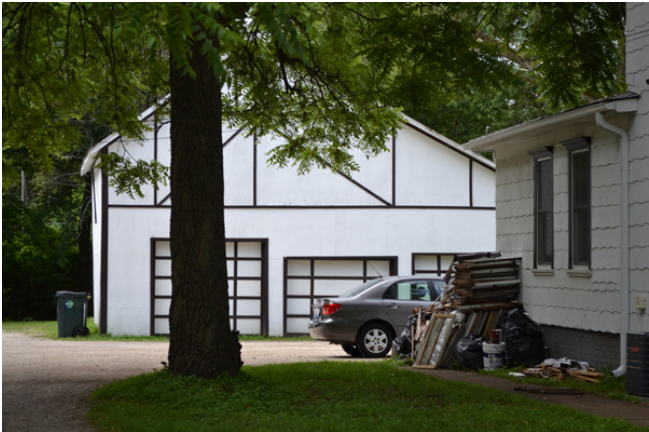
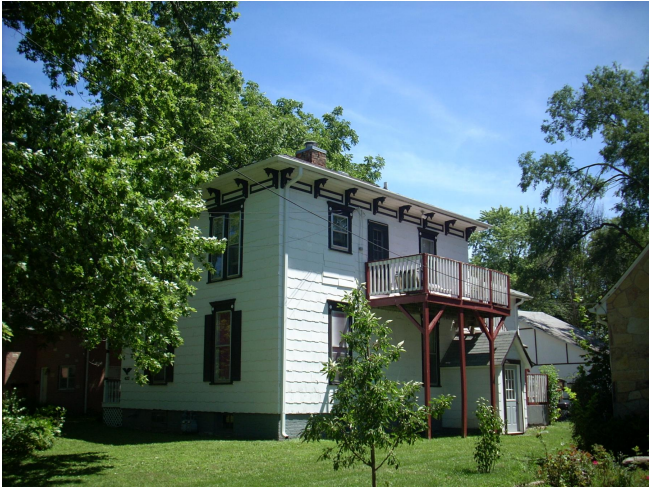
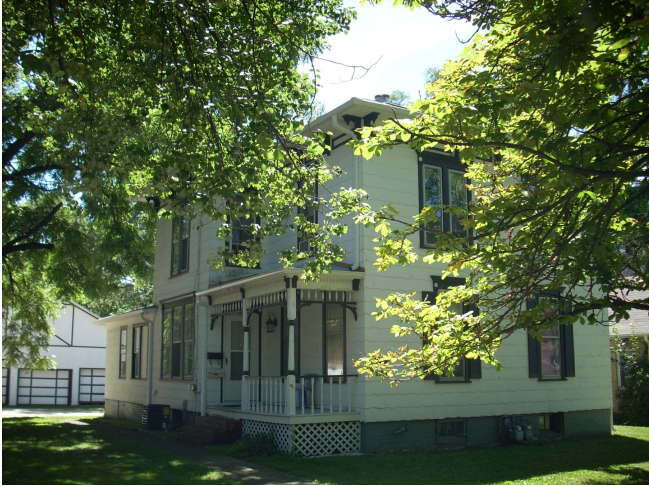
Photo Id: ParkAveW423(1)

CATEGORY	Building	HISTORIC USE	Domestic - single dwelling
CONDITION	Good	SECONDARY STRUCTURE	Barn
INTEGRITY	Minor alterations and additions	NR SECOND	C
CURRENT USE	Domestic - multiple dwelling

Replacement siding; some 1/1 replacement windows in original openings; replacement railing and deck on porch; replacement front door; rear east porch enclosed; fixed shutters; one-story west addition; west side stair addition

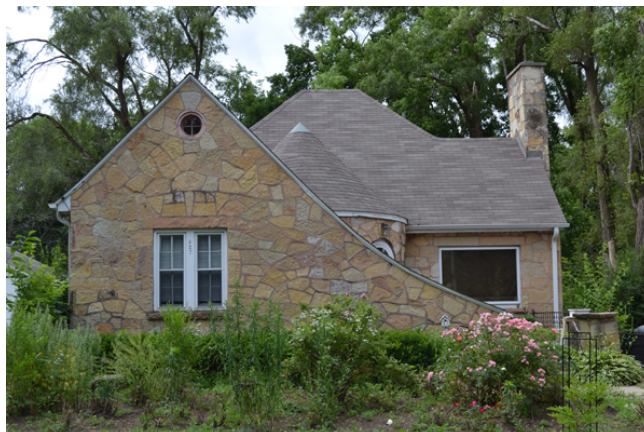
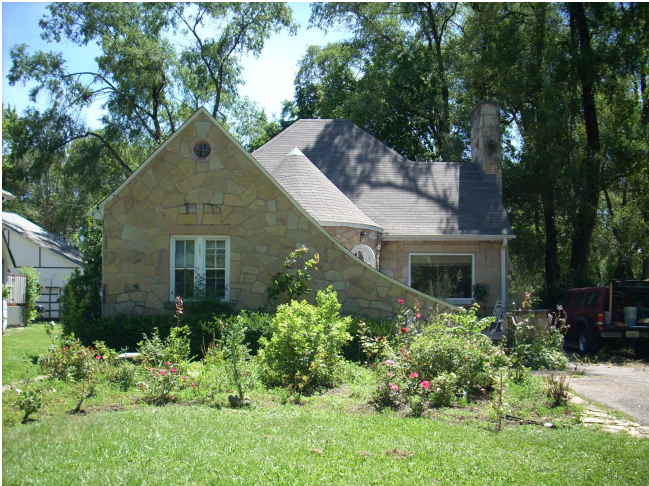
Photo Id: ParkAveW427(1)

CATEGORY	<input type="text" value="Building"/>	HISTORIC USE	<input type="text" value="Domestic - single dwelling"/>
CONDITION	<input type="text" value="Good"/>	SECONDARY STRUCTURE	<input type="text" value="Detached garage"/>
INTEGRITY	<input type="text" value="Minor alterations and additions"/>	NR SECOND	<input type="text" value="NC"/>
CURRENT USE	<input type="text" value="Domestic - single dwelling"/>

Aluminum on east side shed-roof dormer and under eaves

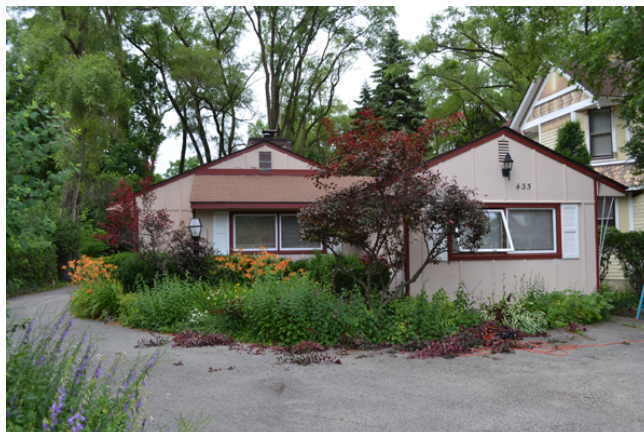
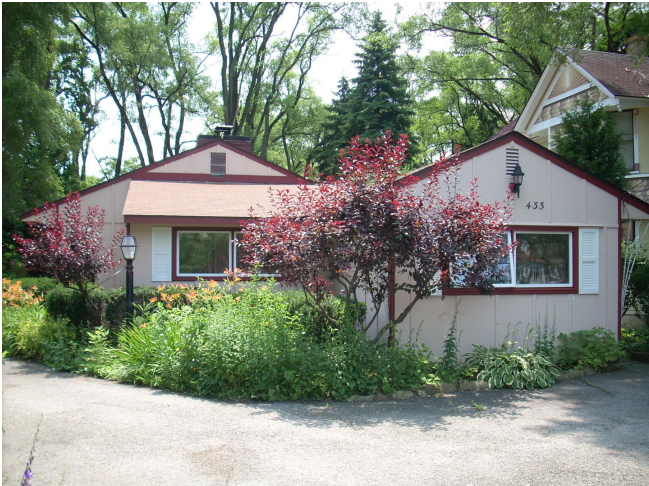
Photo Id: ParkAveW433

CATEGORY	<input type="text" value="Building"/>	HISTORIC USE	<input type="text" value="Domestic - single dwelling"/>
CONDITION	<input type="text" value="Good"/>	SECONDARY STRUCTURE	<input type="text" value="Detached garage"/>
INTEGRITY	<input type="text" value="Moderate alterations and additions"/>	NR SECOND	<input type="text" value="NC"/>
CURRENT USE	<input type="text" value="Domestic - single dwelling"/>

One-story shed-roof front addition (1970)
