Historic Libertyville

BEGINNING STREET NUMBER	118-124
END STREET NUMBER	-
STREET # SUFFIX	-
STREET NAME	Broadway Avenue
PIN	
LOCAL	
WITHIN LOCAL DISTRICT?	No
LOCAL DIST CONTRIB/NON-CONTRIB?	C
LOCAL LANDMARK?	No
YEAR	-
LOCAL LANDMARK ELIGIBLE?	No
CRITERIA	-

Ramsey Historic Consultants

Downtown Libertyville

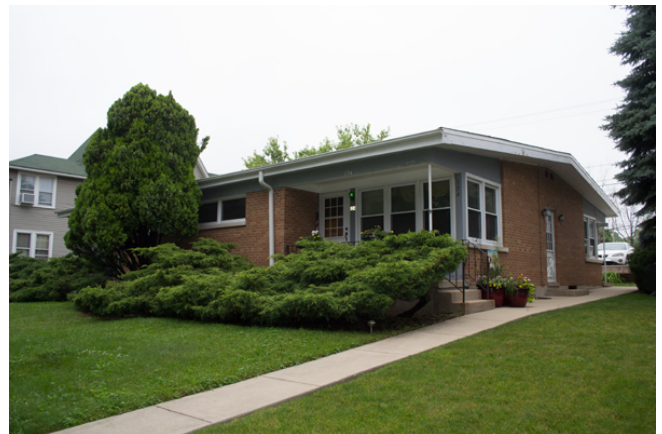
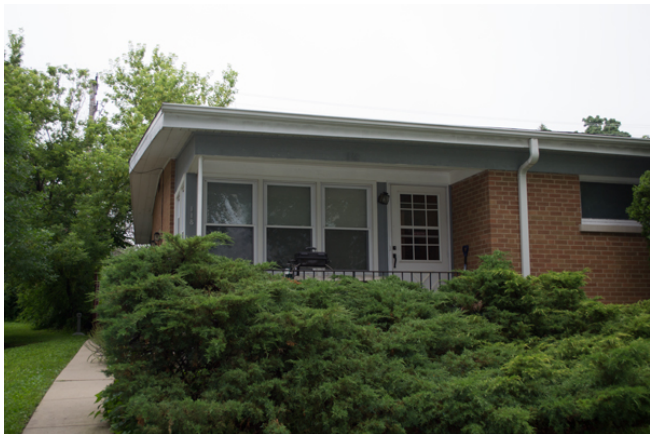
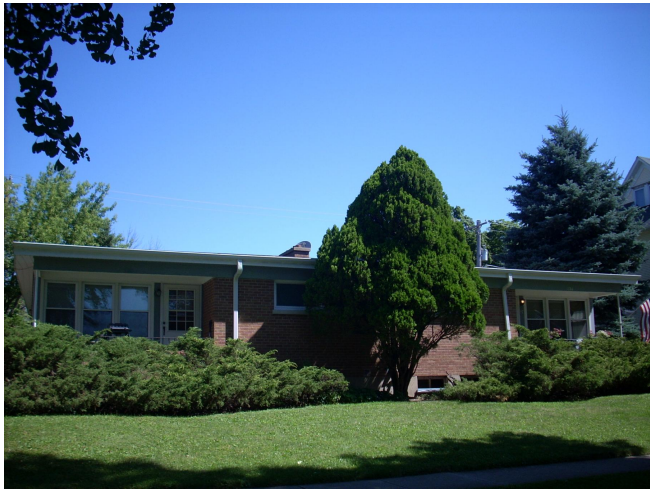
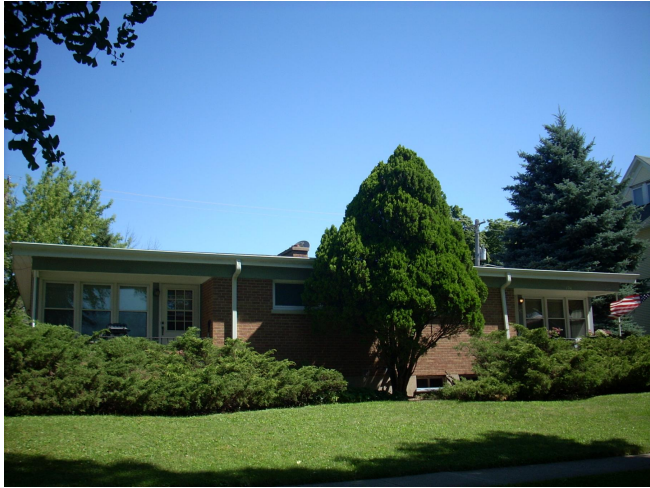
Photo Id: BroadwayAve118-124(1)

CATEGORY	Building	HISTORIC USE	Domestic - multiple dwelling
CONDITION	Good	SECONDARY STRUCTURE	-
INTEGRITY	Minor alterations	NR SECOND	-
CURRENT USE	Domestic - multiple dwelling

Horizontal massing and flat roof; inset corner entry porches for each unit, with wrought iron railings

Replacement windows in original openings; replacement doors

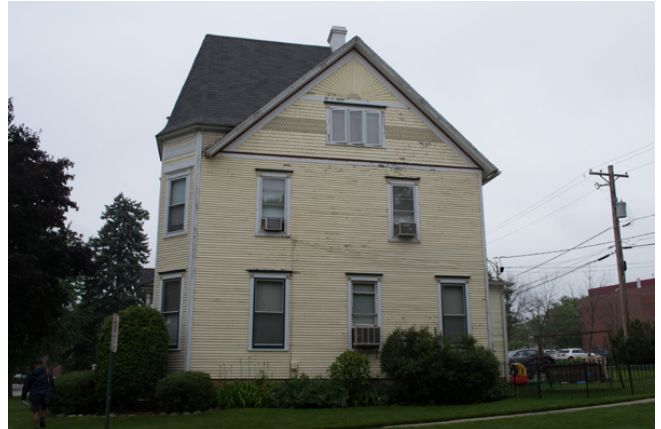
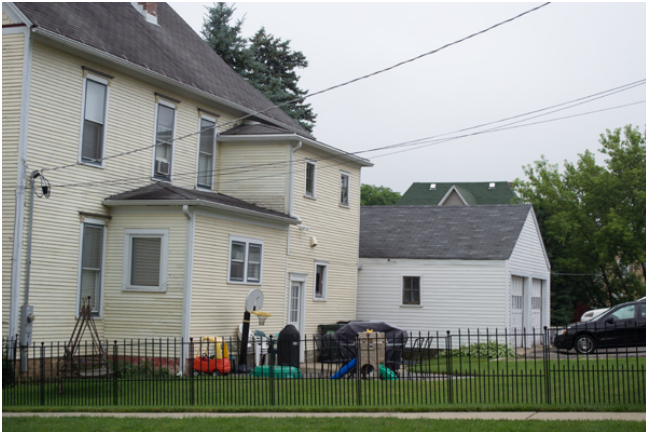
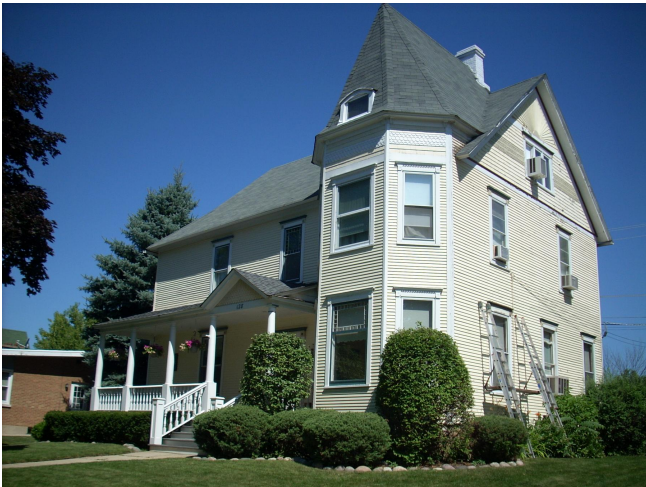
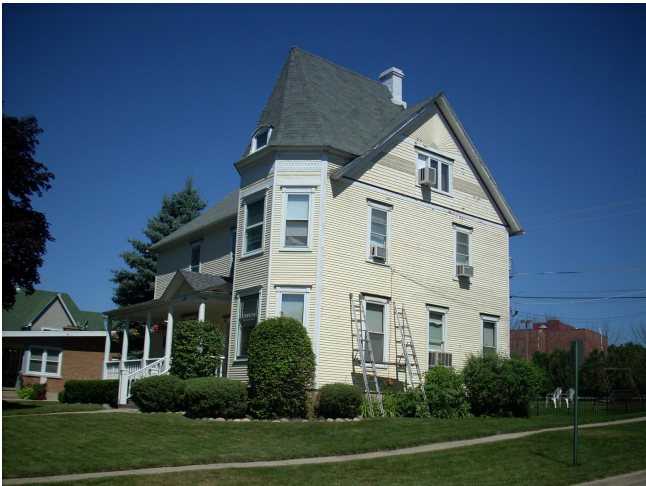
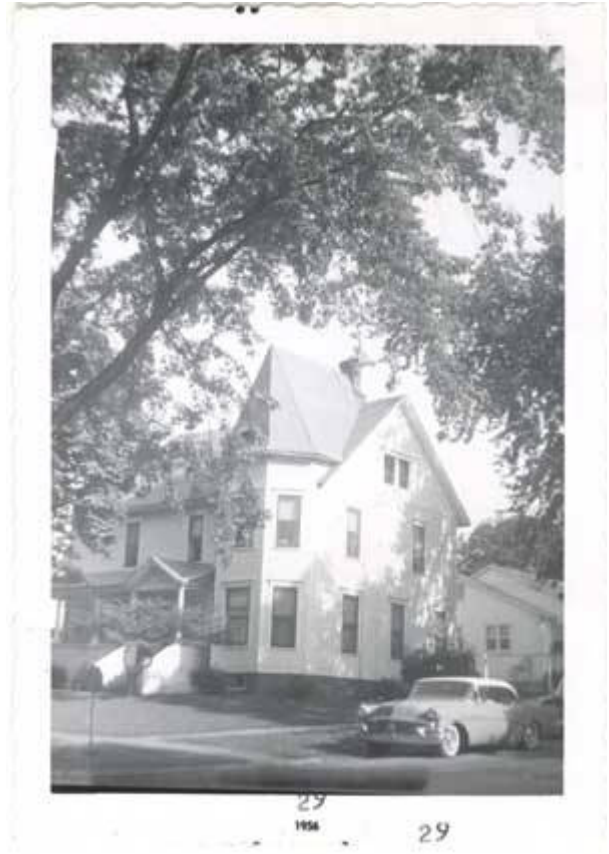
Photo Id: BroadwayAve128(1)

CATEGORY	Building	HISTORIC USE	Domestic - single dwelling
CONDITION	Good	SECONDARY STRUCTURE	Detached garage
INTEGRITY	Minor alterations	NR SECOND	NC
CURRENT USE	Domestic - single dwelling

This 1890s Queen Anne house may be eligible for local landmark designation as the home of Dr. John L. Taylor, a physician who served as Lake County coroner for 43 years.

Steeply pitched side gable roof; fishscale shingles and sunburst motif on gable walls; polygonal full-height bay with pointed roof at southeast corner of facade; full-front porch structure with triangular pediment over entry; historic wood windows, some with Queen Anne-style upper sash

Replacement floor, railings on front porch; 1-story rear addition and 2nd story rear addition (post-1948); some replacement windows in original openings on west elevation

93-474 (8/30/1993)--repairs and replacement to the base and deck of roofed porch

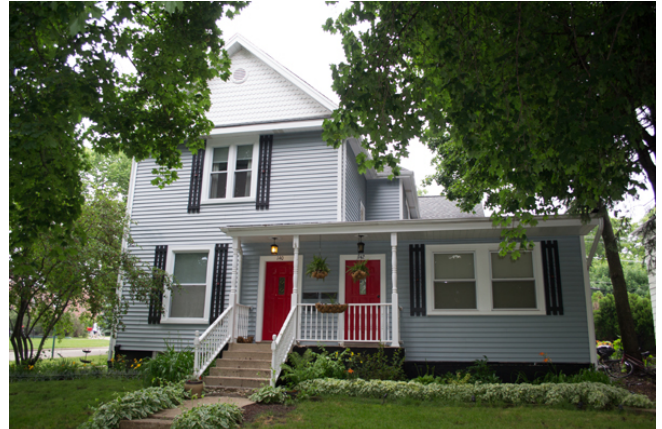
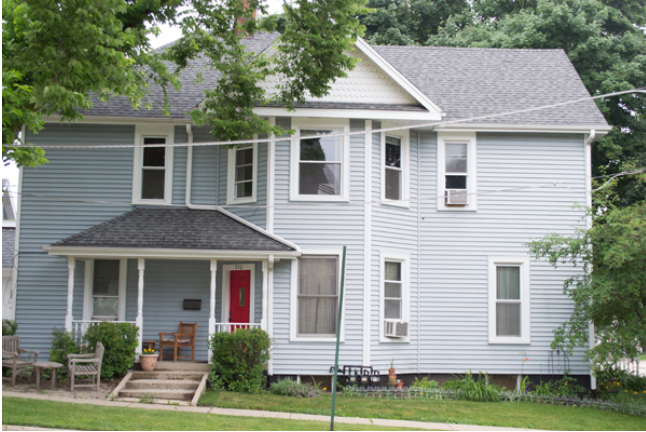
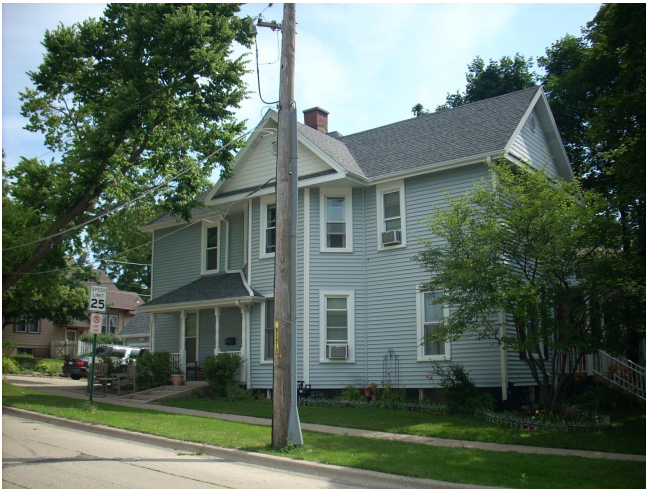
Photo Id: BroadwayAve140-142(2)

CATEGORY	Building	HISTORIC USE	Domestic - single dwelling
CONDITION	Good	SECONDARY STRUCTURE	[attached garage]
INTEGRITY	Minor alterations and additions	NR SECOND	-
CURRENT USE	Domestic - multiple dwelling

Front gable roof; full-height polygonal bay on west facade; front porch structure on front facade; secondary porch structure on west facade

Replacement siding (2000); replacement windows in original openings (2001); replacement columns, railings, and steps on front porch; replacement columns and railings on west porch; rear attached garage addition (2003)

PB-01-0706 (7/25/2001)--replacement windows, door trim, fascia, and soffit; 00413 (5/23/2000)--vinyl siding house and garage; JRA-01-0066 (3/24/2003)--addition, siding, & roof deck

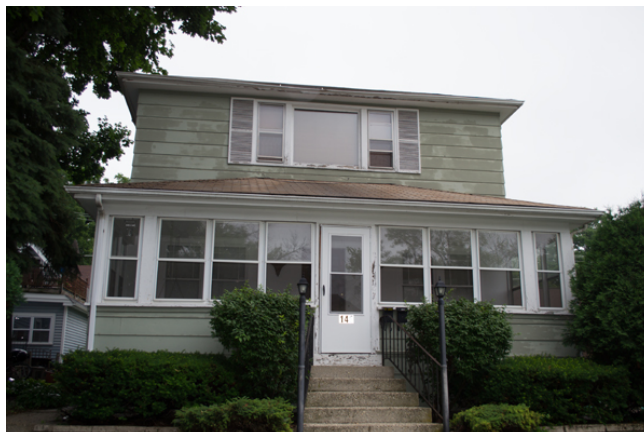
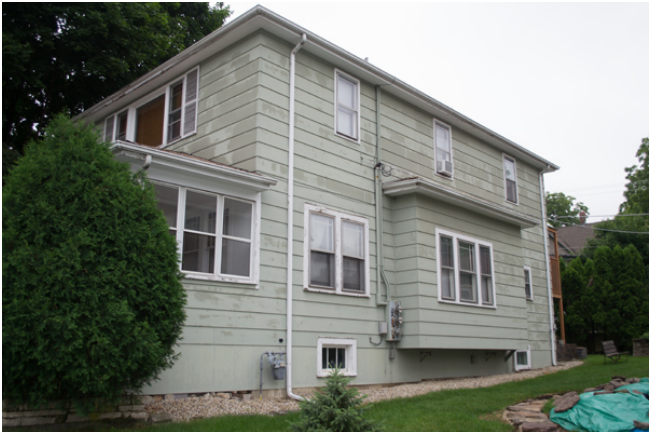
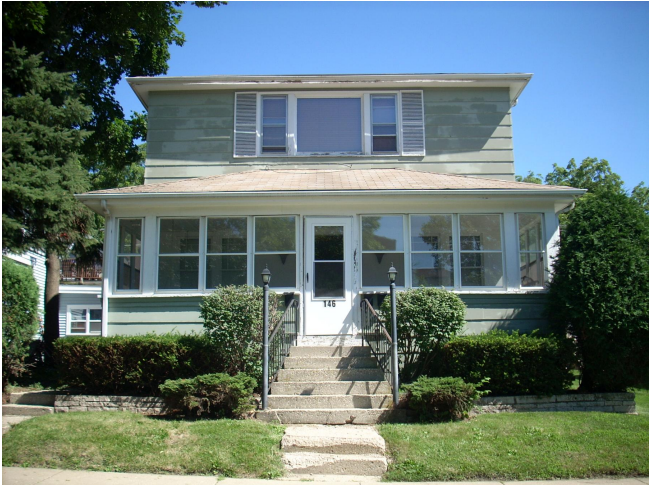
Photo Id: BroadwayAve146(1)

CATEGORY	Building	HISTORIC USE	Domestic - single dwelling
CONDITION	Good	SECONDARY STRUCTURE	-
INTEGRITY	Minor alterations	NR SECOND	-
CURRENT USE	Domestic - single dwelling

Full front porch with hipped roof and solid knee walls; geometric/1 double hung windows; square oriel window bay on east facade

2nd story addition (1969); front porch enclosed; front steps and railing replaced; replacement siding

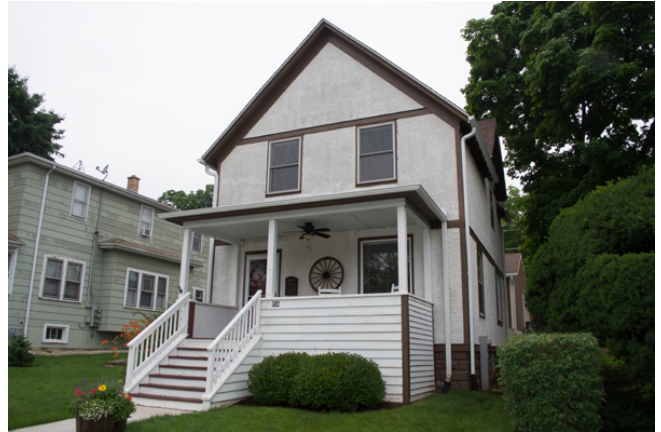
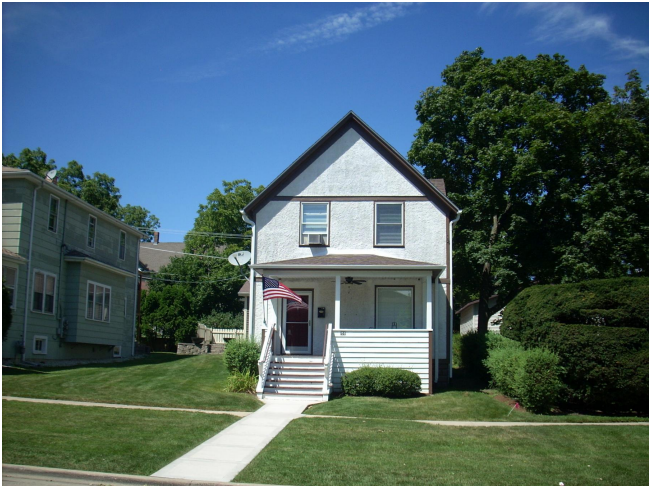
Photo Id: BroadwayAve150(2)

CATEGORY	<input type="text" value="Building"/>	HISTORIC USE	<input type="text" value="Domestic - single family"/>
CONDITION	<input type="text" value="Good"/>	SECONDARY STRUCTURE	<input type="text" value="Detached garage"/>
INTEGRITY	<input type="text" value="Minor alterations"/>	NR SECOND	<input type="text" value="NC"/>
CURRENT USE	<input type="text" value="Domestic - single family"/>

Front gable roof; rectangular massing; north side gable

Replacement front porch columns; replacement windows in original openings; replacement front door; picture window under porch

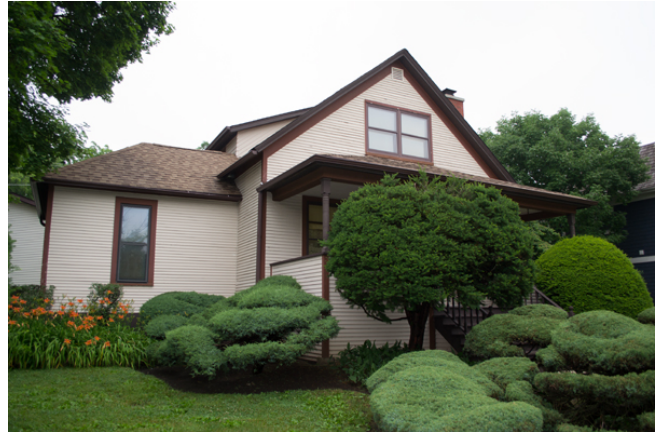
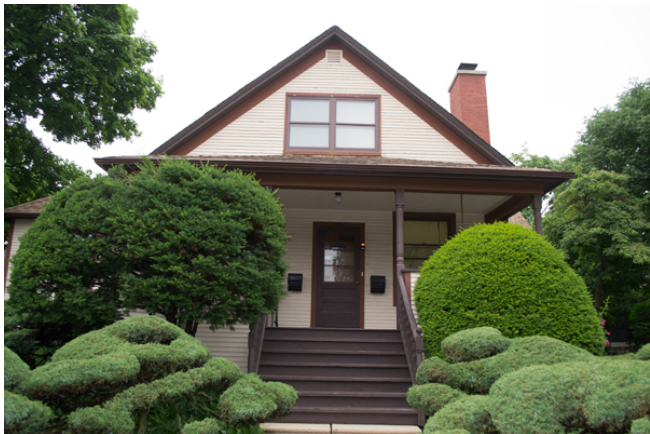
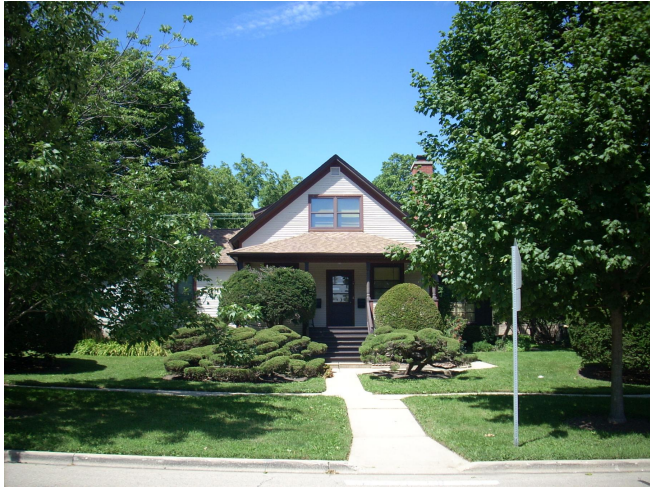
Photo Id: BroadwayAve154(1)

CATEGORY	Building	HISTORIC USE	Domestic - single dwelling
CONDITION	Good	SECONDARY STRUCTURE	-
INTEGRITY	Minor alterations and additions	NR SECOND	-
CURRENT USE	Domestic - single dwelling

Front gable roof and rectangular massing of original structure; front porch structure; west and rear (north) additions appear to be early (pre-1925)

Some replacement windows in original openings.

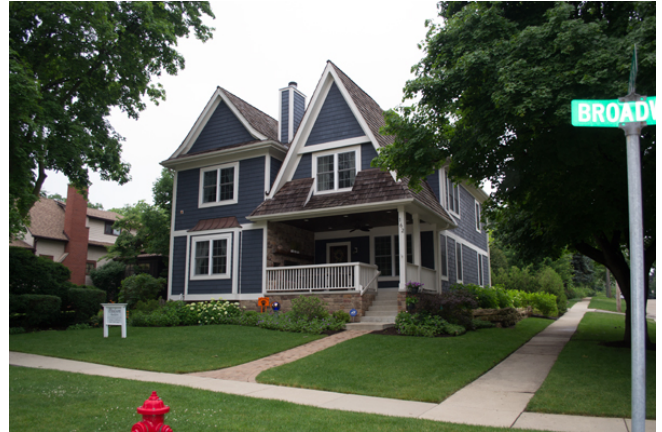
Photo Id: BroadwayAve162

CATEGORY	Building	HISTORIC USE	Domestic - single dwelling
CONDITION	Excellent	SECONDARY STRUCTURE	[attached garage]
INTEGRITY	Not altered	NR SECOND	-
CURRENT USE	Domestic - single dwelling

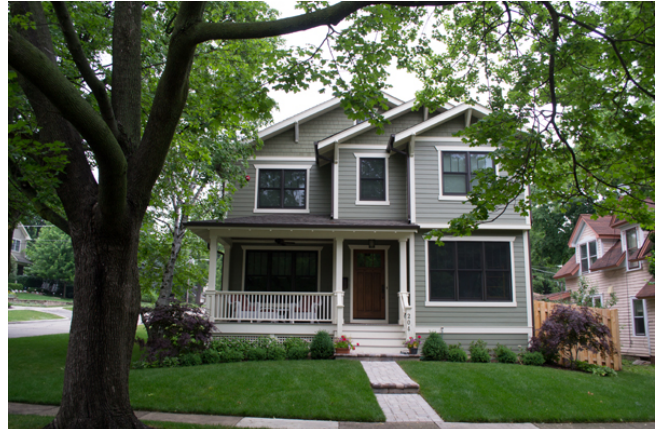
Photo Id: BroadwayAve204(1)

CATEGORY	Building	HISTORIC USE	Domestic - single dwelling
CONDITION	Good	SECONDARY STRUCTURE	Detached garage
INTEGRITY	Not altered	NR SECOND	NC
CURRENT USE	Domestic - single dwelling

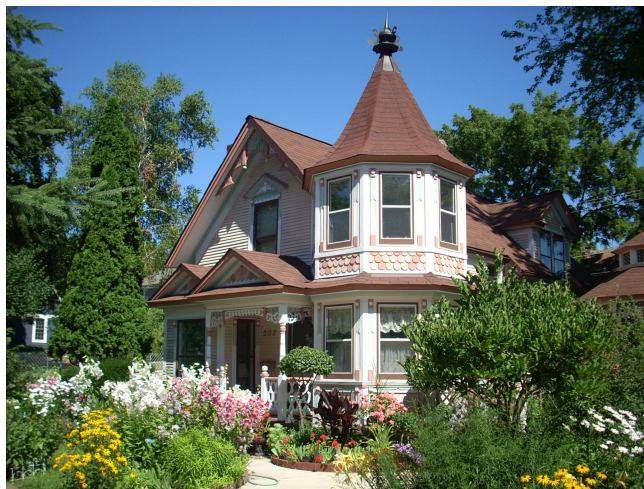
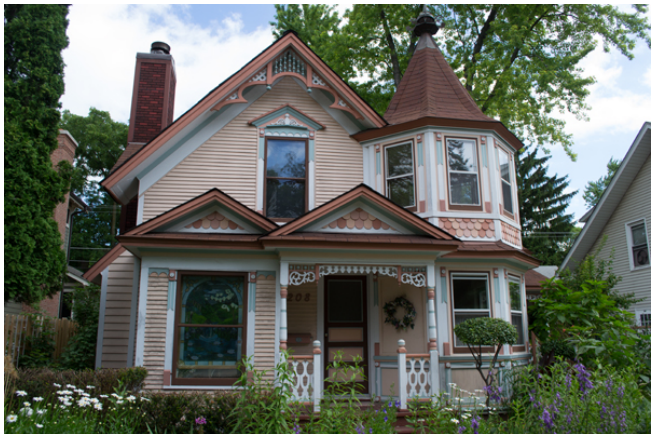
Photo Id: Broadway208

CATEGORY	<input type="text" value="Building"/>	HISTORIC USE	<input type="text" value="Domestic - single dwelling"/>
CONDITION	<input type="text" value="Good"/>	SECONDARY STRUCTURE	<input type="text" value="Detached garage"/>
INTEGRITY	<input type="text" value="Major alterations and additions"/>	NR SECOND	<input type="text" value="NC"/>
CURRENT USE	<input type="text" value="Domestic - single dwelling"/>

Original house obscured by extensive alterations and additions--
turret addition; front porch addition; 1-story rear addition;
Queen Anne trim throughout

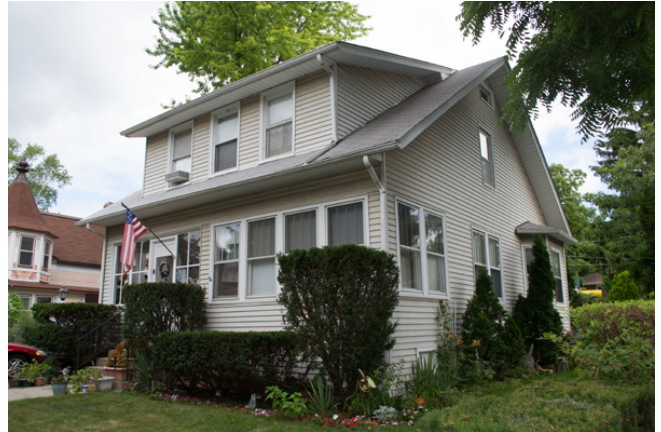
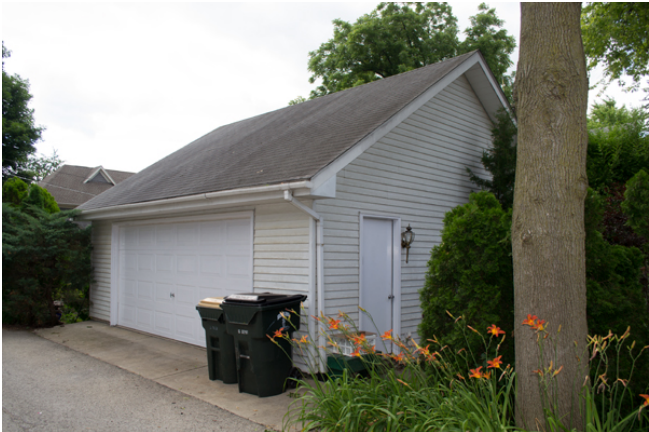
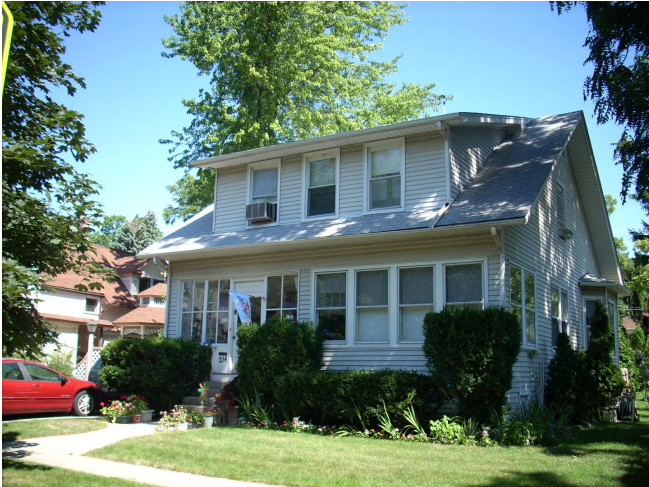
Photo Id: BroadwayAve214(1)

CATEGORY	Building	HISTORIC USE	Domestic - single dwelling
CONDITION	Good	SECONDARY STRUCTURE	Detached garage
INTEGRITY	Minor alterations	NR SECOND	NC
CURRENT USE	Domestic - single dwelling

Replacement siding; replacement windows in dormer; entry porch enclosed
