# Historic Libertyville

<b>BEGINNING STREET NUMBER</b>	435
<b>END STREET NUMBER</b>	-
<b>STREET # SUFFIX</b>	-
<b>STREET NAME</b>	W. Park Avenue
<b>PIN</b>	
<b><u>LOCAL</u></b>	
<b>WITHIN LOCAL DISTRICT?</b>	No
<b>LOCAL DIST CONTRIB/NON-CONTRIB?</b>	C
<b>LOCAL LANDMARK?</b>	No
<b>YEAR</b>	-
<b>LOCAL LANDMARK ELIGIBLE?</b>	No
<b>CRITERIA</b>	-

Photo Id: ParkAveW435(1)

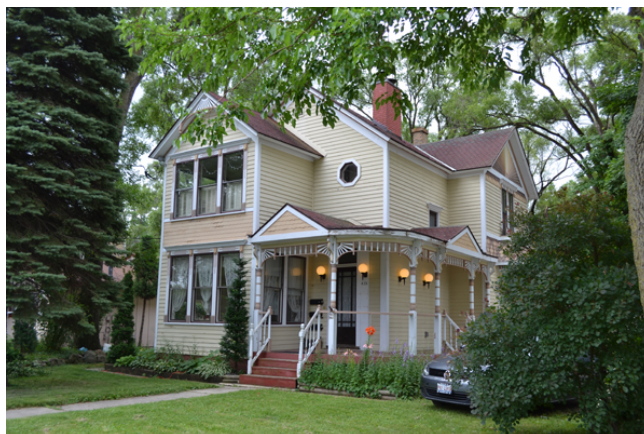
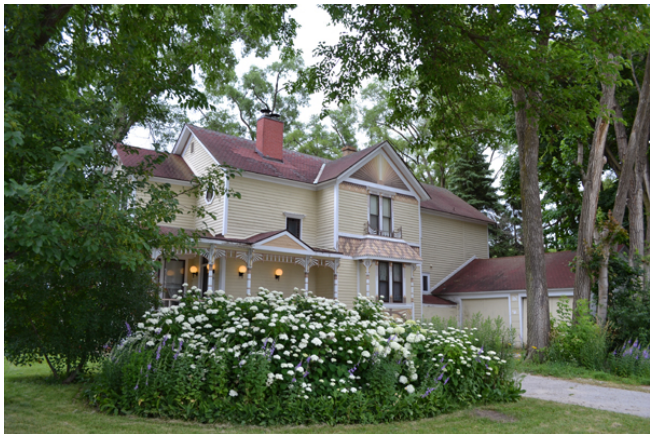
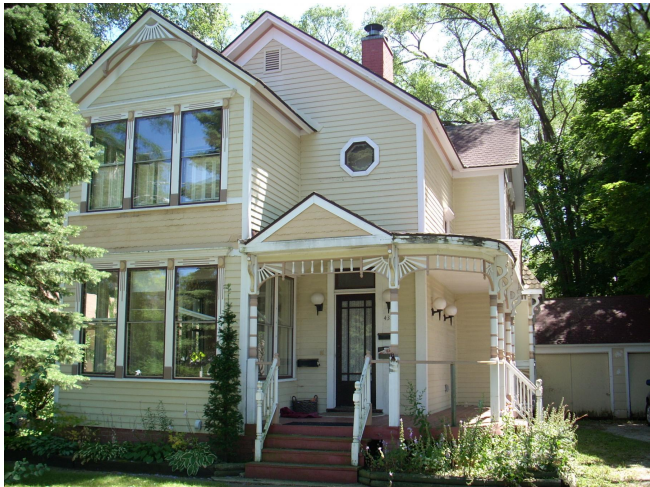
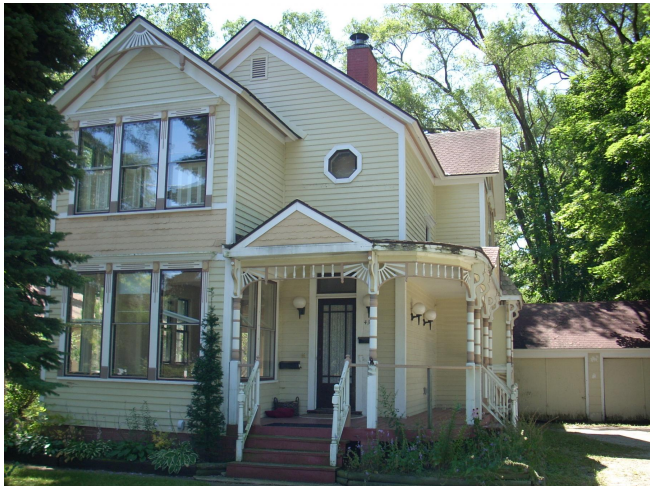
<b>CATEGORY</b>	Building	<b>HISTORIC USE</b>	Domestic - single dwelling
<b>CONDITION</b>	Good	<b>SECONDARY STRUCTURE</b>	[attached garage]
<b>INTEGRITY</b>	Minor alterations	<b>NR SECOND</b>	-
<b>CURRENT USE</b>	Domestic - multiple dwelling

Nested front gables on front facade; wrap around porch with turned columns and spindlework; historic front door; multi-light window on west facade

Replacement siding; railings removed on porch; windows (1/1 double hung) are wood replacement windows, likely from the mid-20th century; octagonal window on front facade; two-story rear addition; one-story rear/west garage addition

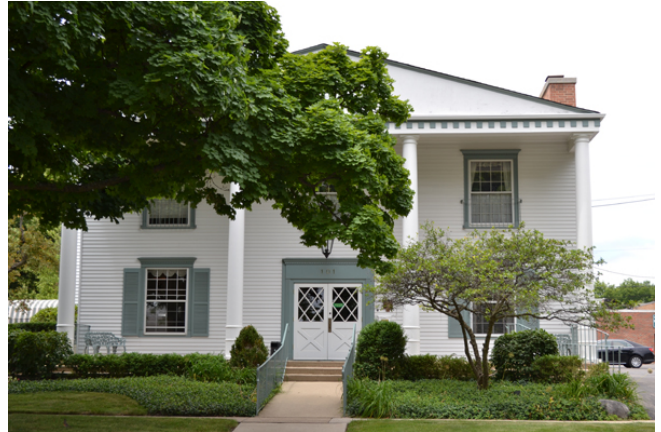
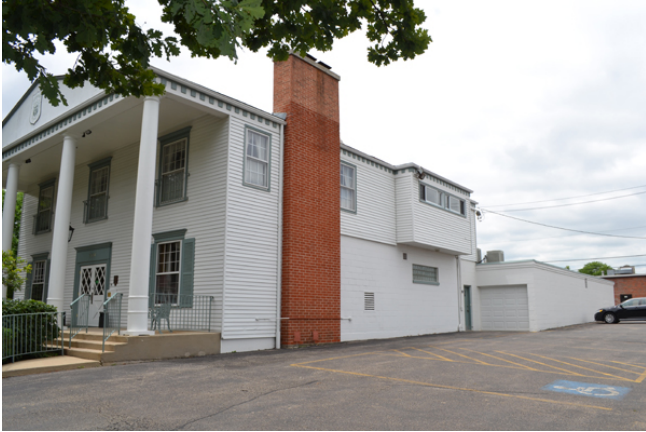
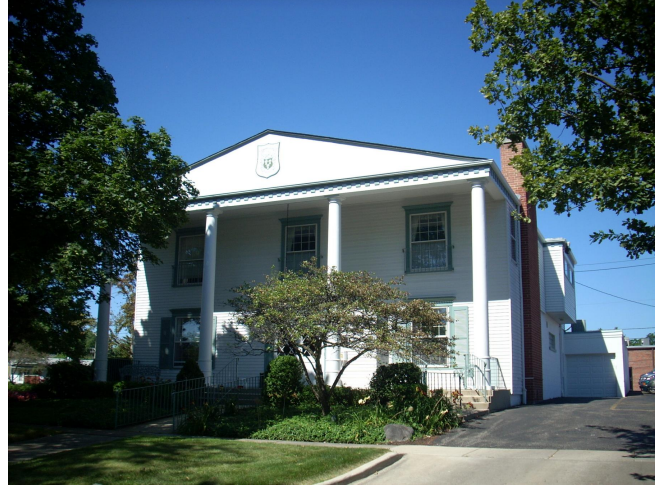
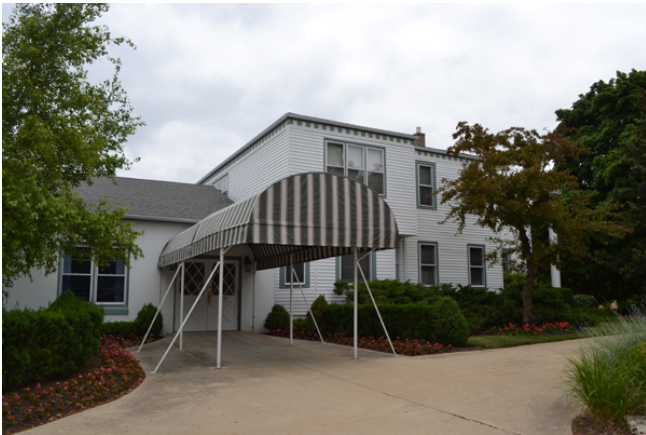
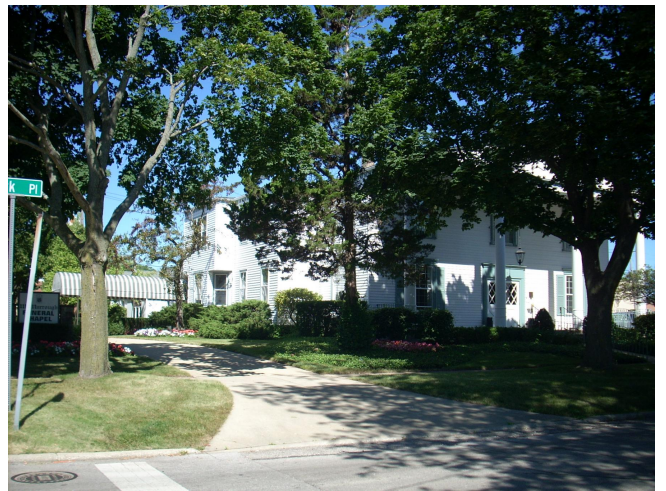
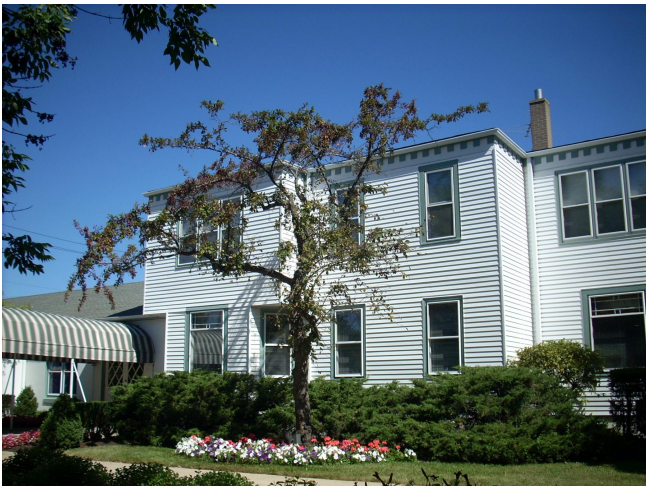
Photo Id: ParkPIN101(1)

<b>CATEGORY</b>	Building	<b>HISTORIC USE</b>	Domestic - single dwelling
<b>CONDITION</b>	Good	<b>SECONDARY STRUCTURE</b>	-
<b>INTEGRITY</b>	Major alterations and additions (historic)	<b>NR SECOND</b>	-
<b>CURRENT USE</b>	Funerary - mortuary

Some original windows visible along south elevation

East facade expanded and reconfigured into a Neo-Colonial design, with full-height front portico and symmetrical fenestration; replacement windows throughout original house; 1-story west addition stretching nearly to the west end of the lot, with secondary entrance facing south onto Park Avenue

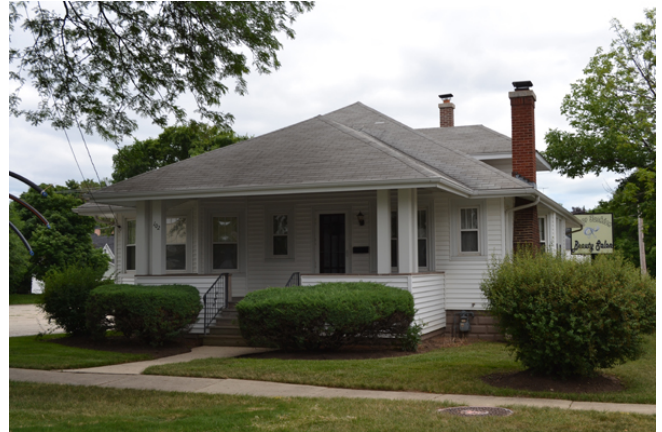
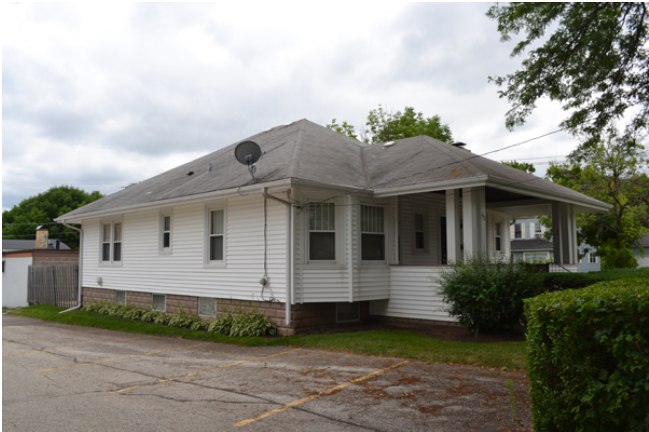
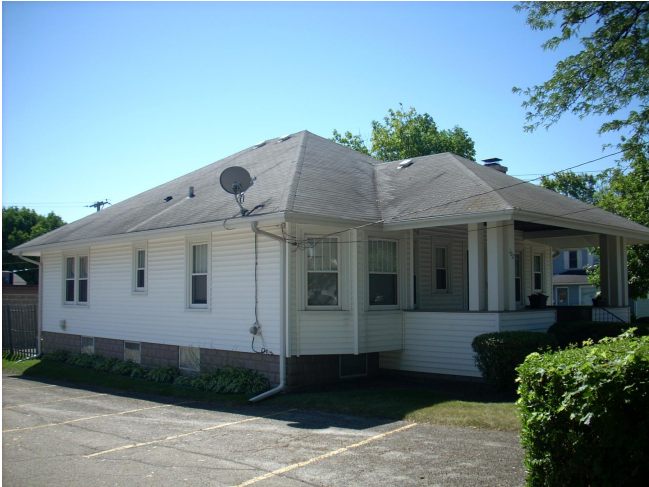
Photo Id: ParkPIN102(1)

<b>CATEGORY</b>	Building	<b>HISTORIC USE</b>	Domestic - single dwelling
<b>CONDITION</b>	Good	<b>SECONDARY STRUCTURE</b>	-
<b>INTEGRITY</b>	minor alterations and additions	<b>NR SECOND</b>	-
<b>CURRENT USE</b>	Commerce/Trade

Hipped roof with overhanging eaves; south side hipped dormer; hipped-roof front porch with solid knee walls and grouped square columns; three-sided front and south bay windows

Replacement siding; replacement windows in original openings (historic configuration); rear porch enclosed

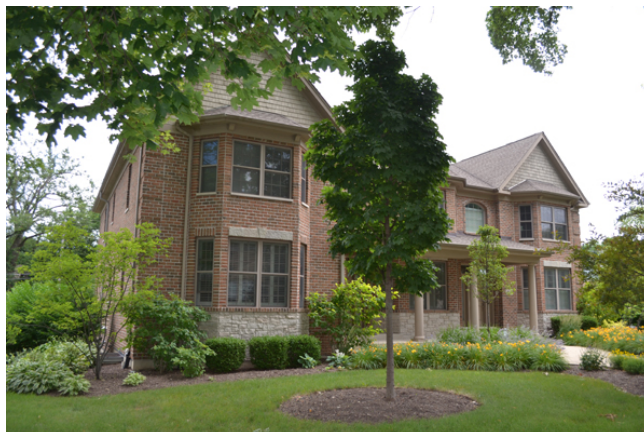
Photo Id: ParkPIN210(2)

<b>CATEGORY</b>	Building	<b>HISTORIC USE</b>	Domestic - multiple dwelling
<b>CONDITION</b>	Excellent	<b>SECONDARY STRUCTURE</b>	-
<b>INTEGRITY</b>	Not altered	<b>NR SECOND</b>	-
<b>CURRENT USE</b>	Domestic - multiple dwelling

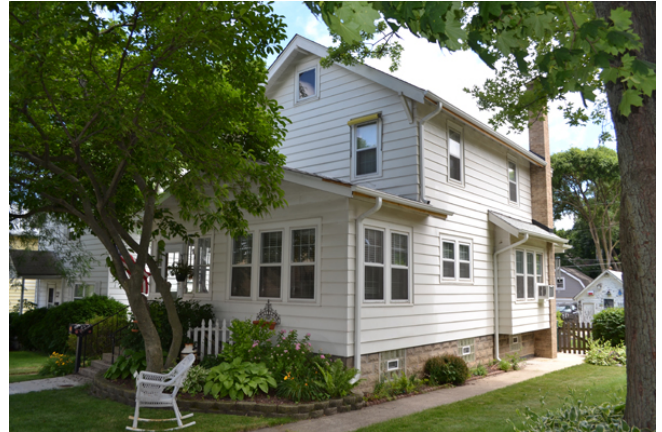
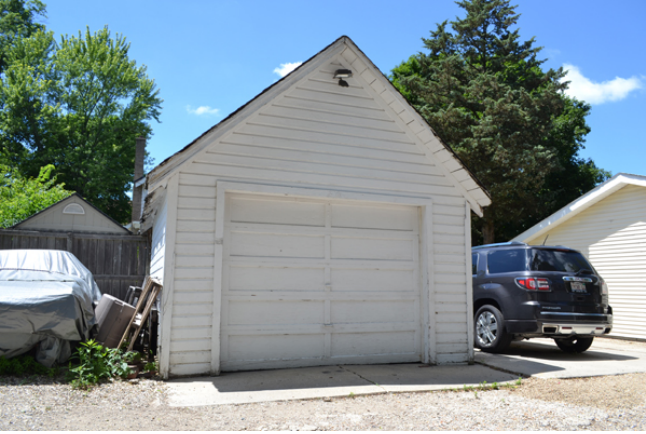
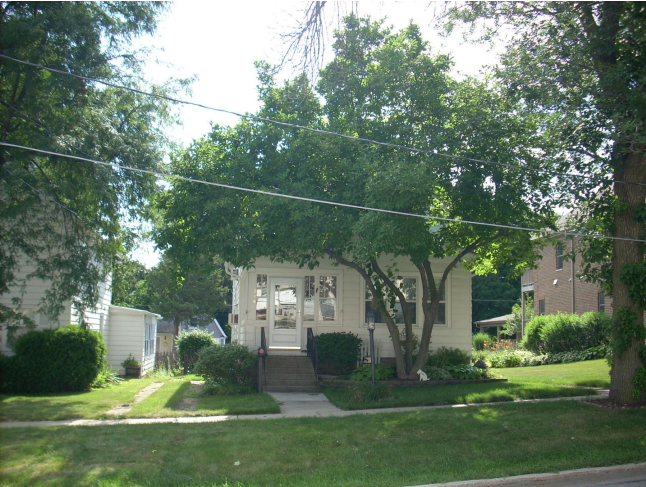
Photo Id: ParkPIN216(1)

<b>CATEGORY</b>	<input type="text" value="Building"/>	<b>HISTORIC USE</b>	<input type="text" value="Domestic - single dwelling"/>
<b>CONDITION</b>	<input type="text" value="Good"/>	<b>SECONDARY STRUCTURE</b>	<input type="text" value="Detached garage"/>
<b>INTEGRITY</b>	<input type="text" value="Minor alterations"/>	<b>NR SECOND</b>	<input type="text" value="C"/>
<b>CURRENT USE</b>	<input type="text" value="Domestic - single dwelling"/>

Front gable bay with inset corner entry porch; 3/1 and 2/1 wood windows enclosing porch

Replacement siding; replacement windows in original openings

2732 (8/26/1960)--construction of concrete stair; No permit # (6/11/1959)--removing old chimney, repair back steps, move one door and one window in rear

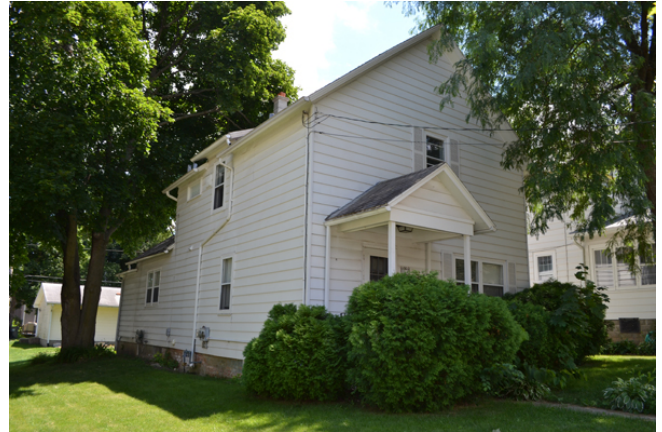
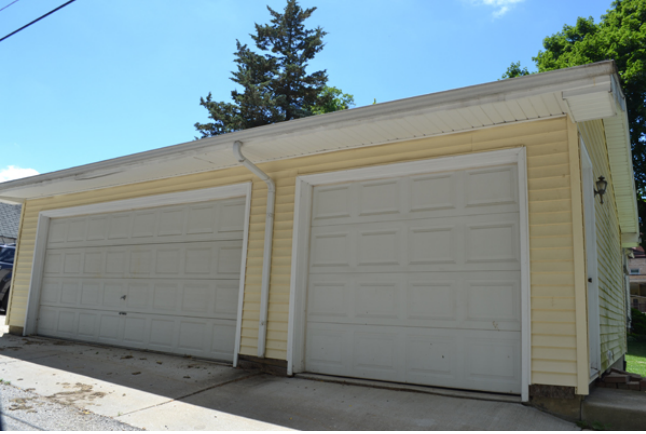
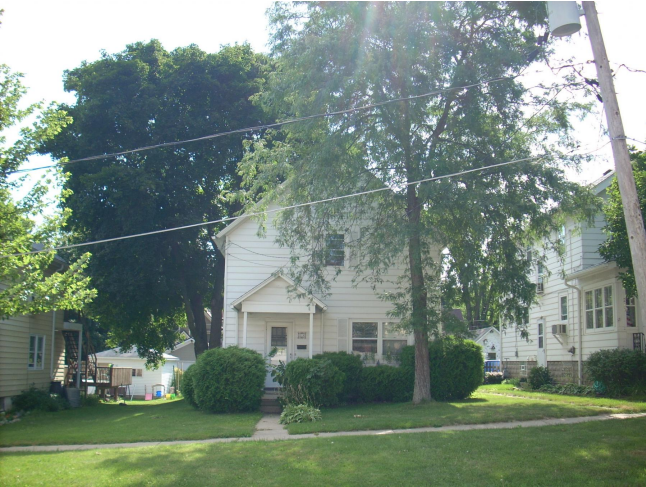
Photo Id: ParkPIN218(1)

<b>CATEGORY</b>	Building	<b>HISTORIC USE</b>	Domestic - single dwelling
<b>CONDITION</b>	Good	<b>SECONDARY STRUCTURE</b>	Detached garage
<b>INTEGRITY</b>	Minor alterations	<b>NR SECOND</b>	NC
<b>CURRENT USE</b>	Domestic - single dwelling

Front gable roof and rectangular massing; gable roof front porch structure; historic wood front door

One-story rear addition; replacement siding; replacement porch supports; fixed shutters

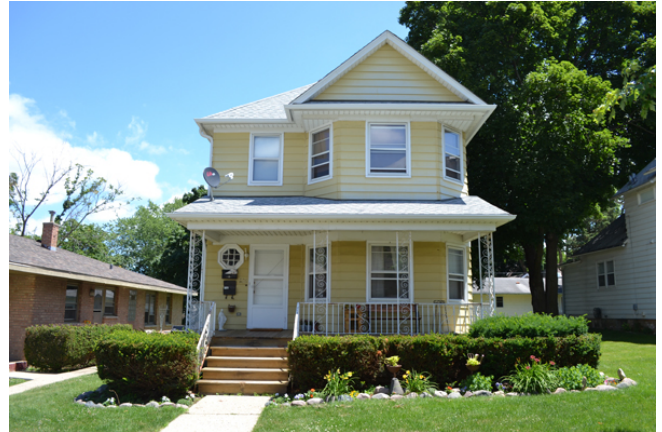
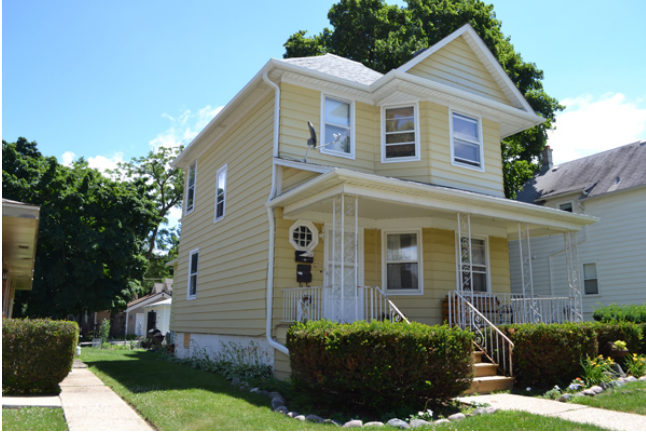
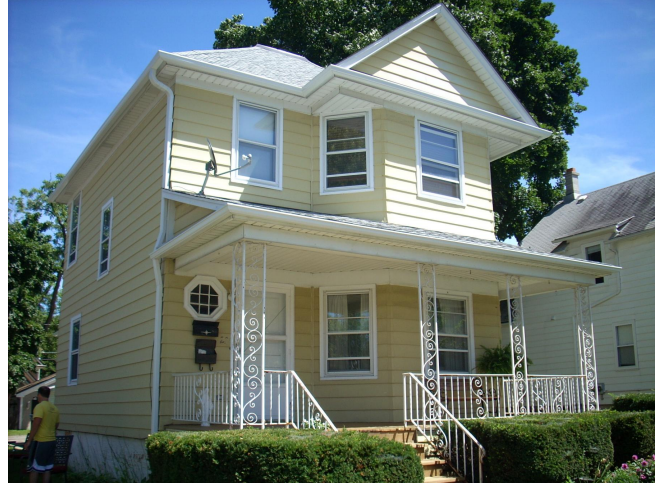
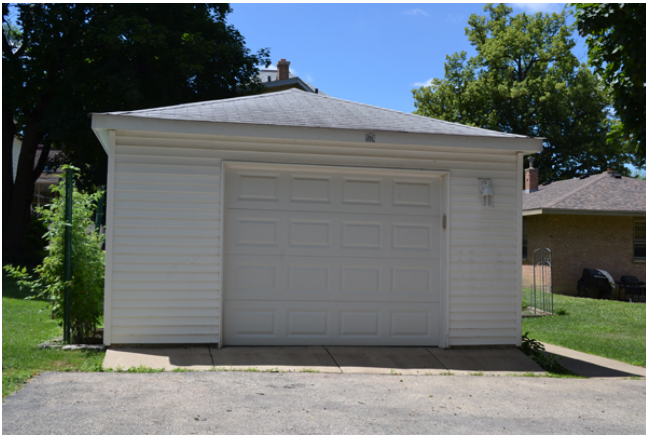
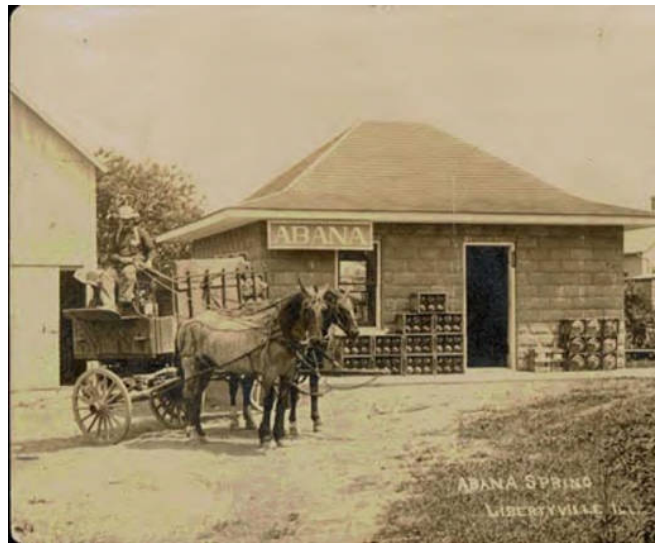
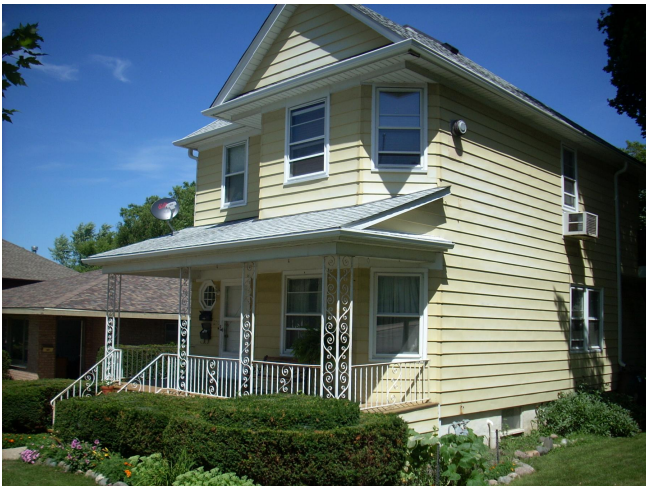
Photo Id: ParkPIN220(1)

<b>CATEGORY</b>	Building	<b>HISTORIC USE</b>	Domestic - single dwelling
<b>CONDITION</b>	Good	<b>SECONDARY STRUCTURE</b>	Detached garage
<b>INTEGRITY</b>	Moderate alterations	<b>NR SECOND</b>	C
<b>CURRENT USE</b>	Domestic - multiple dwelling

Replacement front porch (post-1948); replacement siding (1974); replacement windows in original openings (historic, not original); rear addition (1971)

7666 (3/4/1974)--aluminum siding; 6444 (7/22/1971)--enlarging kitchen 2nd floor apartment, adding small porch, adding outside stairway to 2nd floor apartment; 2695 (7/18/1960)--reshingle roof, change siding, insulate walls, repair front porch and stairs

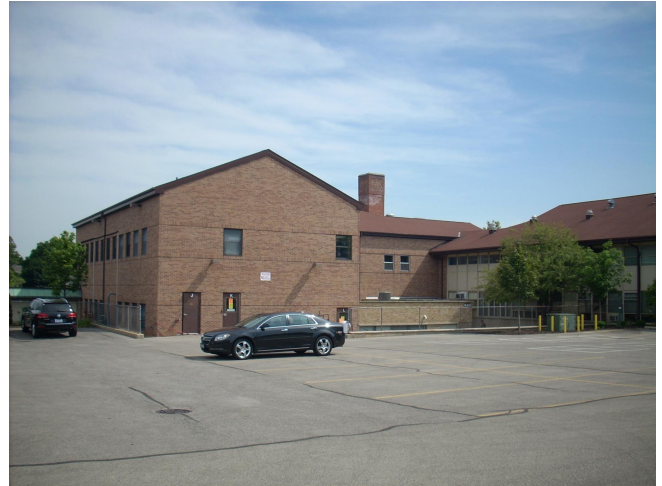
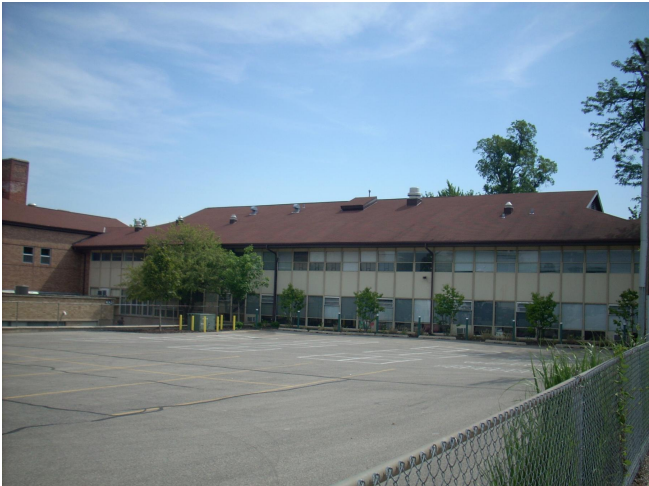
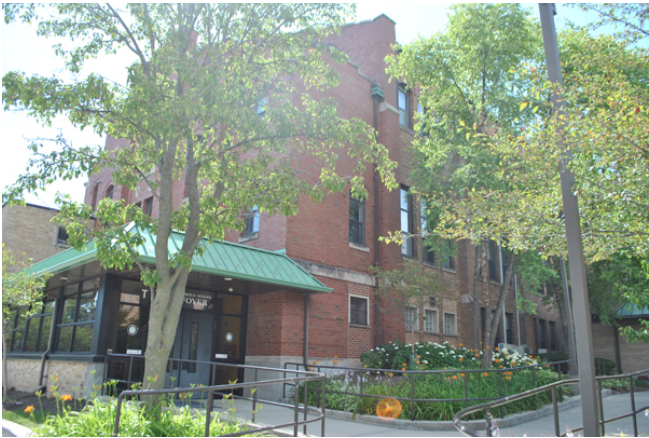
Photo Id: ParkPlace221

<b>CATEGORY</b>	<input type="text" value="Building"/>	<b>HISTORIC USE</b>	<input type="text" value="Education - school"/>
<b>CONDITION</b>	<input type="text" value="Good"/>	<b>SECONDARY STRUCTURE</b>	<input type="text" value="-"/>
<b>INTEGRITY</b>	<input type="text" value="Major alterations and additions"/>	<b>NR SECOND</b>	<input type="text" value="-"/>
<b>CURRENT USE</b>	<input type="text" value="Education - school"/>

1926 building obscured by multiple additions, dating from the mid-20th century and later. 1957 addition (historic)--2-story south addition features ribbon first-floor windows and ribbon clerestory windows on 2nd story; 1-story projecting north section features a flat roof, recessed entry with round columns, and buff brick exterior; long, 1st-story concrete planters Non-historic alterations include: hipped roof added to south section of building (1992); some windows removed for air conditioning units along east and west facades of south section; multiple additions at rear (west) elevation of building (no date, not historic); metal roofing and replacement windows in north side entry (in front of 1920s school building)

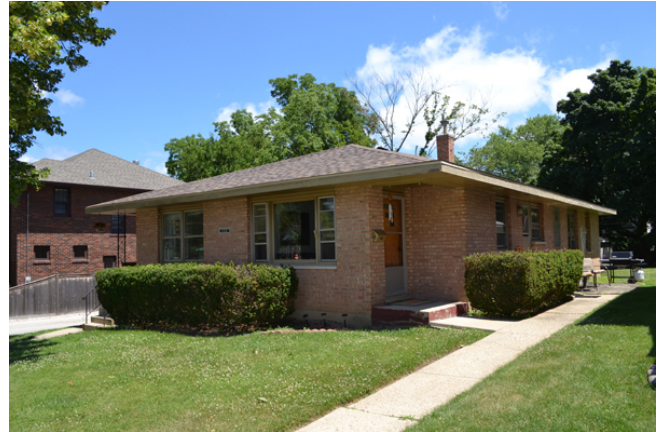
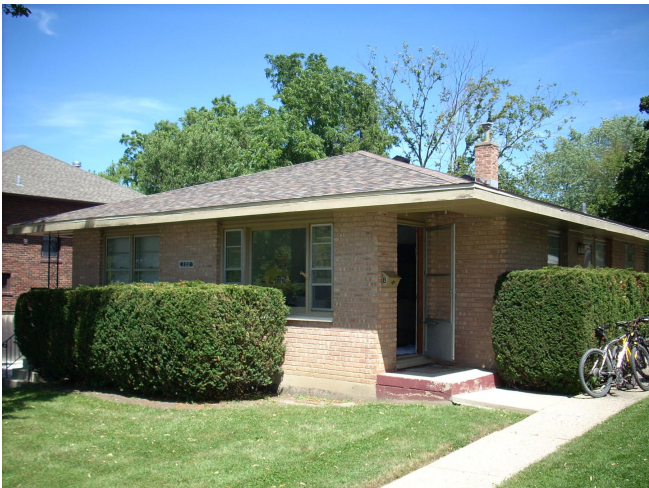
Photo Id: ParkPIN222(1)

<b>CATEGORY</b>	Building	<b>HISTORIC USE</b>	Domestic - multiple dwelling
<b>CONDITION</b>	Good	<b>SECONDARY STRUCTURE</b>	-
<b>INTEGRITY</b>	Minor alterations	<b>NR SECOND</b>	-
<b>CURRENT USE</b>	Domestic - multiple dwelling

Glass block in north side window; replacement secondary entry porch on north elevation

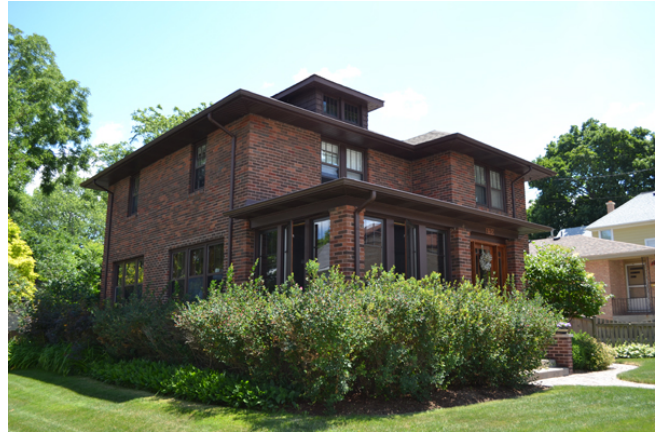
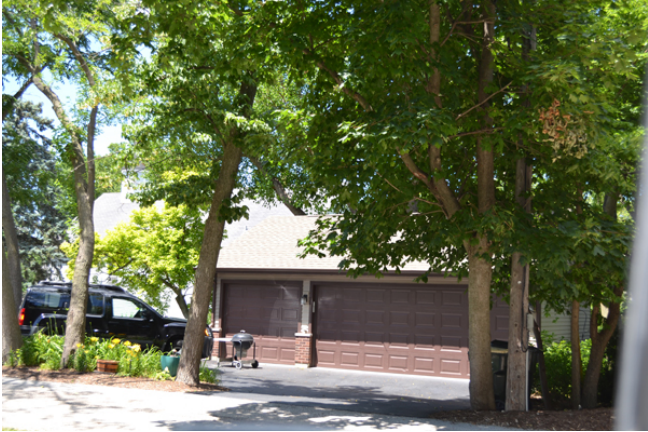
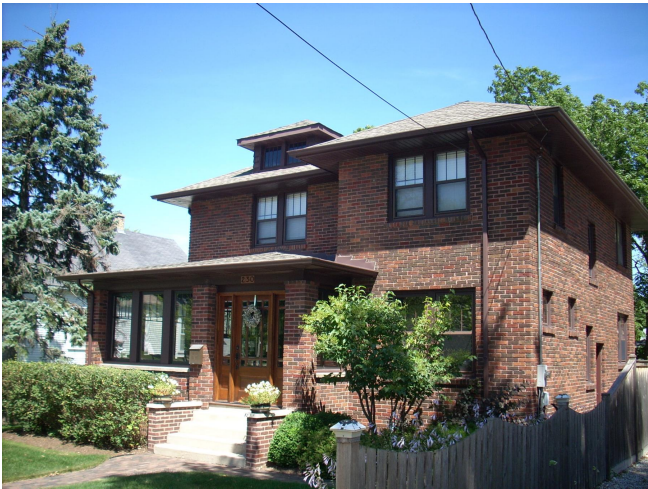
Photo Id: ParkPIN230(3)

<b>CATEGORY</b>	<input type="text" value="Building"/>	<b>HISTORIC USE</b>	<input type="text" value="Domestic - single dwelling"/>
<b>CONDITION</b>	<input type="text" value="Good"/>	<b>SECONDARY STRUCTURE</b>	<input type="text" value="Detached garage"/>
<b>INTEGRITY</b>	<input type="text" value="Minor alterations"/>	<b>NR SECOND</b>	<input type="text" value="NC"/>
<b>CURRENT USE</b>	<input type="text" value="Domestic - single dwelling"/>

Front porch enclosed (new windows and doors in original porch structure--c. 2010)
