Historic Libertyville

BEGINNING STREET NUMBER	<input type="text" value="113"/>
END STREET NUMBER	<input type="text" value="-"/>
STREET # SUFFIX	<input type="text" value="-"/>
STREET NAME	<input type="text" value="First Street"/>
PIN	<input type="text"/>
<u>LOCAL</u>	
WITHIN LOCAL DISTRICT?	<input type="text" value="No"/>
LOCAL DIST CONTRIB/NON-CONTRIB?	<input type="text" value="NC"/>
LOCAL LANDMARK?	<input type="text" value="No"/>
YEAR	<input type="text" value="-"/>
LOCAL LANDMARK ELIGIBLE?	<input type="text" value="No"/>
CRITERIA	<input type="text" value="-"/>

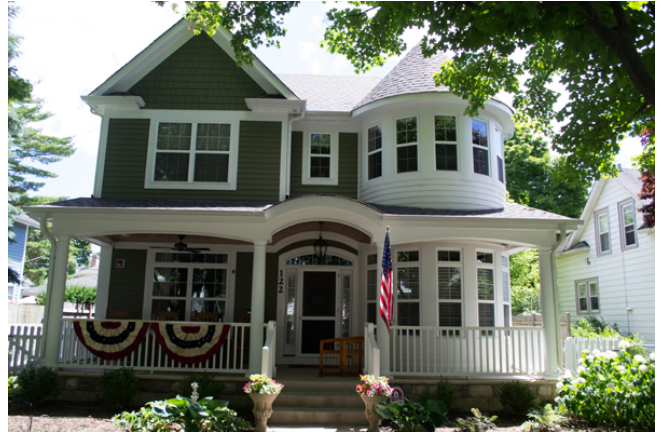
Photo Id: FirstSt122(1)

CATEGORY	Building	HISTORIC USE	Domestic - single dwelling
CONDITION	Excellent	SECONDARY STRUCTURE	Detached garage
INTEGRITY	Not altered	NR SECOND	NC
CURRENT USE	Domestic - single dwelling
