Historic Libertyville

BEGINNING STREET NUMBER	518
END STREET NUMBER	-
STREET # SUFFIX	-
STREET NAME	First Street
PIN	
<u>LOCAL</u>	
WITHIN LOCAL DISTRICT?	No
LOCAL DIST CONTRIB/NON-CONTRIB?	C
LOCAL LANDMARK?	No
YEAR	-
LOCAL LANDMARK ELIGIBLE?	Potentially Eligible
CRITERIA	A

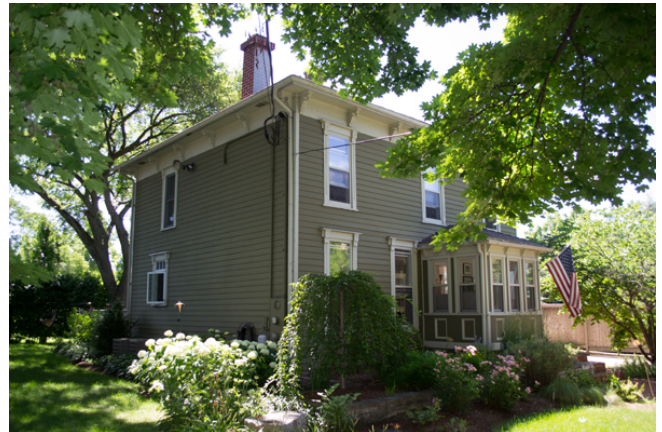
Photo Id: FirstSt518(2)

Fine example Italianate residential architecture in the village, with characteristic bracketed cornice and classical wood window surrounds. The enclosed front porch and open entry porch on the north facade are non-historic alterations.

Shallow hipped roof; wood cornice with scrolled brackets; classical wood window surrounds

Front porch addition (not historic); original north side sun porch removed and replaced with small entry porch (not historic)
