# Historic Libertyville

BEGINNING STREET NUMBER	121
END STREET NUMBER	-
STREET # SUFFIX	-
STREET NAME	W. Park Avenue
PIN	
<b><u>LOCAL</u></b>	
WITHIN LOCAL DISTRICT?	No
LOCAL DIST CONTRIB/NON-CONTRIB?	C
LOCAL LANDMARK?	No
YEAR	-
LOCAL LANDMARK ELIGIBLE?	No
CRITERIA	-

## **BUILDING DETAILS**

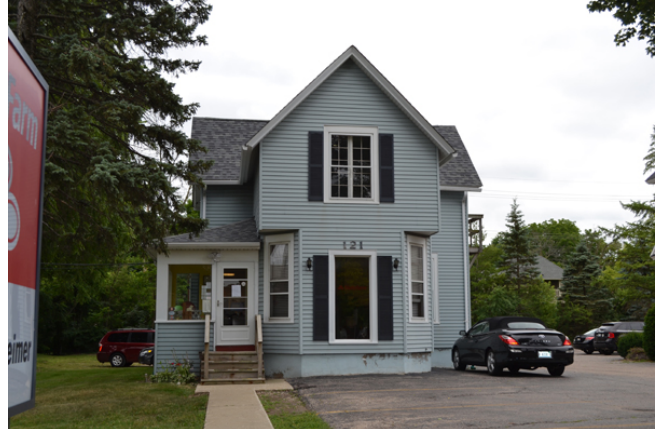
Photo Id: ParkAveW121(2)

<b>CATEGORY</b>	<b>HISTORIC USE</b>
Building	Domestic - single dwelling
<b>CONDITION</b>	<b>SECONDARY STRUCTURE</b>
Good	-
<b>INTEGRITY</b>	<b>NR SECOND</b>
Moderate alterations	-
<b>CURRENT USE</b>	
Commerce/Trade - office

Two story front gable bay with east and west two-story cross-bays; cutaway corners on front bay; square, east-side oriel bay with historic wood windows

Replacement siding (2005); replacement windows in downsized openings (except in oriel bay); corner entry porch (historic alteration likely dating from the 1910s or 20s, enclosed later); fixed shutters; rear east-side addition; east deck addition; exterior staircase on west bay (2006)
