Historic Libertyville

BEGINNING STREET NUMBER	125
END STREET NUMBER	-
STREET # SUFFIX	-
STREET NAME	W. Park Avenue
PIN	
<u>LOCAL</u>	
WITHIN LOCAL DISTRICT?	No
LOCAL DIST CONTRIB/NON-CONTRIB?	C
LOCAL LANDMARK?	No
YEAR	-
LOCAL LANDMARK ELIGIBLE?	No
CRITERIA	-

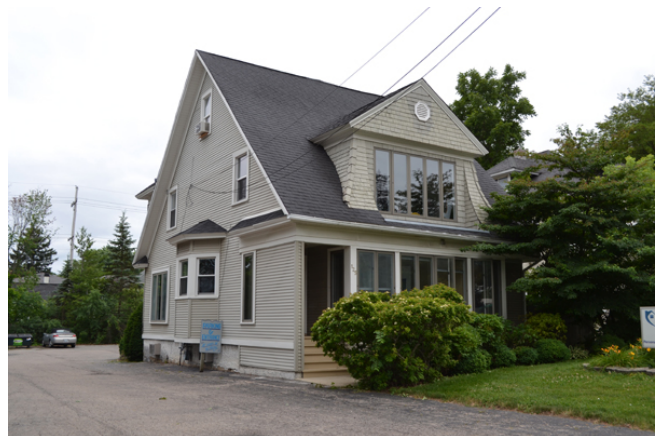
Photo Id: ParkAveW125(2)

CATEGORY	Building	HISTORIC USE	Domestic - single dwelling
CONDITION	Good	SECONDARY STRUCTURE	-
INTEGRITY	Moderate alterations	NR SECOND	-
CURRENT USE	Commerce/Trade - office

Side gable roof with cornice returns; three-sided east oriel bay window; inset front porch structure (altered)

Sanborn maps from 1924-1948 show house with full-front, open porch--porch partially enclosed at center, removed at west end, with open entry porch at east end; replacement windows in original openings on side elevations; inset porch in front dormer enclosed with casement windows; replacement siding
