# Historic Libertyville

BEGINNING STREET NUMBER	423
END STREET NUMBER	-
STREET # SUFFIX	-
STREET NAME	W. Park Avenue
PIN	
<b><u>LOCAL</u></b>	
WITHIN LOCAL DISTRICT?	No
LOCAL DIST CONTRIB/NON-CONTRIB?	C
LOCAL LANDMARK?	No
YEAR	-
LOCAL LANDMARK ELIGIBLE?	No
CRITERIA	-

# **ARCHITECTURAL DESCRIPTION**

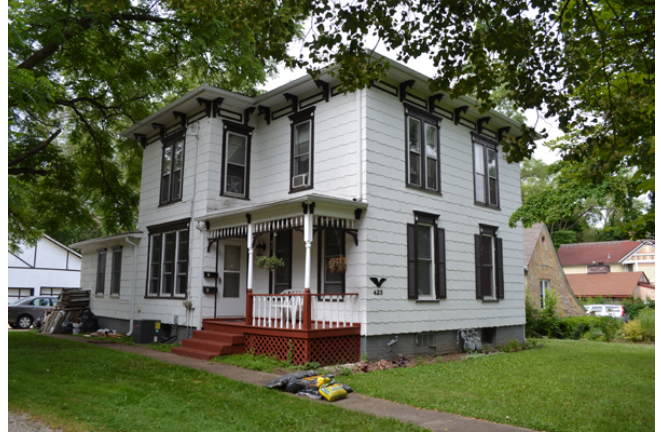
Photo Id: ParkAveW423(1)

Hipped roof; cornice with paneled frieze and brackets; classical lintels over windows and doors with bulls eye corner blocks; corner entry porch; some wood 1/1 windows on 2nd story (historic, but likely not original)

Replacement siding; some 1/1 replacement windows in original openings; replacement railing and deck on porch; replacement front door; rear east porch enclosed; fixed shutters; one-story west addition; west side stair addition
