Historic Libertyville

BEGINNING STREET NUMBER	315
END STREET NUMBER	-
STREET # SUFFIX	-
STREET NAME	W. Maple Avenue
PIN	
<u>LOCAL</u>	
WITHIN LOCAL DISTRICT?	No
LOCAL DIST CONTRIB/NON-CONTRIB?	C
LOCAL LANDMARK?	No
YEAR	-
LOCAL LANDMARK ELIGIBLE?	Potentially Eligible
CRITERIA	A

Photo Id: MapleAveW315(1)

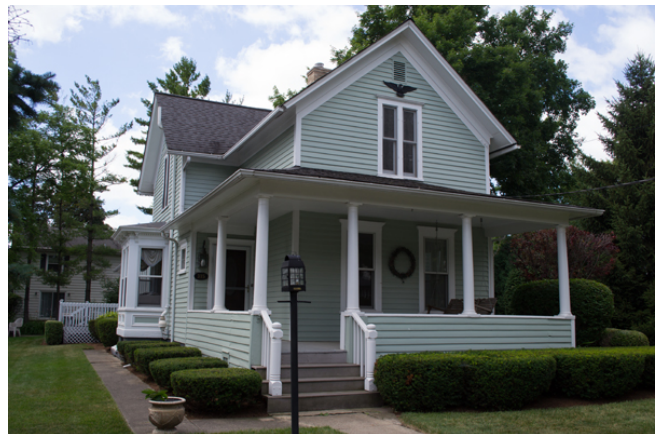
CATEGORY	Building	HISTORIC USE	Domestic - single dwelling
CONDITION	Good	SECONDARY STRUCTURE	Detached garage
INTEGRITY	Minor alterations	NR SECOND	NC
CURRENT USE	Domestic - single dwelling

Even with alterations to east porch and replacement windows, this Cross Form residence with Queen Anne and Italianate detailing may be eligible for local landmark designation.

Cross gable roofline, with 2-story front gable bay intersected by east and west projecting gable bays; wraparound front porch (likely an historic alteration from early 20th century); 1-story east window bay with classical cornice

Replacement windows in original openings; rear and southeast porches enclosed and connected (1982)
