Historic Libertyville

| STREET NAME | Stewart Avenue |

ARCHITECTURAL DESCRIPTION

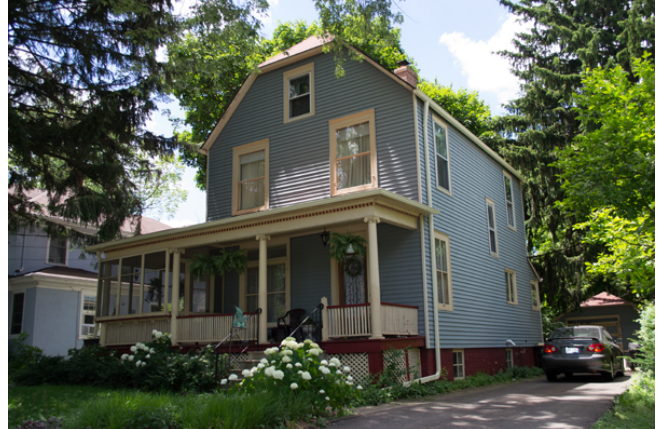
Photo Id: StewartAveN201(2)

Clipped front gable with south side gable-roof ell; wraparound porch with Ionic columns and historic wood railing; historic wood fixed and double hung windows; historic front door

Replacement siding; concrete front porch steps with wrought iron railing; rear porch addition (1999)
