# Historic Libertyville

BEGINNING STREET NUMBER	126
END STREET NUMBER	-
STREET # SUFFIX	-
STREET NAME	Lake Street
PIN	
<b><u>LOCAL</u></b>	
WITHIN LOCAL DISTRICT?	No
LOCAL DIST CONTRIB/NON-CONTRIB?	C
LOCAL LANDMARK?	No
YEAR	-
LOCAL LANDMARK ELIGIBLE?	No
CRITERIA	-

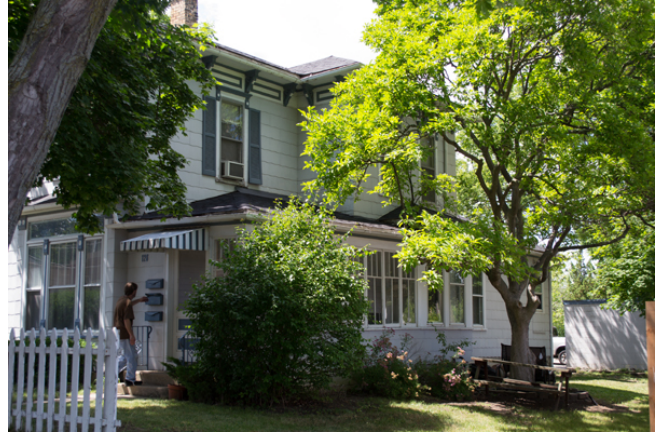
Photo Id: LakeSt126(2)

Shallow hipped roof; wood cornice with paneled frieze and scrolled brackets; classical lintels above window openings; southeast corner porch structure (enclosed); square oriel bay window on front facade; east side oriel window

Replacement windows in original openings (replacement windows in front bay are historic, dating from the 1920s or 30s); corner entry porch enclosed (historic alteration--c. 1920s-30s); 2-story rear/northwest addition; exterior staircase (1952)
