Historic Libertyville

BEGINNING STREET NUMBER	126
END STREET NUMBER	-
STREET # SUFFIX	-
STREET NAME	Lake Street
PIN	
<u>LOCAL</u>	
WITHIN LOCAL DISTRICT?	No
LOCAL DIST CONTRIB/NON-CONTRIB?	C
LOCAL LANDMARK?	No
YEAR	-
LOCAL LANDMARK ELIGIBLE?	No
CRITERIA	-

BUILDING DETAILS

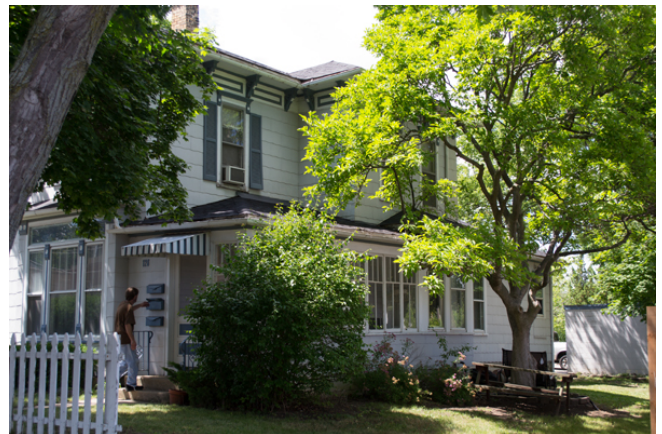
Photo Id: LakeSt126(2)

CATEGORY	Building	HISTORIC USE	Domestic - single dwelling
CONDITION	Good	SECONDARY STRUCTURE	Detached garage
INTEGRITY	Moderate alterations	NR SECOND	C
CURRENT USE	Domestic - multiple dwelling

Shallow hipped roof; wood cornice with paneled frieze and scrolled brackets; classical lintels above window openings; southeast corner porch structure (enclosed); square oriel bay window on front facade; east side oriel window

Replacement windows in original openings (replacement windows in front bay are historic, dating from the 1920s or 30s); corner entry porch enclosed (historic alteration--c. 1920s-30s); 2-story rear/northwest addition; exterior staircase (1952)
