Historic Libertyville

BEGINNING STREET NUMBER	329
END STREET NUMBER	-
STREET # SUFFIX	-
STREET NAME	W. Park Avenue
PIN	
<u>LOCAL</u>	
WITHIN LOCAL DISTRICT?	No
LOCAL DIST CONTRIB/NON-CONTRIB?	C
LOCAL LANDMARK?	No
YEAR	-
LOCAL LANDMARK ELIGIBLE?	Yes
CRITERIA	A

Photo Id: ParkAveW329(1)

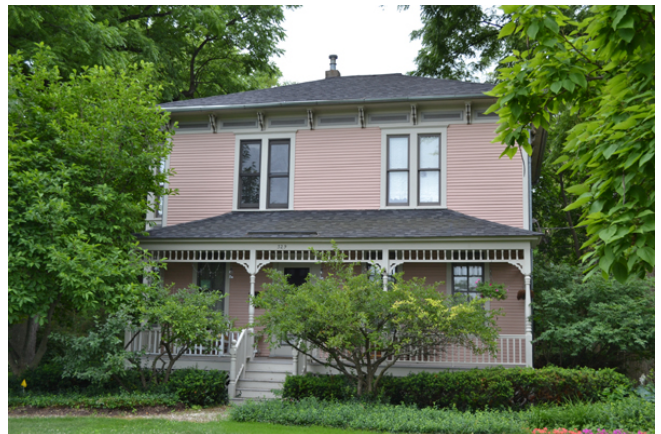
Handsome Folk Victorian residence from the late 19th century. Notable features include cornice with paneled frieze and scrolled brackets, hipped-roof front porch, and two-story east side bay.

Hipped roof; cornice with paneled frieze and brackets; hipped roof porch with turned porch columns and railings and spindlework frieze (may be early alteration from the 1890s); two-story, three-sided bay on east facade; some windows on first floor appear to be historic wood double hung windows

Second-story windows are wood replacement; rear deck addition (1996)

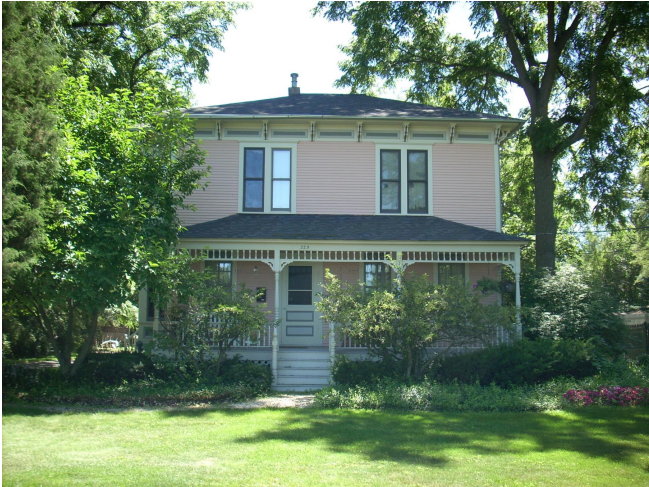
Photo Id: WPark329

Historic photograph at Illinois Digital Archives (info from Libertyville-Mundelein Historical Society and Cook Memorial Public Library) "Note on back [of photograph]: "1. Harvey Home, 2. Baldwin Home, 3. Kollman is an architect - Libertyville, 329 W. Park, Built 1898." Photograph by Beswick Photo Studio, Libertyville, Ill. The Beswick Photo Studio is listed in the Libertyville section of the Waukegan city directory between 1903 and 1913. According to the Lake County Assessor's Office, the house was built in 1899.
<http://www.idaillinois.org/cdm/singleitem/collection/cookmemo11/id/6519/rec/3>
