Historic Libertyville

BEGINNING STREET NUMBER	109
END STREET NUMBER	-
STREET # SUFFIX	-
STREET NAME	W. Maple Avenue
PIN	
<u>LOCAL</u>	
WITHIN LOCAL DISTRICT?	No
LOCAL DIST CONTRIB/NON-CONTRIB?	NC
LOCAL LANDMARK?	No
YEAR	-
LOCAL LANDMARK ELIGIBLE?	No
CRITERIA	-

BUILDING DETAILS

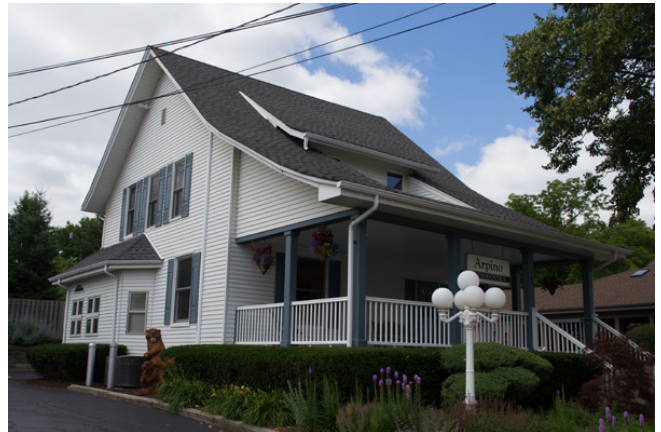
Photo Id: MapleAveW109(2)

Flared side gable roof with overhanging eaves; curving shed-roof front through-the-cornice dormer; east side first-story window bay with hipped roof

Replacement siding; replacement windows in original openings; shutters; replacement front porch (1983)
