# Historic Libertyville

<b>BEGINNING STREET NUMBER</b>	221
<b>END STREET NUMBER</b>	-
<b>STREET # SUFFIX</b>	-
<b>STREET NAME</b>	N. Milwaukee Avenue
<b>PIN</b>	
<b><u>LOCAL</u></b>	
<b>WITHIN LOCAL DISTRICT?</b>	No
<b>LOCAL DIST CONTRIB/NON-CONTRIB?</b>	C
<b>LOCAL LANDMARK?</b>	No
<b>YEAR</b>	-
<b>LOCAL LANDMARK ELIGIBLE?</b>	No
<b>CRITERIA</b>	-

Photo Id: MilwaukeeAveN221(1)

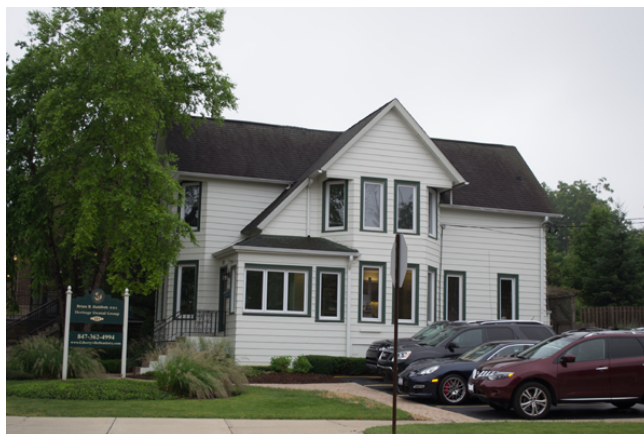
<b>CATEGORY</b>	Building
<b>CONDITION</b>	Good
<b>INTEGRITY</b>	Moderate alterations
<b>CURRENT USE</b>	Commerce/Trade

Cross gable roof line; front and side two-story bays with cutaway corners; corner entry porch is likely historic, but not original

Replacement windows in original openings (configuration and type are not historically appropriate); replacement siding; front entry porch enclosed; 1-story south addition (post-1948)
