# Historic Libertyville

<b>BEGINNING STREET NUMBER</b>	510-514
<b>END STREET NUMBER</b>	-
<b>STREET # SUFFIX</b>	-
<b>STREET NAME</b>	N. Milwaukee Avenue
<b>PIN</b>	
<b>LOCAL</b>	
<b>WITHIN LOCAL DISTRICT?</b>	No
<b>LOCAL DIST CONTRIB/NON-CONTRIB?</b>	NC
<b>LOCAL LANDMARK?</b>	No
<b>YEAR</b>	-
<b>LOCAL LANDMARK ELIGIBLE?</b>	No
<b>CRITERIA</b>	-

Two Part Commercial Block

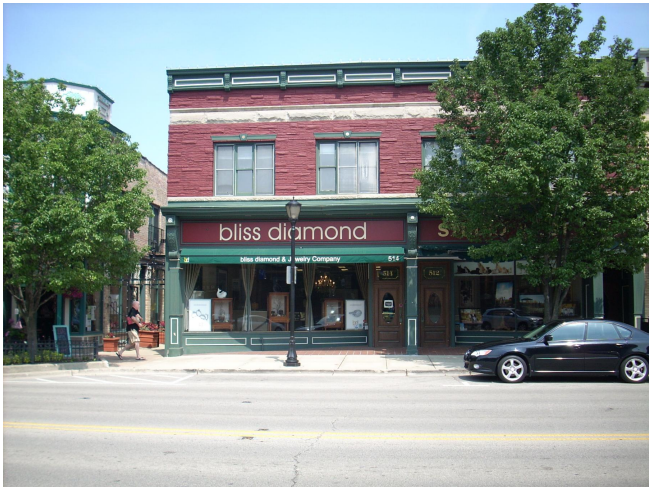
Photo Id: 512-514NMilwaukeeAve

Rusticated stone string course above 2nd story windows; window openings on front facade and north facade appear original

Second story of front facade covered with Lannon Stone cladding (c. 1950); storefront configuration and materials are replacement (configuration dates from the 1950s, the materials are from the 1989 remodeling); replacement 2nd story windows in original openings (1950s); lintels and cornice date from 1989 remodeling.

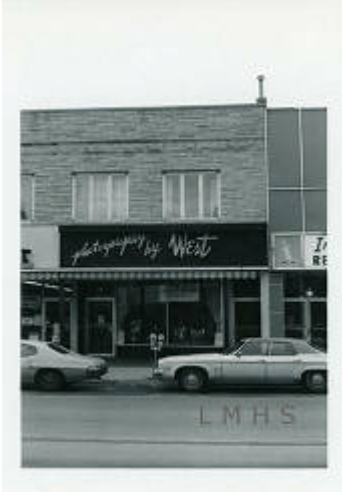
MilwaukeeAveN510-514(1970spartial)

Assessor's photograph from the mid-1970s on Illinois Digital Archives (in collection of Libertyville-Mundelein Historical Society and Cook Memorial Public Library)--  
<http://www.idaillinois.org/cdm/singleitem/collection/cookmemo11/id/6649/rec/204>
