# Historic Libertyville

<b>BEGINNING STREET NUMBER</b>	614-618
<b>END STREET NUMBER</b>	-
<b>STREET # SUFFIX</b>	-
<b>STREET NAME</b>	N. Milwaukee Avenue
<b>PIN</b>	
<b>LOCAL</b>	
<b>WITHIN LOCAL DISTRICT?</b>	No
<b>LOCAL DIST CONTRIB/NON-CONTRIB?</b>	C
<b>LOCAL LANDMARK?</b>	No
<b>YEAR</b>	-
<b>LOCAL LANDMARK ELIGIBLE?</b>	No
<b>CRITERIA</b>	-

Photo Id: 614-618NMilwaukee

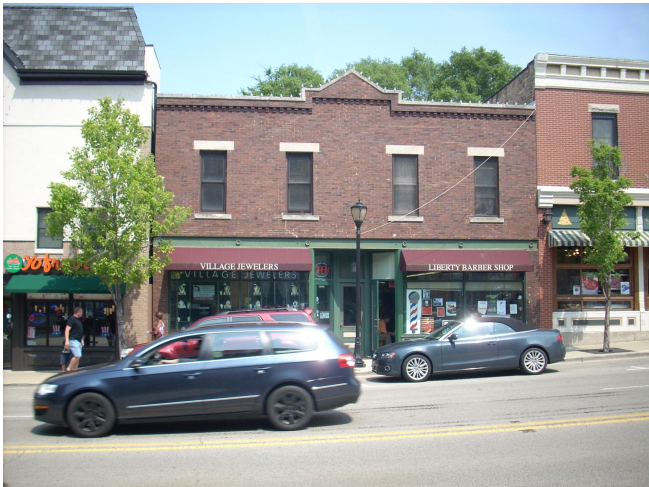
<b>CATEGORY</b>	Building
<b>CONDITION</b>	Good
<b>INTEGRITY</b>	Minor alterations
<b>CURRENT USE</b>	Commerce/Trade

Brick facade; stone-capped brick parapet with center flanged triangular pediment; corbeled brick cornice below parapet; ashlar stone lintels and sills on 2nd story window; historic storefront configuration with center 2nd story entry and flanking storefronts with angled entry doors; metal storefront frieze with tiebacks

Replacement 2nd story windows in original openings; replacement storefront windows and doors; awnings
