# Historic Libertyville

<b>BEGINNING STREET NUMBER</b>	130
<b>END STREET NUMBER</b>	-
<b>STREET # SUFFIX</b>	-
<b>STREET NAME</b>	W. Maple Avenue
<b>PIN</b>	
<b><u>LOCAL</u></b>	
<b>WITHIN LOCAL DISTRICT?</b>	No
<b>LOCAL DIST CONTRIB/NON-CONTRIB?</b>	C
<b>LOCAL LANDMARK?</b>	No
<b>YEAR</b>	-
<b>LOCAL LANDMARK ELIGIBLE?</b>	No
<b>CRITERIA</b>	-

Ramsey Historic Consultants

May-June 2016

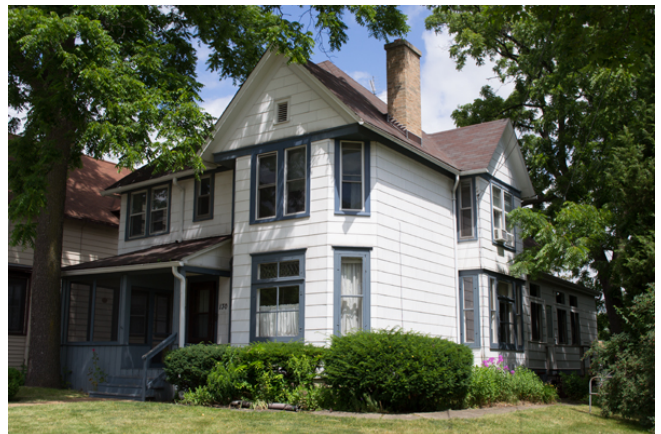
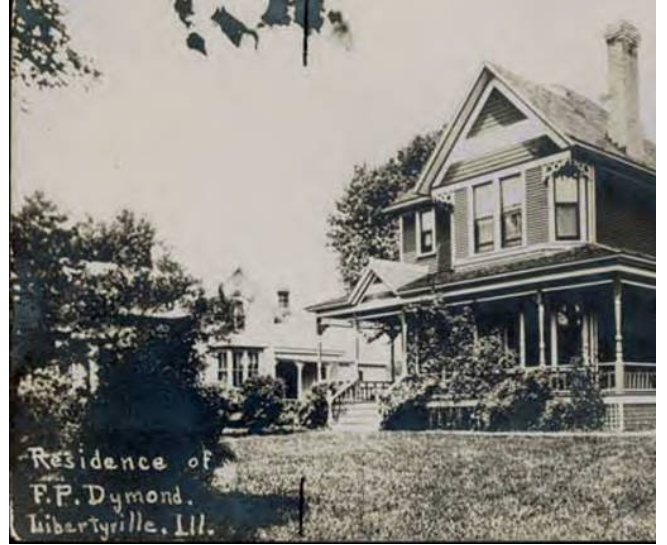
Photo Id: MapleAveW130(4)

<b>CATEGORY</b>	Building	<b>HISTORIC USE</b>	Domestic - single dwelling
<b>CONDITION</b>	Good	<b>SECONDARY STRUCTURE</b>	Detached garage
<b>INTEGRITY</b>	Moderate alterations and additions	<b>NR SECOND</b>	NC
<b>CURRENT USE</b>	Domestic - multiple dwelling

Hipped roof; three-sided 2-story front bay with pent roof; 2-story square pent roof bay on east elevation; east side hipped roof porch structure north of bay (enclosed); wood windows on first story; classical lintels over window openings; beveled glass transom over window on 1st story of front bay

Replacement siding; wraparound front porch removed and replaced with smaller entry and west side porch (post-1948); east side porch enclosed (post-1948); 2nd story replacement windows in original openings

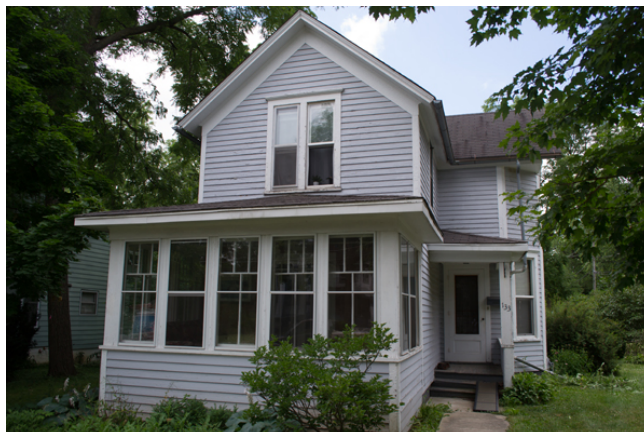
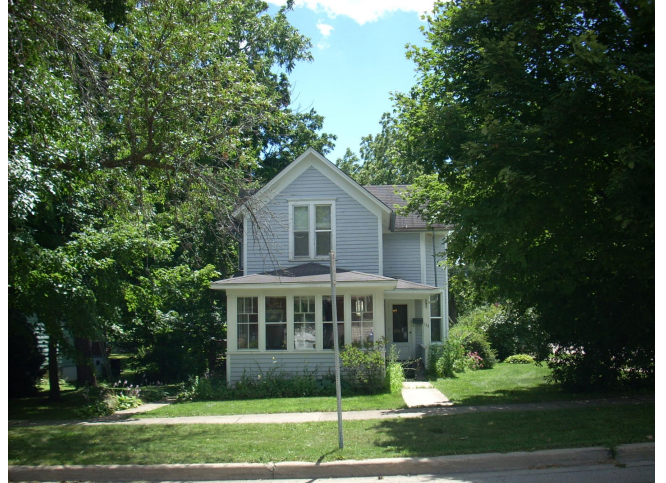
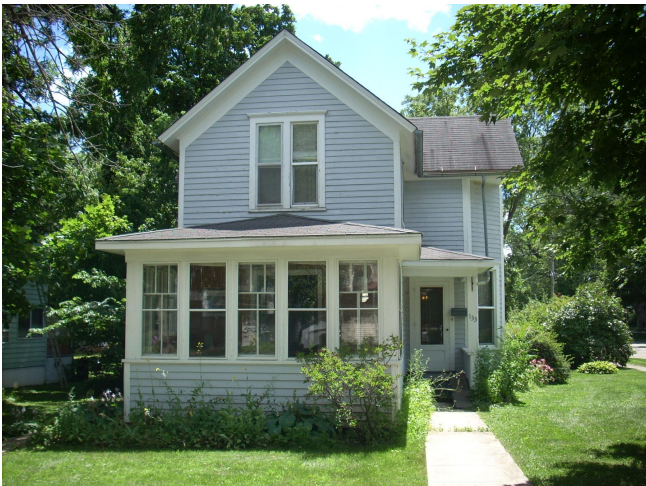
Photo Id: MapleAveW133(1)

<b>CATEGORY</b>	Building	<b>HISTORIC USE</b>	Domestic - single dwelling
<b>CONDITION</b>	Good	<b>SECONDARY STRUCTURE</b>	Detached garage
<b>INTEGRITY</b>	Minor alterations	<b>NR SECOND</b>	C
<b>CURRENT USE</b>	Domestic - single dwelling

Front gable bay intersected by west-side gable ell; with cutaway corners and sunburst ornament under gable; 2-story square gable bay on east facade; historic wood surrounds and lintels on window openings

Hipped roof front entry porch and front sun porch are historic alterations (replaced original wraparound front porch some time between 1924 and 1933); 1/1 replacement windows in original openings (not historic)

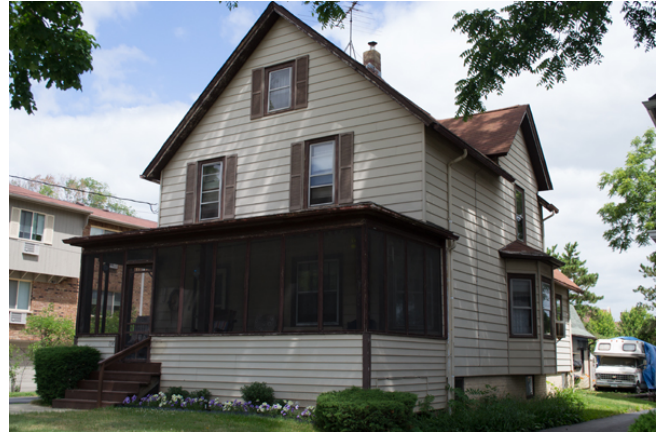
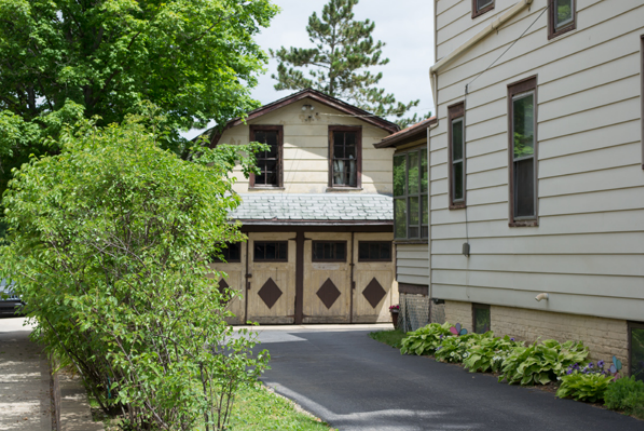
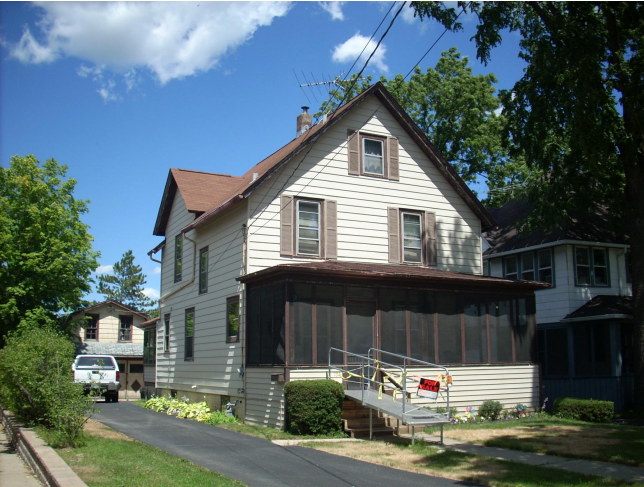
Photo Id: MapleAveW134(3)

<b>CATEGORY</b>	Building	<b>HISTORIC USE</b>	Domestic - single dwelling
<b>CONDITION</b>	Good	<b>SECONDARY STRUCTURE</b>	Detached garage
<b>INTEGRITY</b>	Minor alterations	<b>NR SECOND</b>	C
<b>CURRENT USE</b>	Domestic - single dwelling

Front gable roof and rectangular massing; east and west gables; east side three-sided window bay; wood windows

Replacement siding; front porch screened; shutters

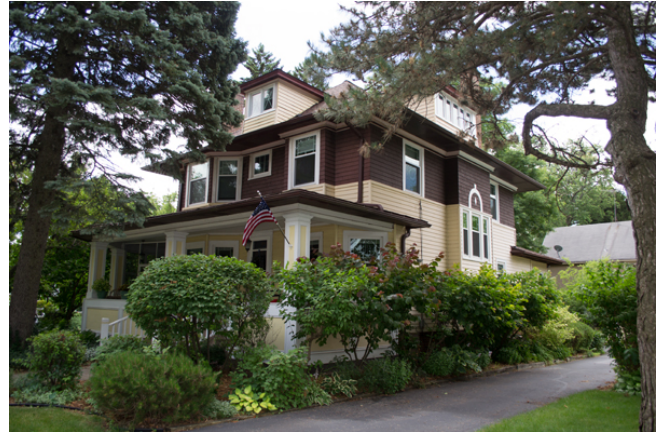
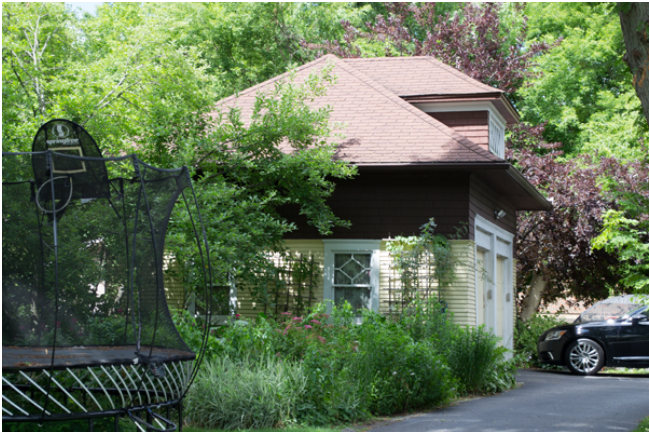
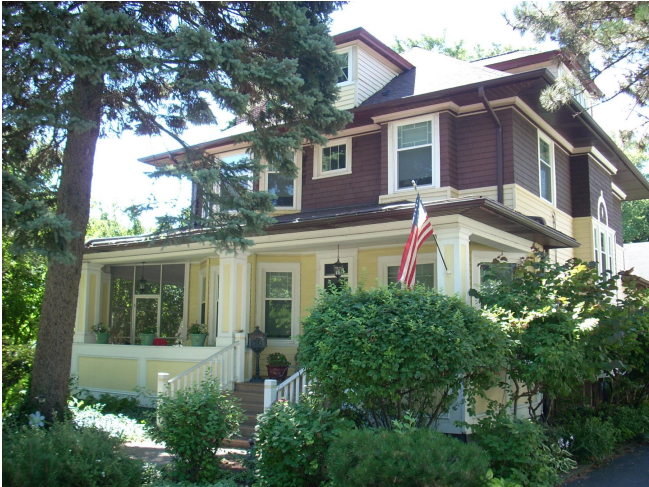
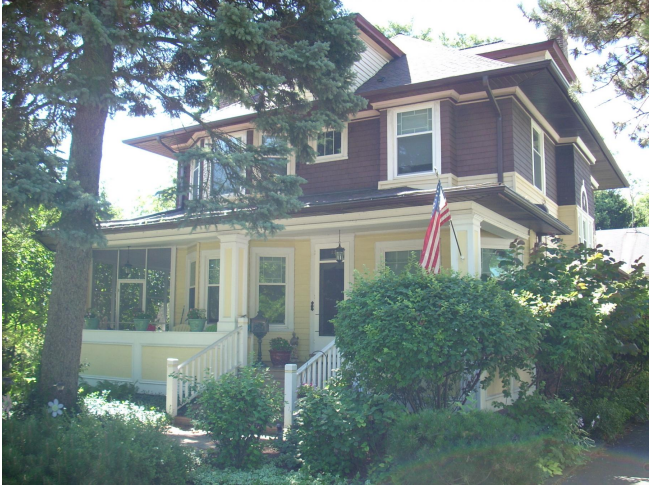
Photo Id: MapleAveW205(1)

<b>CATEGORY</b>	Building	<b>HISTORIC USE</b>	Domestic - single dwelling
<b>CONDITION</b>	Good	<b>SECONDARY STRUCTURE</b>	Detached garage
<b>INTEGRITY</b>	Minor alterations and additions	<b>NR SECOND</b>	C
<b>CURRENT USE</b>	Domestic - single dwelling

Although altered, this turn-of-the-century Queen Anne with Colonial Revival detailing may be eligible for local landmark designation.

Flared hipped roof with overhanging eaves; front and side hipped roof dormers; hipped roof wraparound porch structure; three-sided and square window bays on front facade above porch; east side square oriel bay; 2-story three-sided bay on west elevation

Replacement windows in original openings; rear deck addition; one-story rear addition; east end of porch screened; replacement porch piers and front steps/railing on porch

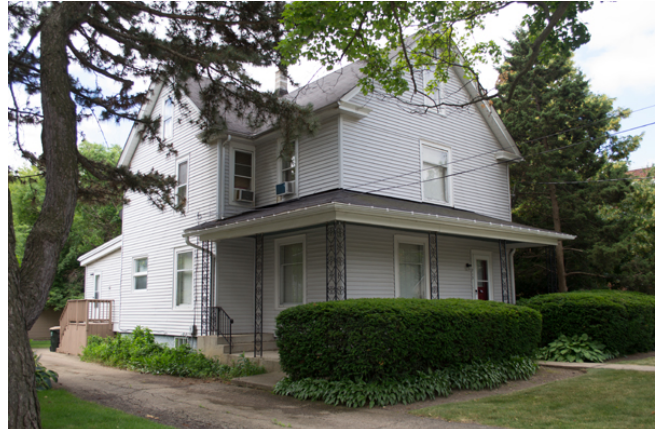
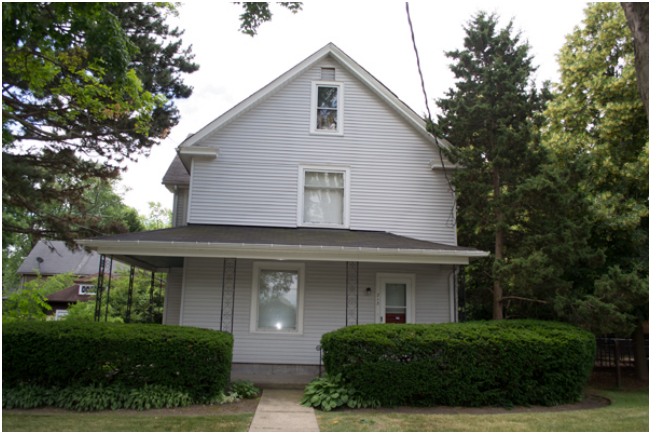
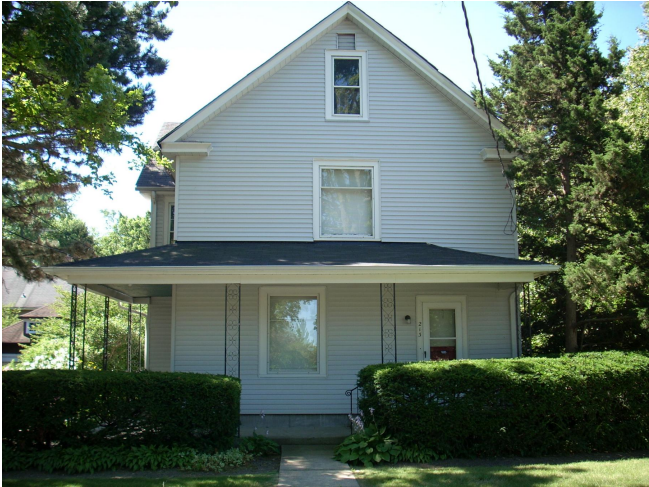
Photo Id: MapleAveW213(1)

<b>CATEGORY</b>	Building	<b>HISTORIC USE</b>	Domestic - single dwelling
<b>CONDITION</b>	Good	<b>SECONDARY STRUCTURE</b>	-
<b>INTEGRITY</b>	Minor alterations and additions	<b>NR SECOND</b>	-
<b>CURRENT USE</b>	Domestic - single dwelling

Front gable roof and rectangular massing; 2-story east side gable bay; some historic windows (1st and 2nd stories of front facade)

Replacement siding; some replacement windows in original openings on side elevation; new window under front gable; extensive alterations to porch (concrete base and steps, wrought iron railings); 1 story rear addition (1980); rear deck addition (1980)

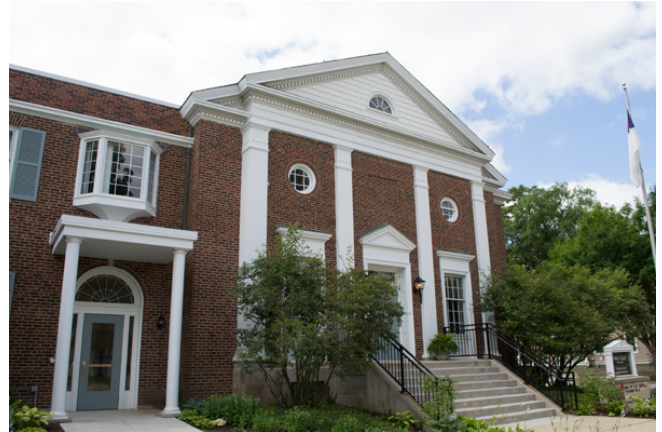
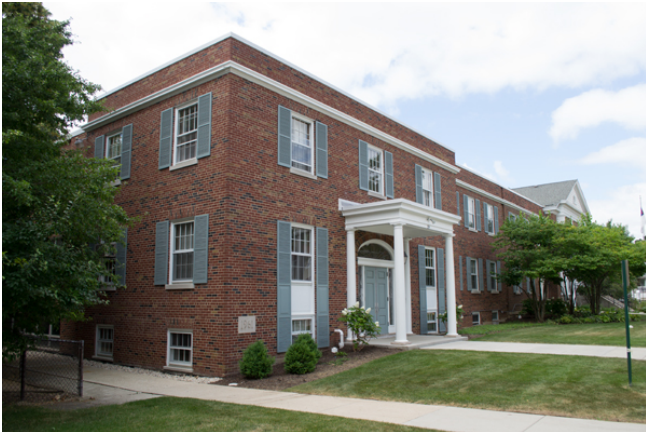
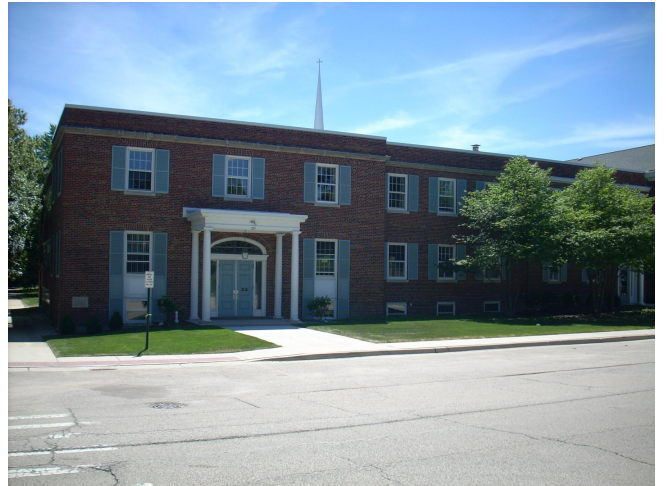
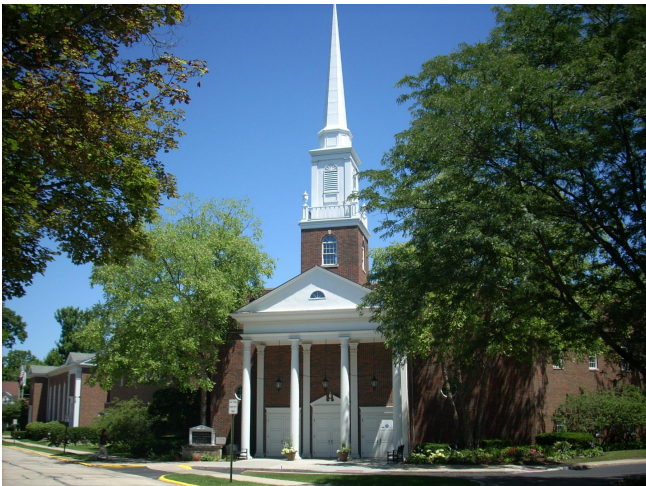
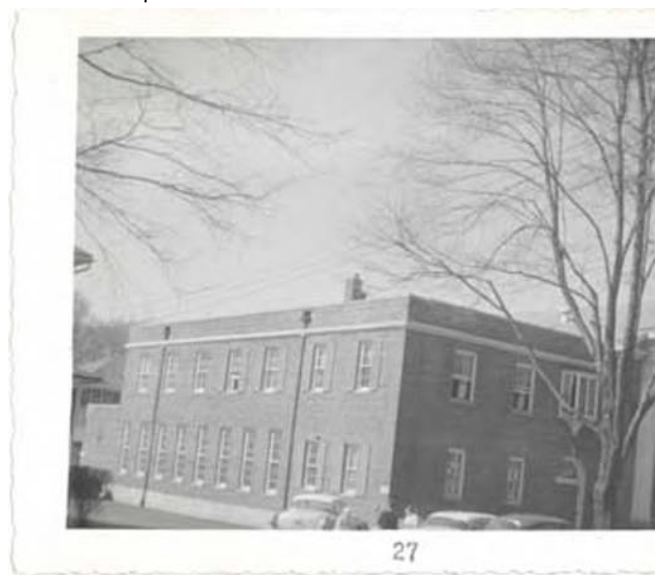
Photo Id: MapleAveW219(7)

<b>CATEGORY</b>	<input type="text" value="Building"/>	<b>HISTORIC USE</b>	<input type="text" value="Religion - religious facility"/>
<b>CONDITION</b>	<input type="text" value="Good"/>	<b>SECONDARY STRUCTURE</b>	<input type="text" value="-"/>
<b>INTEGRITY</b>	<input type="text" value="Major alterations and/or additions"/>	<b>NR SECOND</b>	<input type="text" value="-"/>
<b>CURRENT USE</b>	<input type="text" value="Religion - religious facility"/>

2-story educational building addition at east end of original building (1961); 2-story addition south of original church building (larger than original building and 1961 addition combined), with new sanctuary and offices--addition features a new main entrance with front portico and steeple along Douglas Avenue

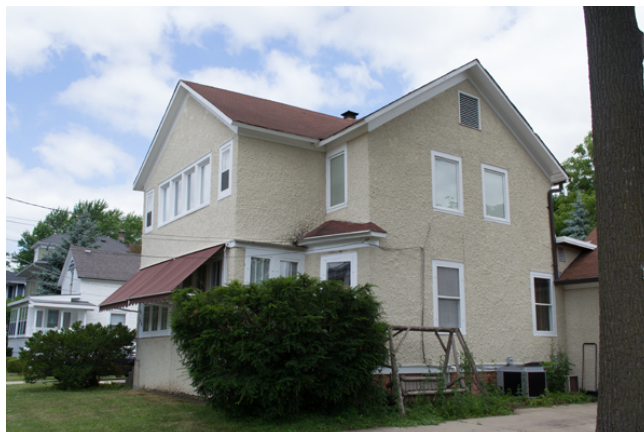
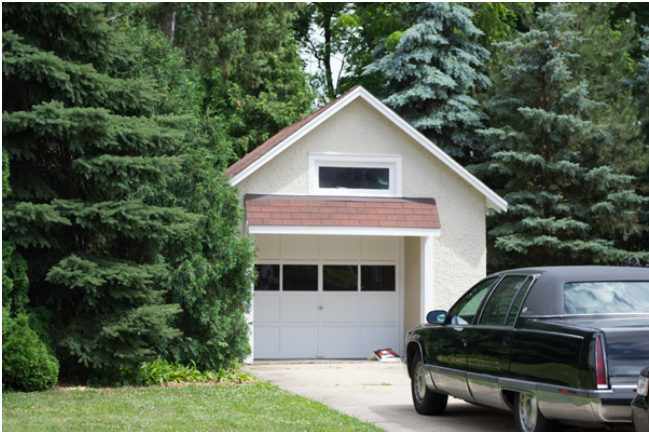
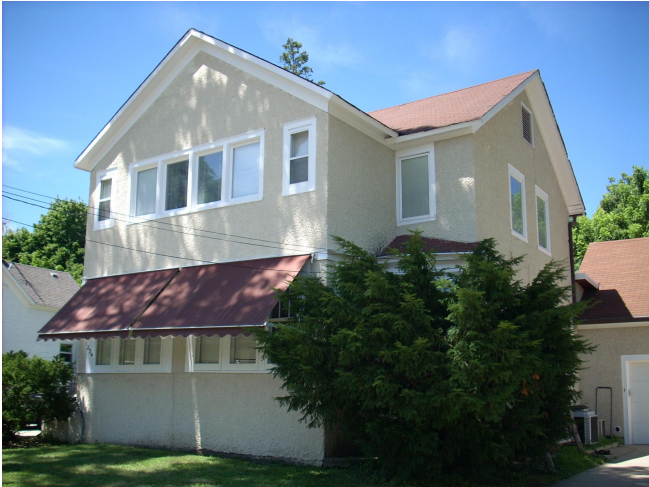
Photo Id: MapleAveW234(1)

<b>CATEGORY</b>	Building	<b>HISTORIC USE</b>	Domestic - single dwelling
<b>CONDITION</b>	Good	<b>SECONDARY STRUCTURE</b>	[attached garage]
<b>INTEGRITY</b>	Historic alterations and additions	<b>NR SECOND</b>	-
<b>CURRENT USE</b>	Domestic - single dwelling

2-story enclosed front porch addition (1920s--foundation is different than side gable section) with 3/1 windows on front facade; stucco cladding (1920s); single-light wood replacement windows throughout (not historically compatible type or configuration); 1-story rear addition and garage addition (2001)

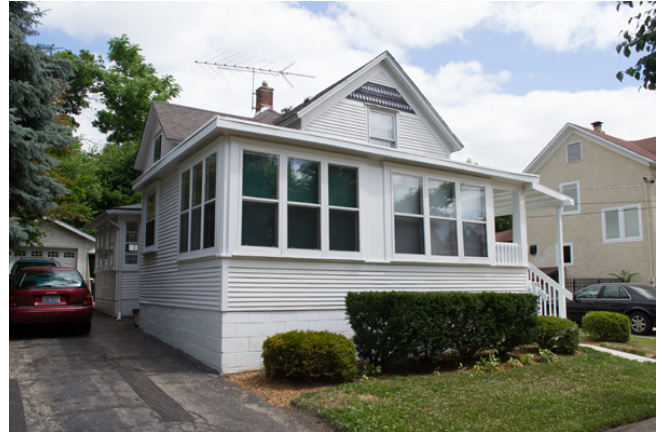
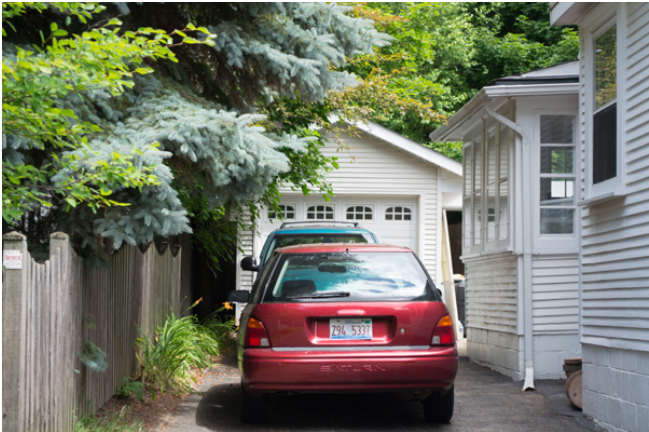
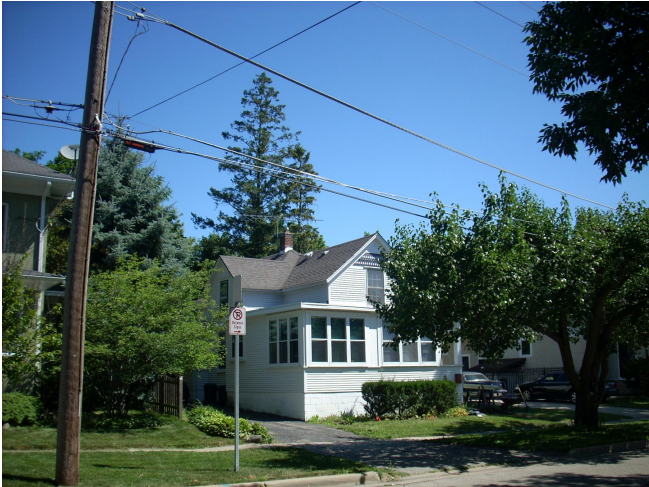
Photo Id: MapleAveW302(3)

<b>CATEGORY</b>	Building	<b>HISTORIC USE</b>	Domestic - single dwelling
<b>CONDITION</b>	Good	<b>SECONDARY STRUCTURE</b>	Detached garage
<b>INTEGRITY</b>	Historic additions/minor alterations	<b>NR SECOND</b>	NC
<b>CURRENT USE</b>	Domestic - single dwelling

Replacement front sun porch (historic--pre-1933); non-historic shed-roof entry porch at east end of front sun porch; northwest corner sun porch (historic--pre-1933); non-historic replacement windows in original openings on front and side elevations of house; one-story rear addition (historic--pre-1933)

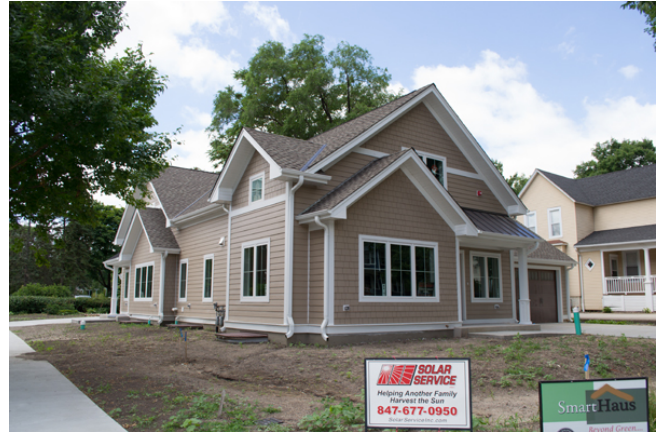
Photo Id: MapleAveW305(1)

<b>CATEGORY</b>	Building	<b>HISTORIC USE</b>	Domestic - single dwelling
<b>CONDITION</b>	Good	<b>SECONDARY STRUCTURE</b>	[attached garage]
<b>INTEGRITY</b>	Minor alterations and additions	<b>NR SECOND</b>	-
<b>CURRENT USE</b>	Domestic - single dwelling
