# Historic Libertyville

<b>BEGINNING STREET NUMBER</b>	136
<b>END STREET NUMBER</b>	-
<b>STREET # SUFFIX</b>	-
<b>STREET NAME</b>	Newberry Avenue
<b>PIN</b>	
<b><u>LOCAL</u></b>	
<b>WITHIN LOCAL DISTRICT?</b>	No
<b>LOCAL DIST CONTRIB/NON-CONTRIB?</b>	C
<b>LOCAL LANDMARK?</b>	No
<b>YEAR</b>	-
<b>LOCAL LANDMARK ELIGIBLE?</b>	Potentially Eligible
<b>CRITERIA</b>	A

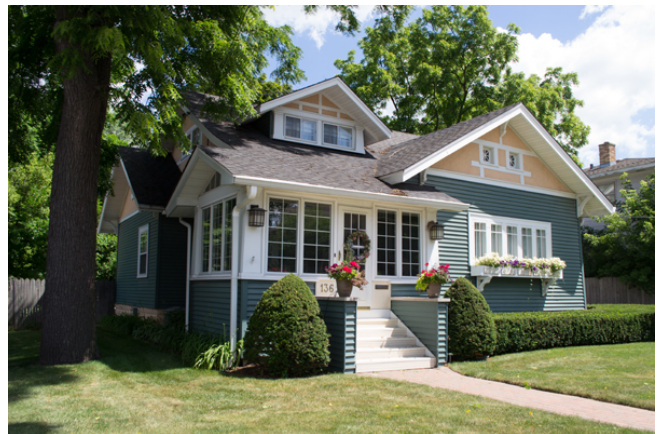
Photo Id: NewberryAve136(1)

Side gable roof with L brackets under eaves; front gable bay with battered corners, decorative half timbering; east side oriel window bay; corner entry porch with battered square columns; gable front dormer

Replacement siding on sections of exterior; front porch enclosed; alterations to rear porch (replaced 1956, alterations 1970)

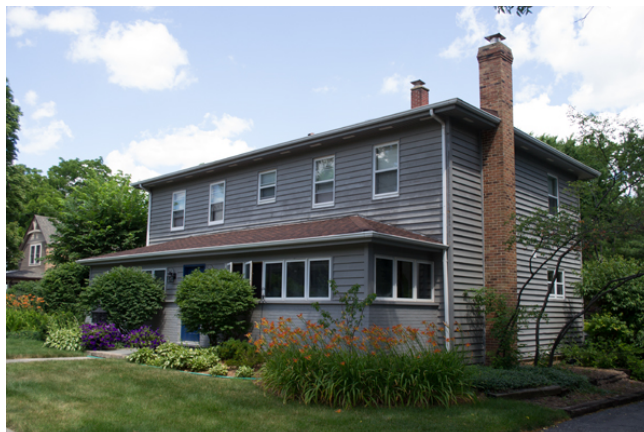
Photo Id: NewberryAve158(1)

Original massing and roofline of house obscured by large, 2-story west side addition built in 1986; original porch removed and replaced with new enclosed porch; replacement siding; replacement windows in original openings
