Historic Libertyville

BEGINNING STREET NUMBER	121
END STREET NUMBER	-
STREET # SUFFIX	-
STREET NAME	W. Church Street
PIN	
<u>LOCAL</u>	
WITHIN LOCAL DISTRICT?	No
LOCAL DIST CONTRIB/NON-CONTRIB?	C
LOCAL LANDMARK?	No
YEAR	-
LOCAL LANDMARK ELIGIBLE?	No
CRITERIA	-

SURVEY DATE

SURVEY AREA

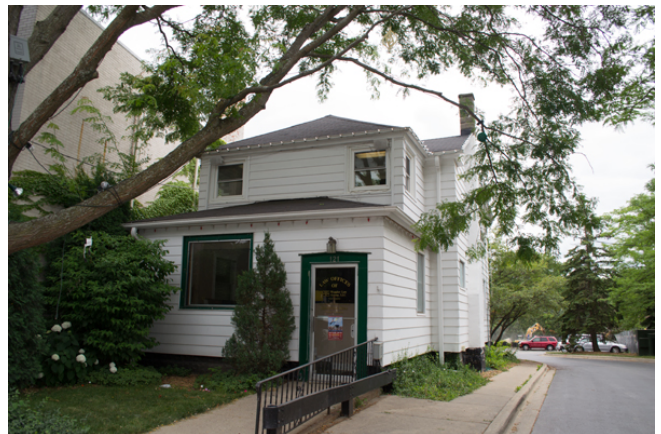
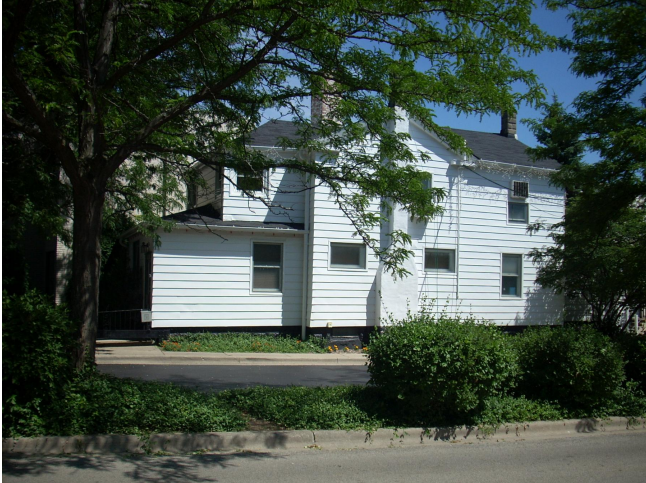
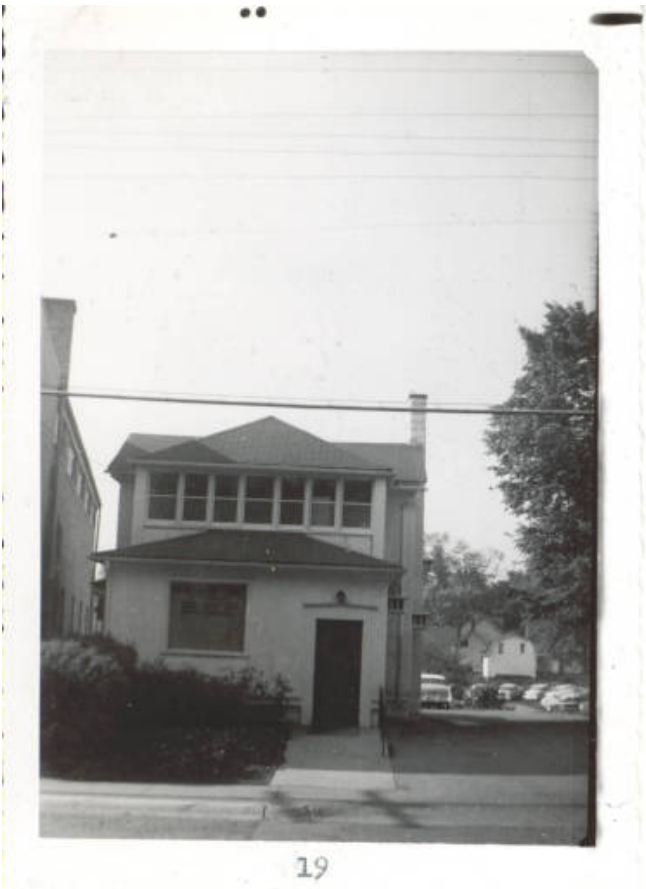
Photo Id: ChurchStW121(1)

CATEGORY	Building	HISTORIC USE	Domestic - single dwelling
CONDITION	Good	SECONDARY STRUCTURE	-
INTEGRITY	Moderate alterations	NR SECOND	-
CURRENT USE	Commerce/Trade - business

Side gable roof with cornice returns; rectangular massing

Replacement siding (1970); replacement windows in original openings; rear porch enclosed; front porch enclosed (c. 1945) and expanded (post 1948); 2nd story front (north) addition above enclosed porch (post 1948)

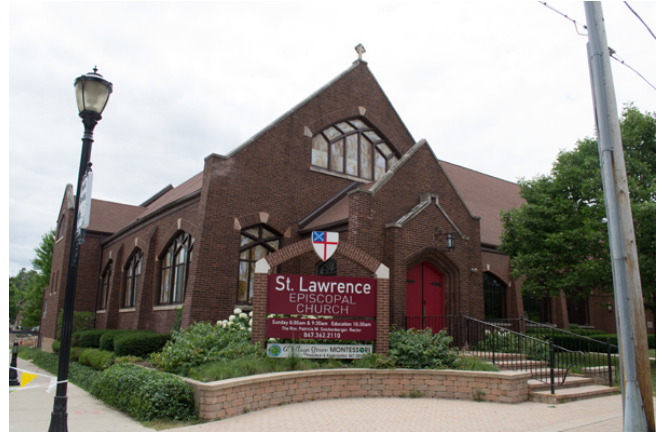
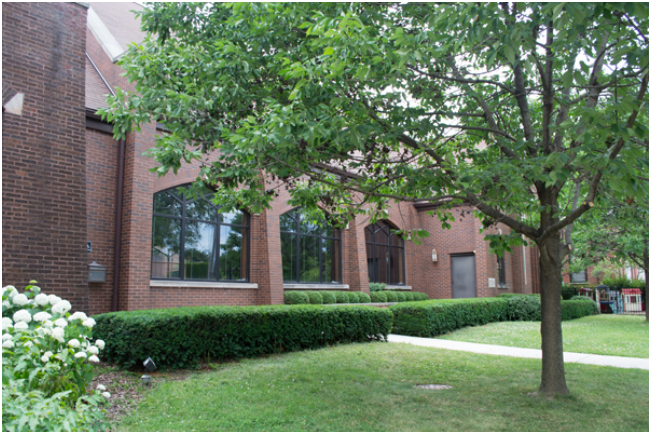
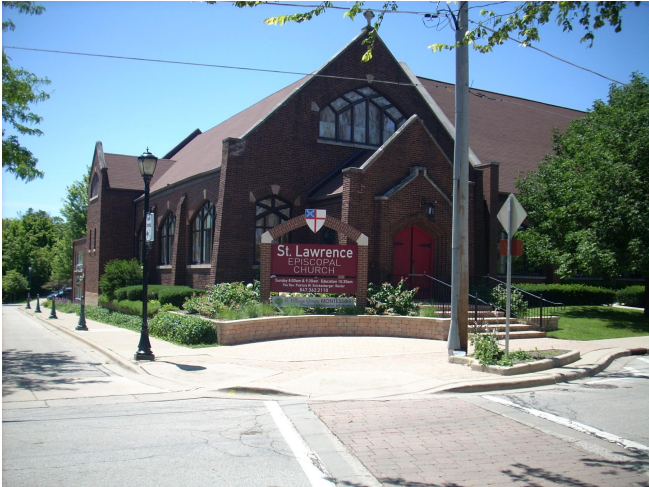
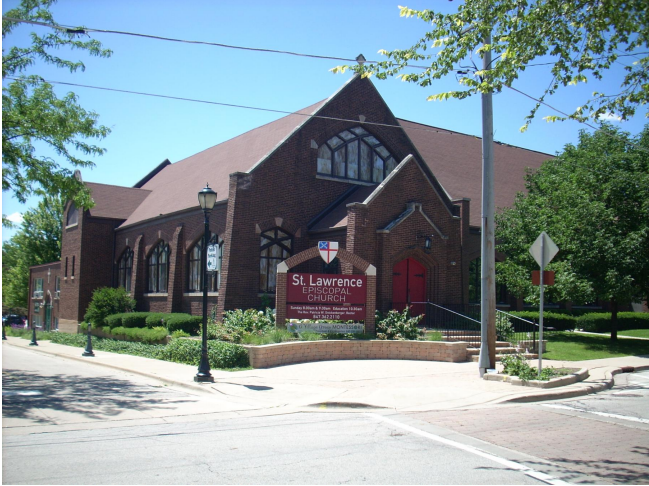
Photo Id: ChurchStW125(1)

CATEGORY	Building	HISTORIC USE	Religion - religious facility
CONDITION	Good	SECONDARY STRUCTURE	-
INTEGRITY	Additions	NR SECOND	-
CURRENT USE	Religion - religious facility

Sanctuary section of building features a broad, parapeted front gable roof; nested gable entry bay with double wood plank doors; side of sanctuary features decorative brick buttresses; multi-light pointed arch stained glass windows at original building

1-story addition behind sanctuary and original educational wing (1963-4); large 1.5-story east and north addition (2003)

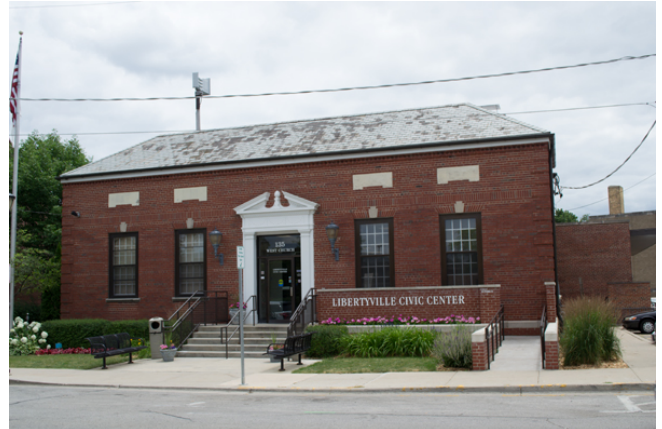
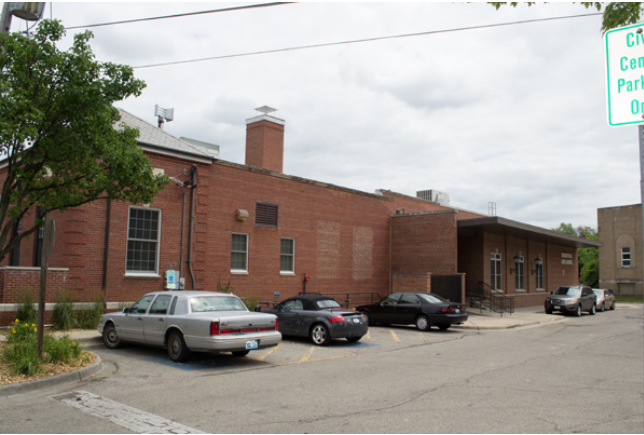
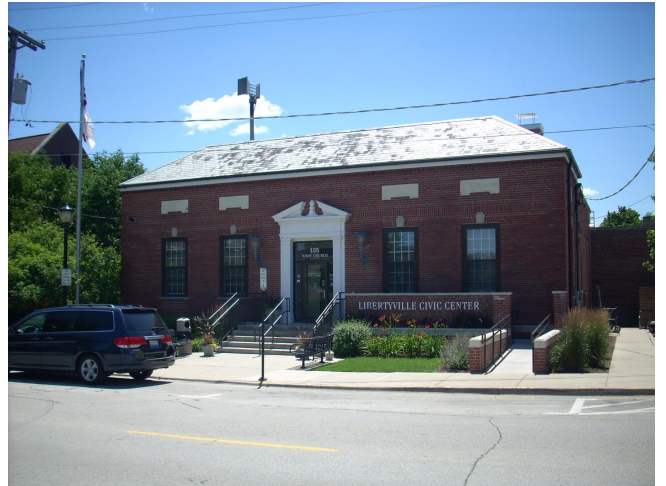
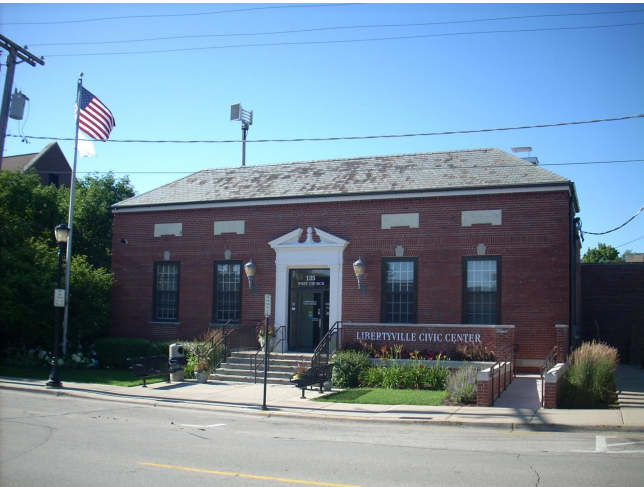
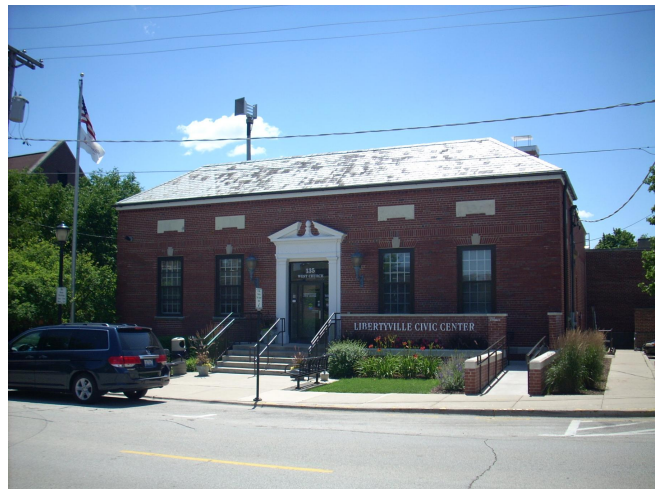
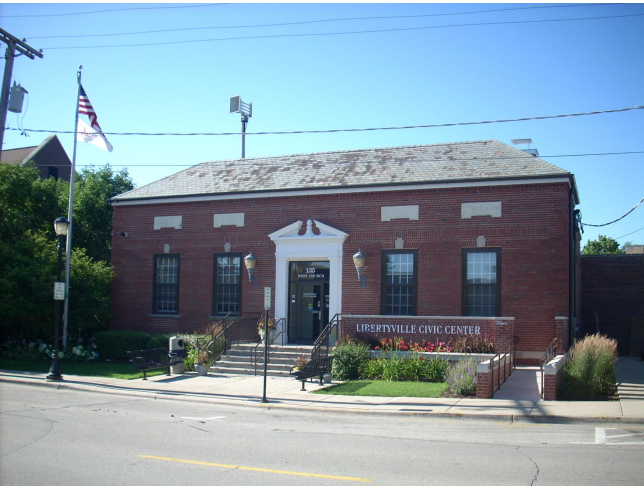
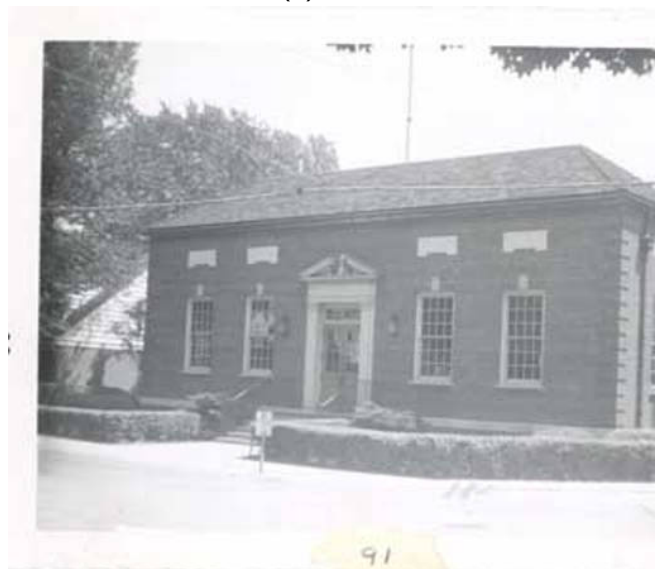
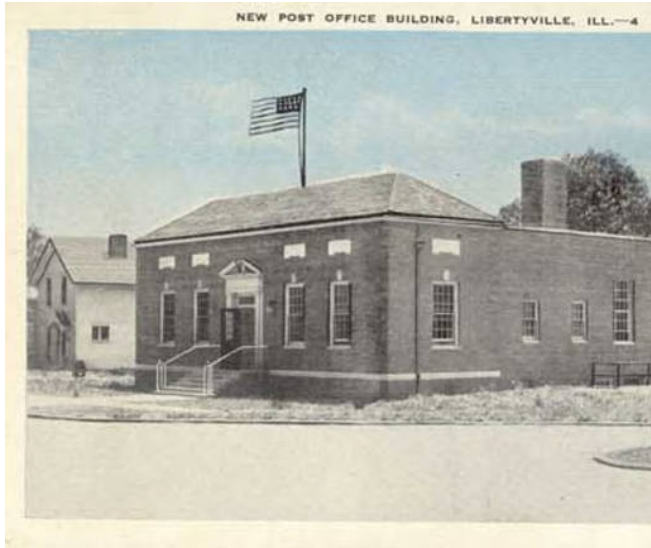
Photo Id: ChurchStW135(1)

CATEGORY	Building
CONDITION	Good
INTEGRITY	Minor alterations and additions
CURRENT USE	Social - civic

Low-pitched hipped roof and rectangular massing; symmetrical front facade with center entry; classical entry surround with broken pediment; center keystone window lintels; decorative stone panels above window openings

1-story rear addition; 1-story west loading dock addition; replacement windows in original openings; replacement front door; some windows on side elevations bricked in

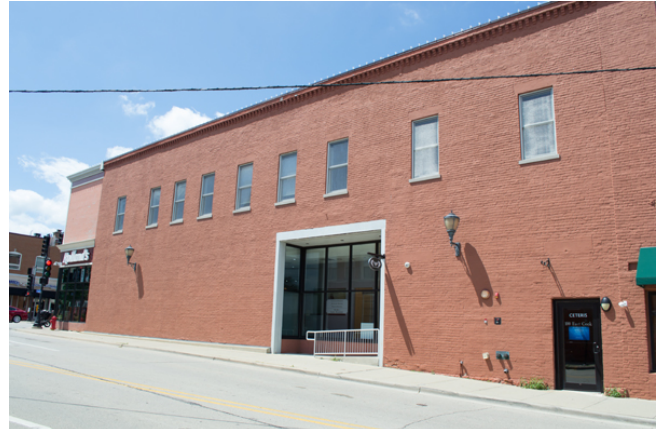
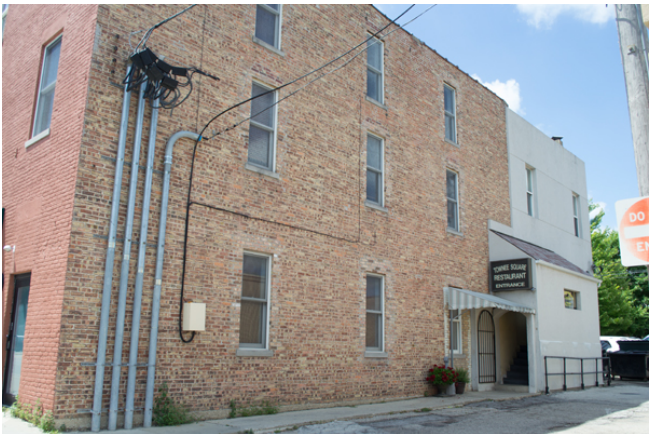
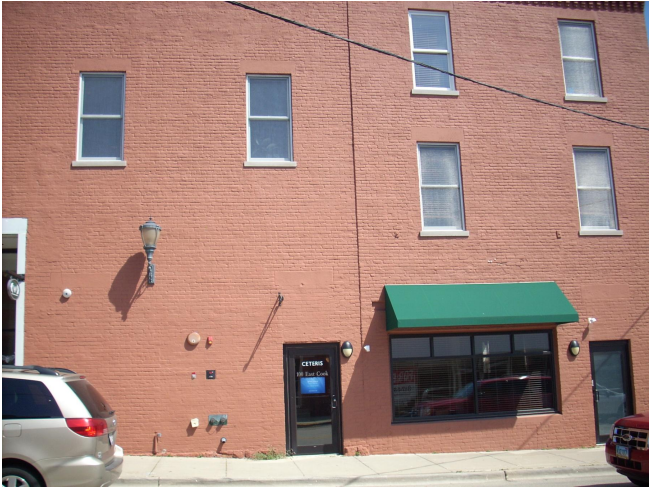
Photo Id: CookAveE100(1)

CATEGORY	Building	HISTORIC USE	Commerce/Trade
CONDITION	Good	SECONDARY STRUCTURE	-
INTEGRITY	Moderate alterations	NR SECOND	-
CURRENT USE	Commerce/Trade

corbelled brick cornice; original stone lintels visible on 2nd floor

Brick painted; replacement windows in downsized openings on upper floors; replacement storefront windows and door in altered/downsized openings

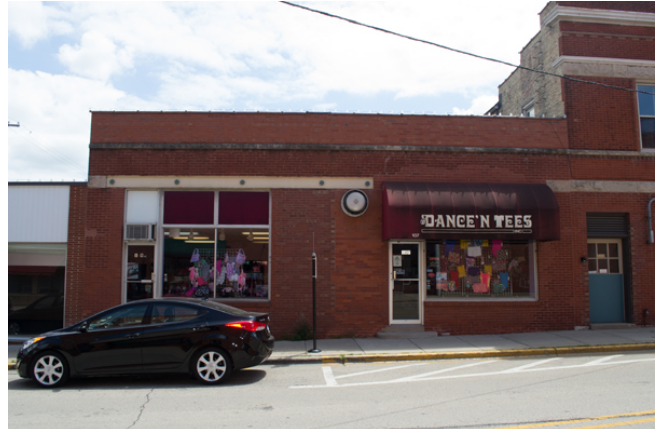
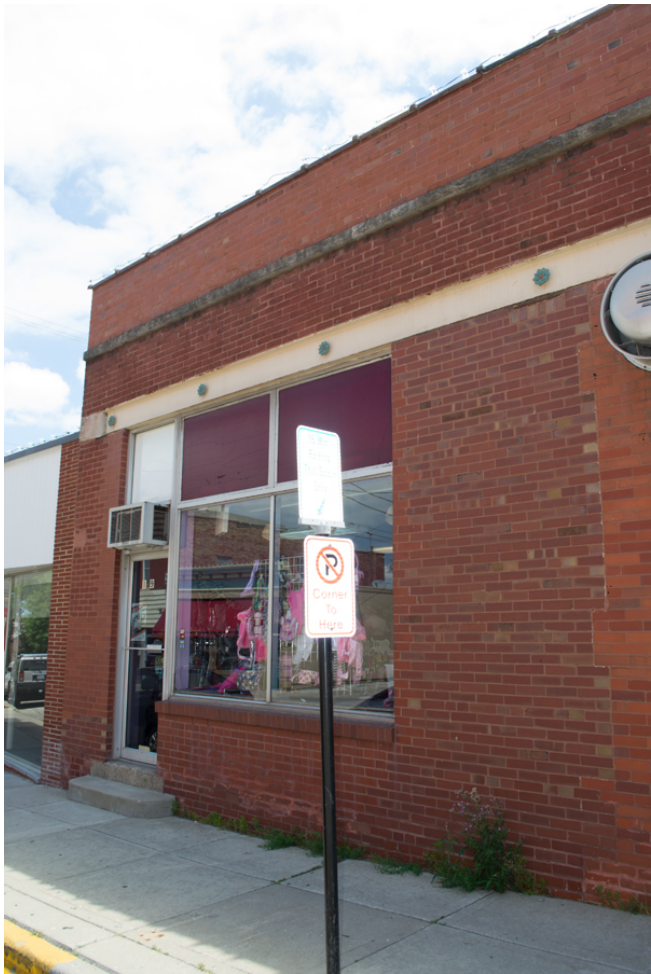
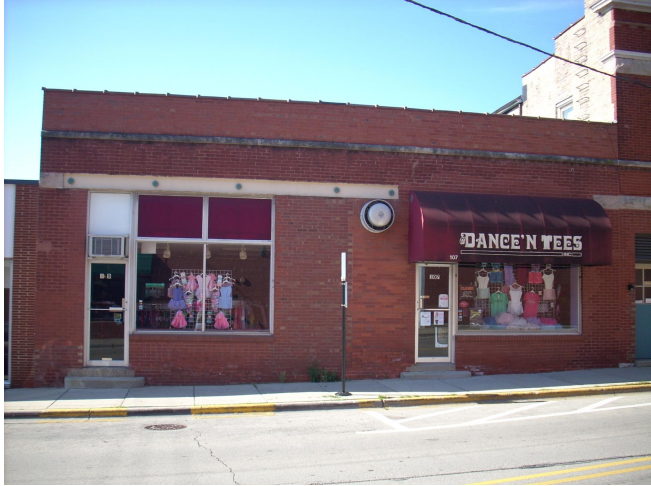
Photo Id: CookAveE107-109(1)

CATEGORY	Building	HISTORIC USE	Commerce/Trade
CONDITION	Good	SECONDARY STRUCTURE	-
INTEGRITY	Major alterations	NR SECOND	-
CURRENT USE	Commerce/Trade - retail

Brick exterior; rectangular massing; metal lintel with tie backs over east storefront; stone stringcourse between storefront level and parapet wall

Replacement storefront windows and doors in altered openings; parapet wall appears rebuilt or added; awning over west storefront

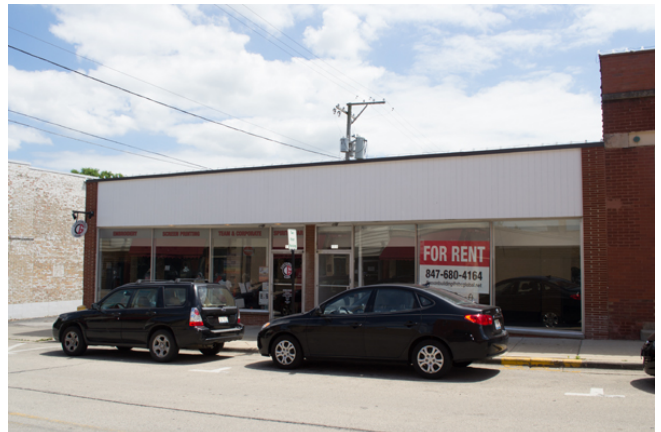
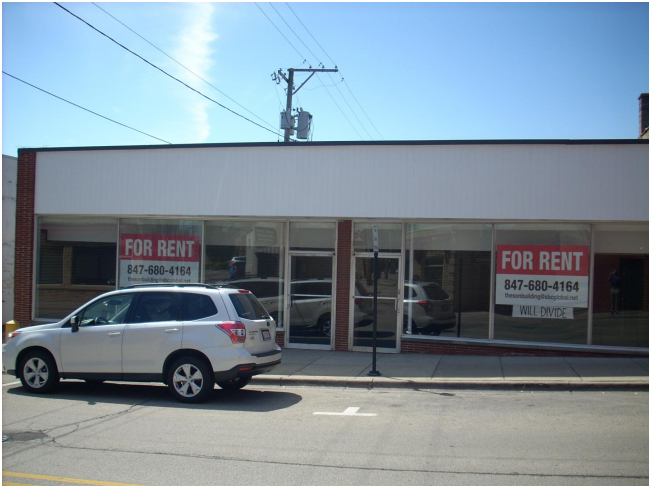
Photo Id: CookAveE111-113(1)

CATEGORY	Building	HISTORIC USE	Commerce/Trade
CONDITION	Good	SECONDARY STRUCTURE	-
INTEGRITY	Not altered	NR SECOND	-
CURRENT USE	Vacant

Curving front facade with roman brick cladding; paired, mirror image storefronts with aluminum windows and doors

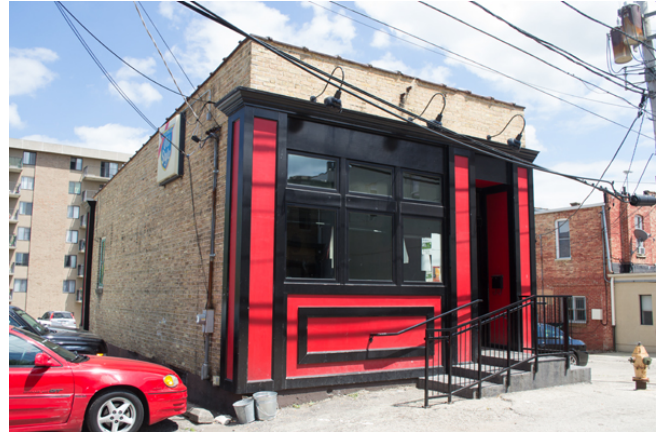
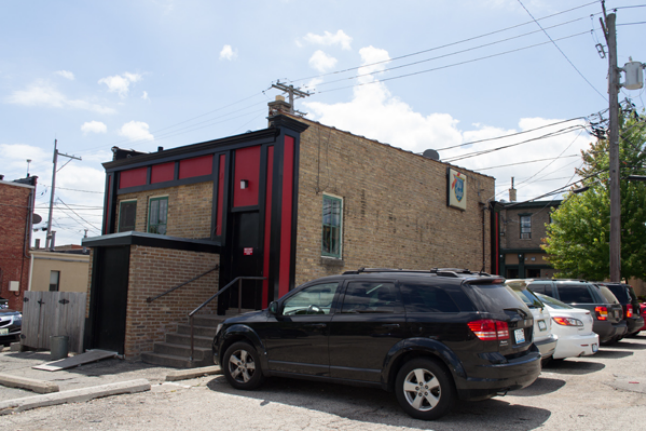
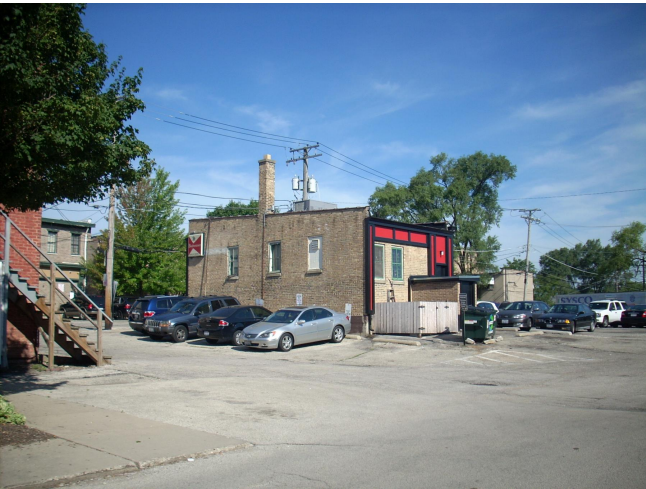
Photo Id: CookAveE112(1)

CATEGORY	Building	HISTORIC USE	Commerce/Trade
CONDITION	Good	SECONDARY STRUCTURE	-
INTEGRITY	Major alterations	NR SECOND	-
CURRENT USE	Commerce/Trade - restaurant

Flat roof, rectangular massing, common brick exterior; some historic 2/2 wood windows on side and rear elevations

Storefront configuration and materials are not historic; 1-story rear addition; rear concrete steps

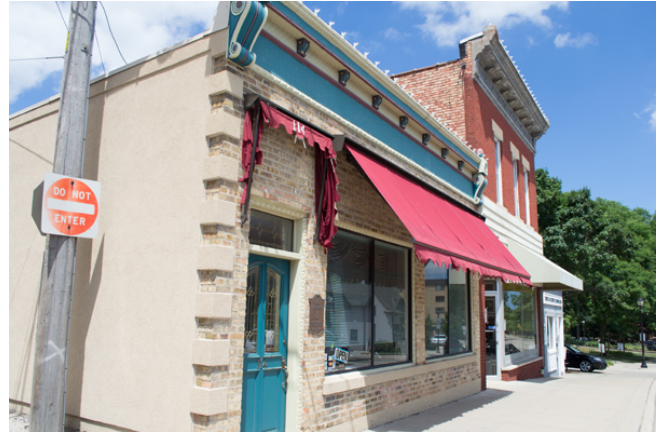
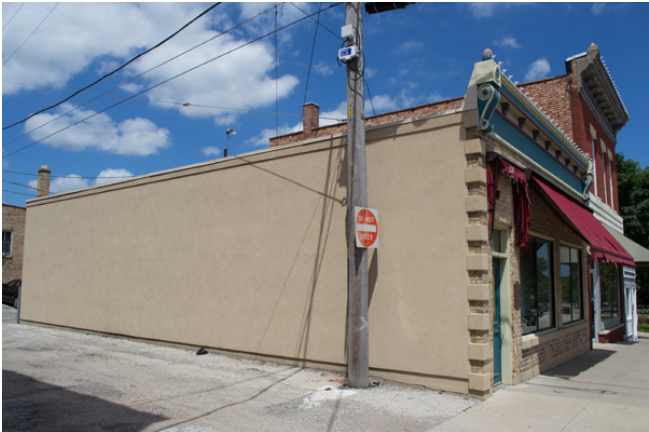
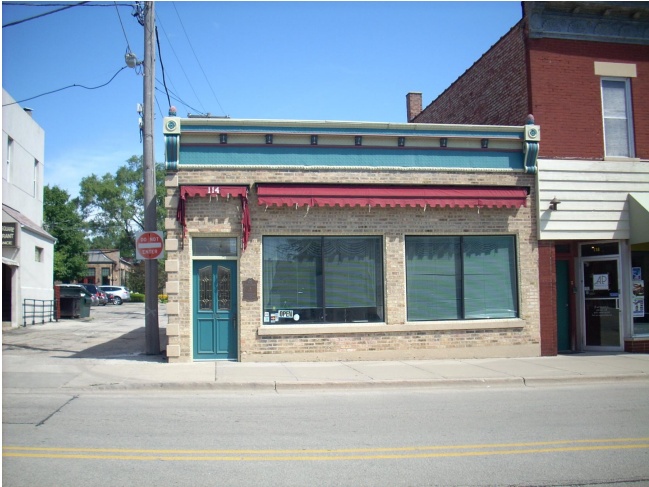
Photo Id: CookAveE114(1)

CATEGORY	<input type="text" value="Building"/>	HISTORIC USE	<input type="text" value="Commerce/Trade"/>
CONDITION	<input type="text" value="Good"/>	SECONDARY STRUCTURE	<input type="text" value="-"/>
INTEGRITY	<input type="text" value="Major alterations"/>	NR SECOND	<input type="text" value="-"/>
CURRENT USE	<input type="text" value="Commerce/Trade"/>

Building remodeled in 1992--cornice addition; replacement front door; stucco finish on concrete corner quoins; other alterations include replacement windows in original openings

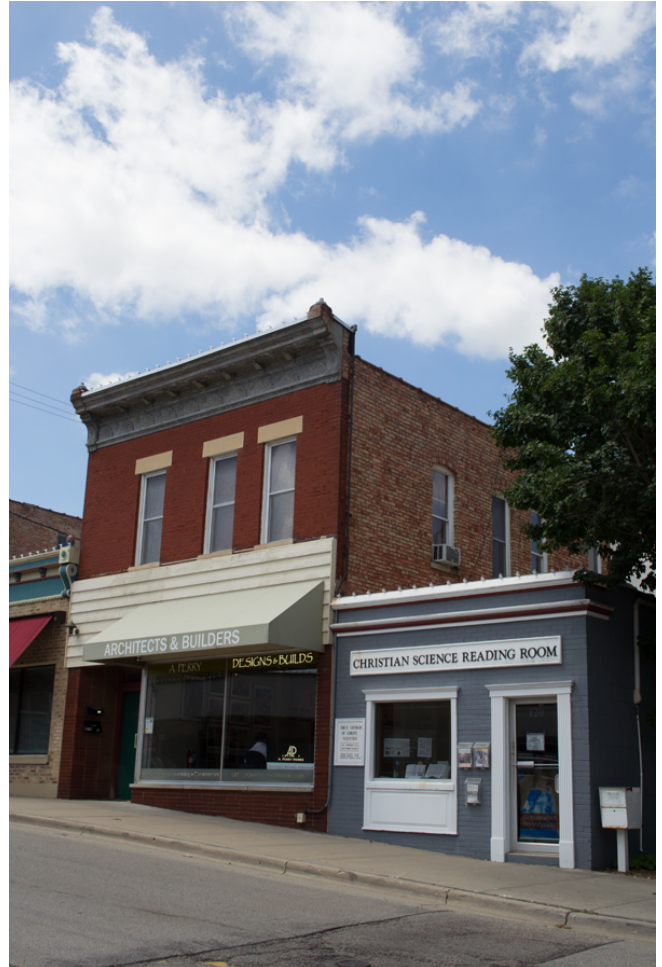
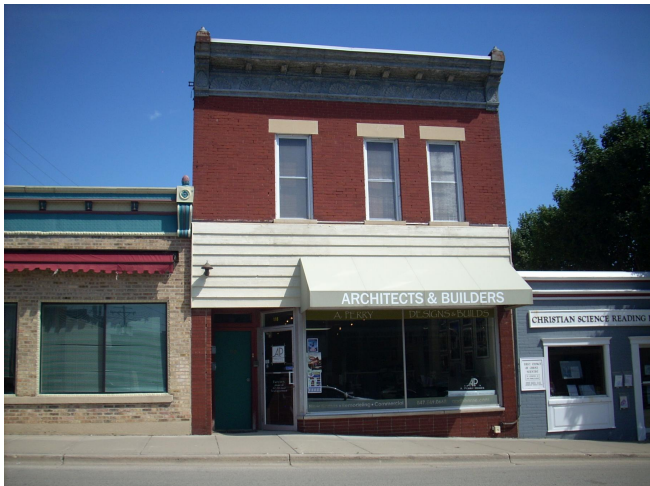
Photo Id: CookAveE116-118

Replacement windows on upper story; storefront level reconfigured with angled storefront entry, recessed 2nd story entry, and Roman brick bulkhead (1956); wood siding between 1st and 2nd stories on front facade; awning; 2nd story east side addition

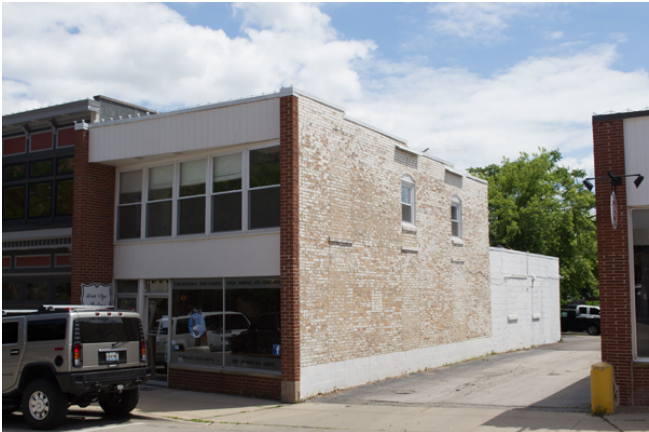
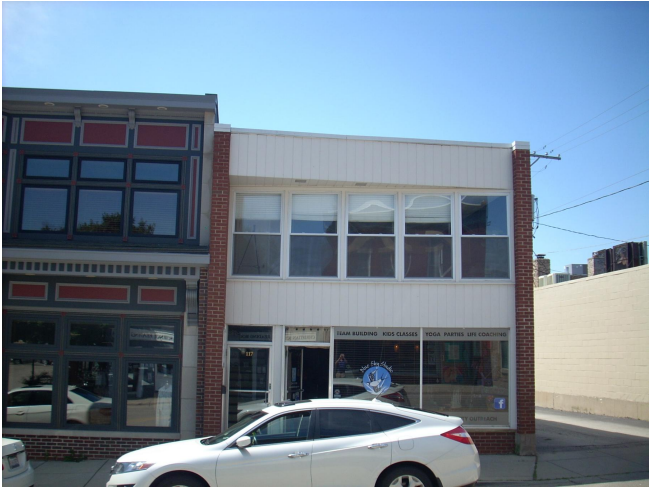
Photo Id: CookAveE117(1)

Front facade extensively remodeled in the 1958; non-historic replacement windows in original openings on 2nd story; replacement storefront windows and doors; segmental arch window openings bricked in on side
